FOR CONTRACT NO.: 07-2X9204

GEOTECHNICAL DESIGN REPORT

ROUTE: 07-LA-91-R9.8/R12.1

Subject: GEOTECHNICAL DESIGN REPORT

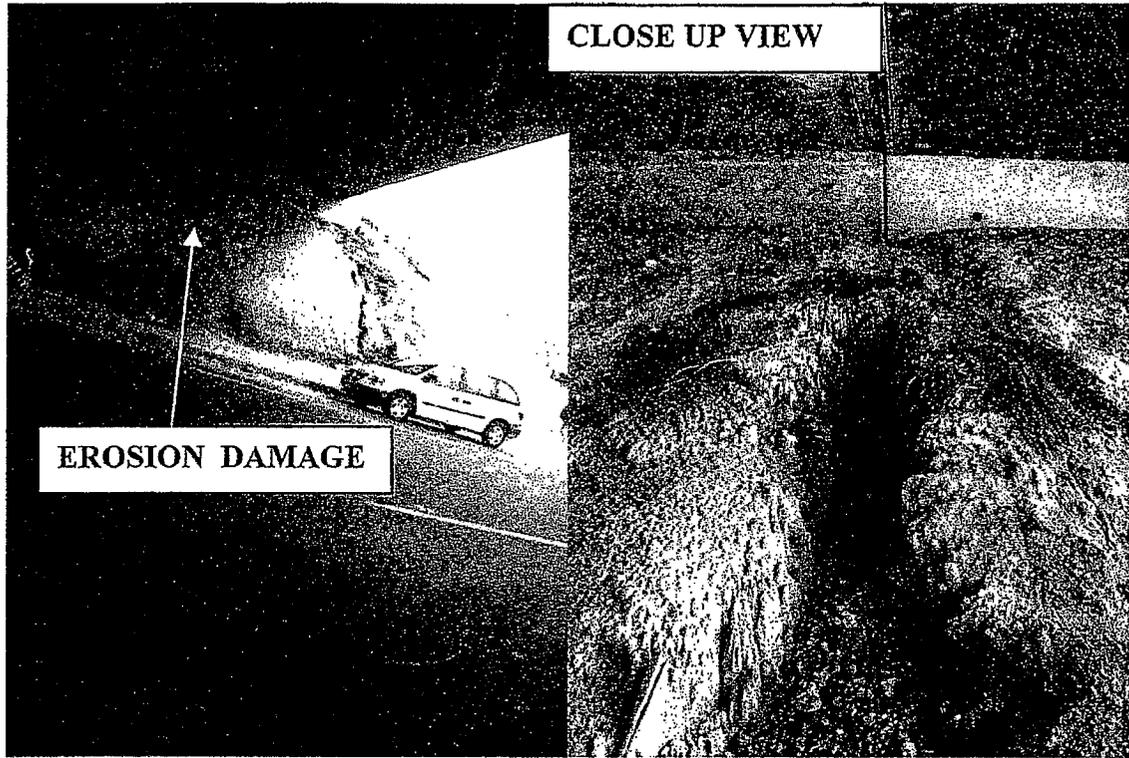
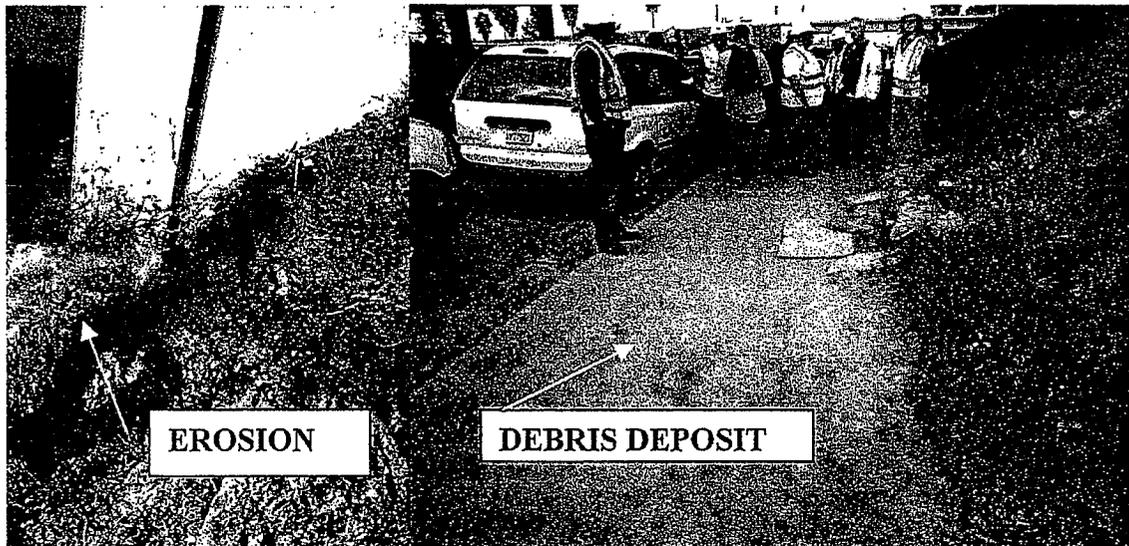
At the time of our field investigation moderate to severe slope erosion from the joints of the bridges as well as from weep holes under the bridge occurred. Maintenance field personnel reported that the heavy rain on January 17 caused the erosion with gullies as deep as 3-feet, located just below the joints of the OH.

Debris deposits on the existing sidewalk, at the toe of the slope, adjacent to Santa Fe Ave was also observed.

We recommend the slope conditions described in the sections above should be mitigated by emergency project by installing downrain pipes below the joint of the structures, under the bridge, and followed by reconstructing the slope in accordance with Section 19 of Standard Specification dated May 2006. The joint at the SE corner should be mitigated with concrete open channel or a swale.

As a long-term solution, we also recommend to pave the whole slope following section 72-6 of the Caltrans Standard Specifications dated May 2006. This will also prevent water from causing erosion and allowing mud and debris from entering the sidewalk area.

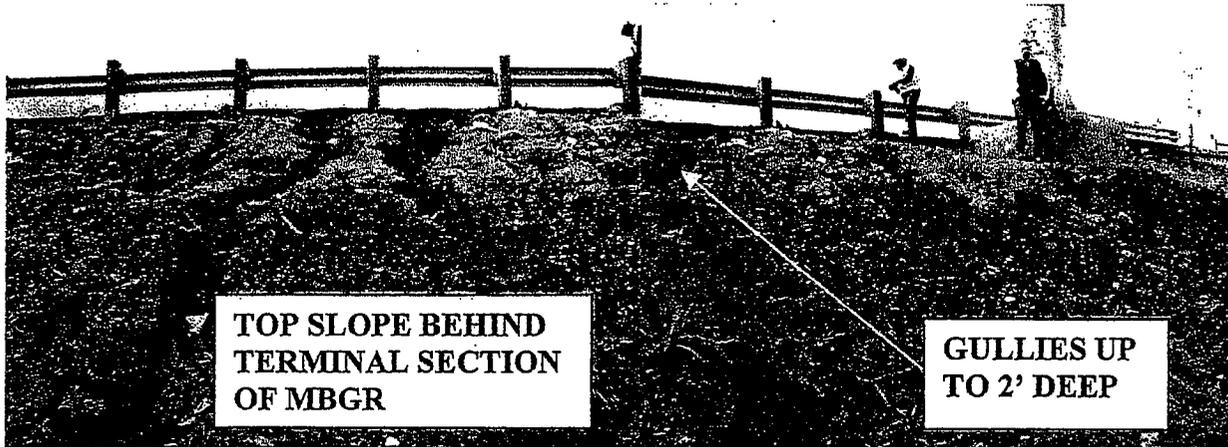
07-LA-91-PM 10.3

At the time of our field investigation moderate slope erosion on the upper portion of the slope just below the existing Metal Beam Guard Rail (MBGR) occurred. Maintenance field personnel reported that the heavy rain on January 17 caused the erosion with gullies as deep as 2-feet. There is an overhead sign structure at the top of the slope, which is protected with MBGR. The cause of erosion is run-off overtopping the existing 2-inch high dike (Type C dike), located in front of the terminal section of the Metal Beam Guard Rail (MBGR).

Hydraulics should be consulted to provide recommendations for the slope conditions described in the sections above to be mitigated by emergency project. The 2-inch dike is insufficient to control runoff on the slope. Hydraulics also shall provide a means of draining the run-off down the slope with out causing further slope erosion. We also recommend, temporarily placing sand bags behind the terminal section of MBGR to direct or channel runoff and mitigate overtopping of the existing Type C dike until the permanent fix is completed.

In addition we recommend the slope be repaired by filling the erosion gullies to reconstruct the embankment and covered with jute mesh. To encourage vegetative growth, applying hydro seeding and mulching is also recommended.

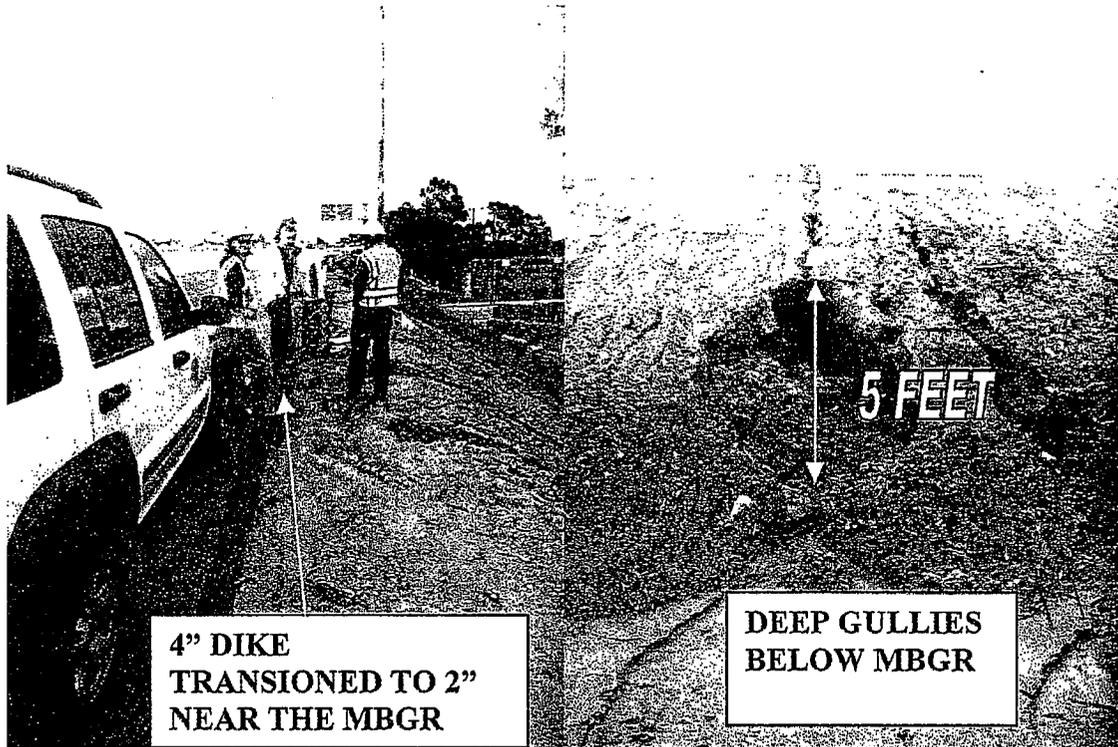
07-LA-91-PM 10.8

At the time of our field investigation severe slope erosion on the portion of the slope just below the existing Metal Beam Guard Rail (MBGR) occurred. Maintenance field personnel reported that the heavy rain on January 17 caused the erosion with gullies as deep as 5-feet. The existing 4-inch (Type "F") dike transitioned to 2-inch (Type "C") dike in front of the terminal section of MBGR is the cause for run-off overtopping the 2-inch high dike. No sign of overtopping of runoff observed over the section where we have 4-inch dike.

**4" DIKE
TRANSIONED TO 2"
NEAR THE MBGR**

**DEEP GULLIES
BELOW MBGR**

Hydraulics should be consulted to provide recommendations for the slope conditions described in the sections above to be mitigated by emergency project. The 2-inch dike is insufficient to control runoff on the slope. Hydraulics also shall provide a means of draining the run-off down the slope without causing further slope erosion. We also recommend, temporarily placing sand bags behind the terminal section of MBGR to direct or channel runoff and mitigate overtopping of the existing Type C dike until the permanent fix is completed.

Reconstruction of the slope (again) by filling the erosion gullies to reconstruct the embankment. The slope shall be covered with jute mesh following Section 19 of the Standard Specifications. Should the height of the dike not be increased as previously recommended, then, pavement of the slope (100-foot in length along the shoulder) per Section 72-6 of Standard Specifications will be required.

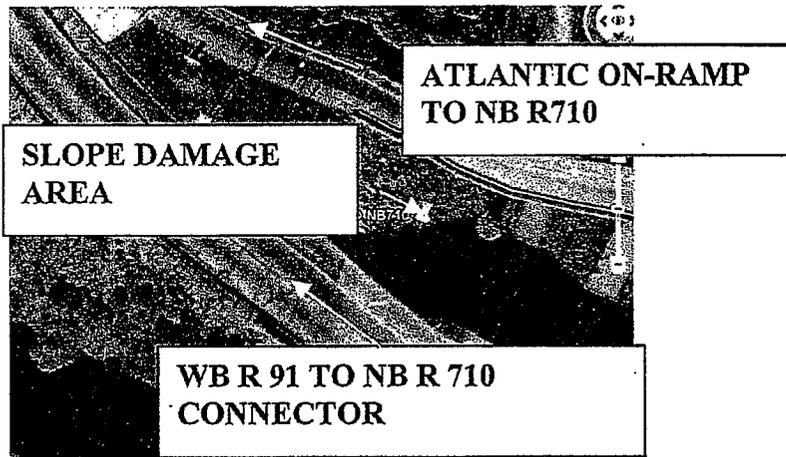
FIGURE 1

At the time of our field investigation slumping on the upper portion of slope was observed. Maintenance field personnel reported that the intense rain on January 17 caused 10-15-foot wide area of the upper portion of the slope to slump, approximately 10 feet down the slope. The WB SR 91 connector near the gore area is in full super-elevated curve allowing surface run-off to overtop the existing approximately 2-inch dike near the gore area, causing erosion damage of the fill slope (as shown on attached pictures). No drainage device was observed at the site to carry the concentrated run-off from the connector and the gore area, at the top of the slope, to the bottom of the slope.

We recommend reconstructing the entire 60-foot slope width in accordance with section 19 of the Standard Specifications. Increasing the height of the berm (dike) near the gore area, at the end of the connector is also recommended. The onsite material can be used to rebuild the slope. The material shall be benched as shown in Figure 2 and a minimum of 90% relative compaction shall be achieved. If no re-vegetation is done as part of this project, the slope shall be Hydro-seeded and covered with jute mesh upon completion of grading.
