**LIMITED ASBESTOS AND LEAD-BASED PAINT SURVEY REPORT  
BUCKMAN SPRINGS REST AREA  
PINE VALLEY, CALIFORNIA  
FEBRUARY 25, 2009**

**ROUTE: 11-SD-8-49.0**

**CALTRANS DISTRICT 11 EA 243201  
CONTRACT NO. 11A1638  
TASK ORDER NO. 3**

**February 25, 2009**

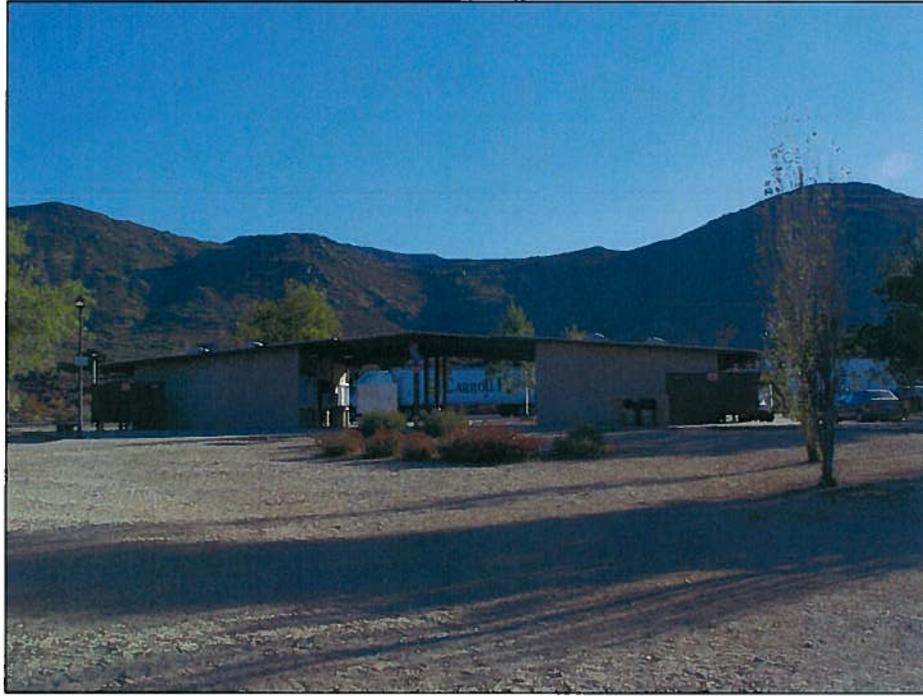
VIEW OF SITE COMFORT BUILDING FROM WEST.

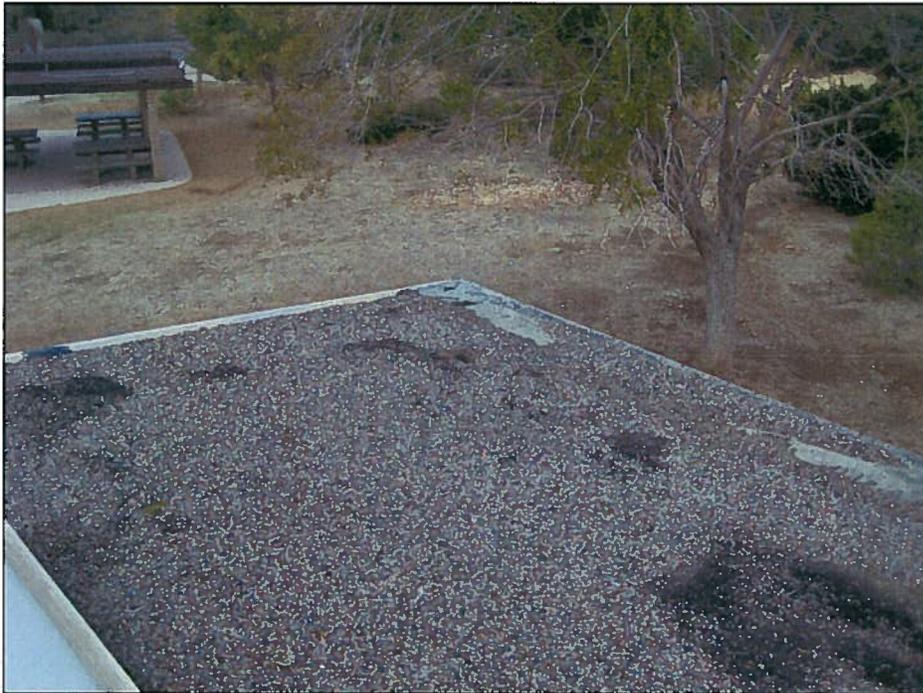
TYPICAL ROOF AND BSRA-1A SAMPLE LOCATION-NORTH ROOF.

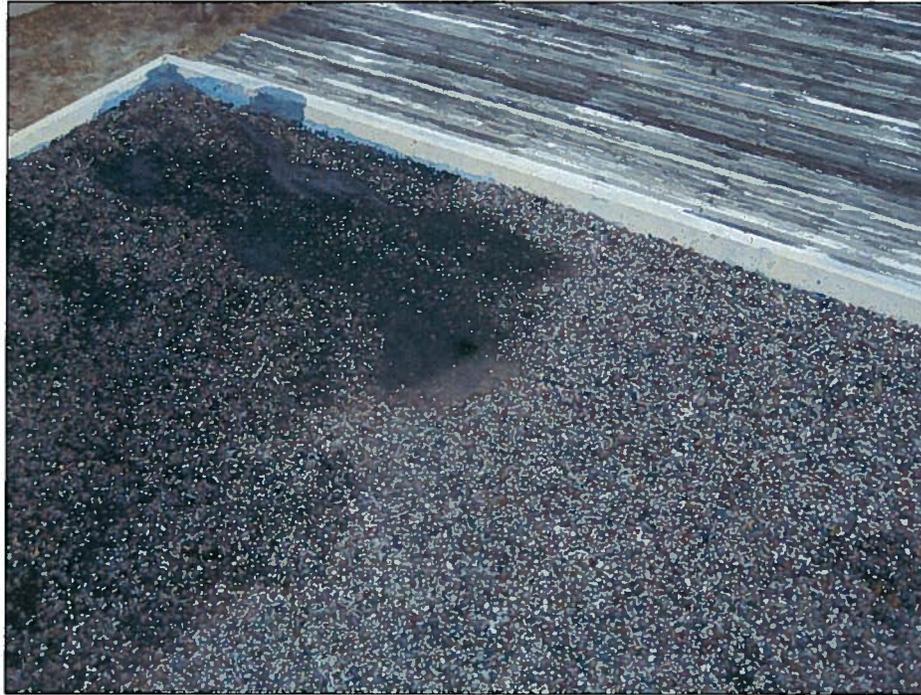
**BSRA-1B SAMPLE LOCATION-NORTH ROOF.**

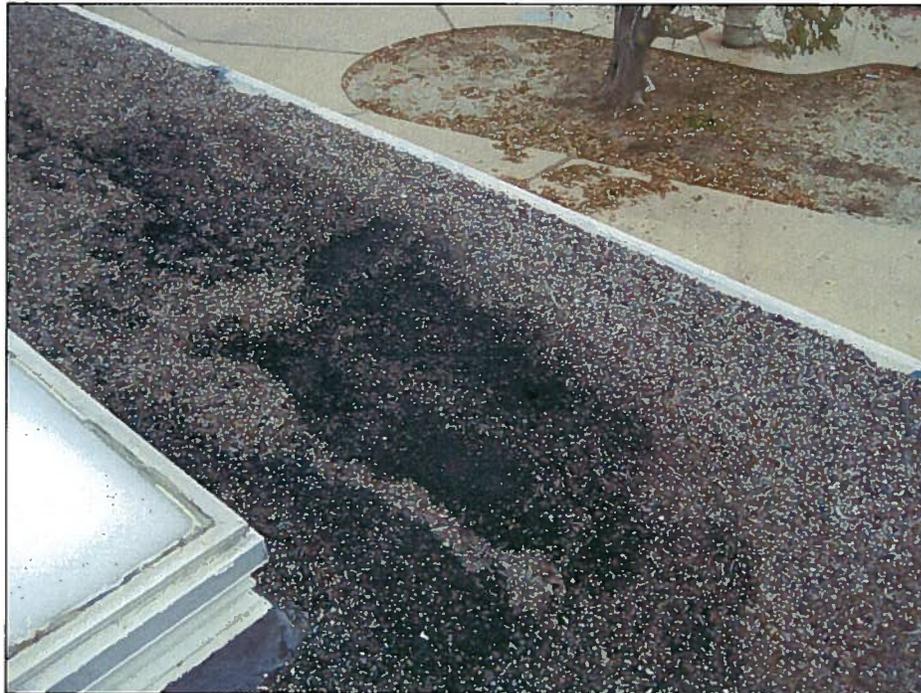
**BSRA-1C SAMPLE LOCATION-SOUTH ROOF.**

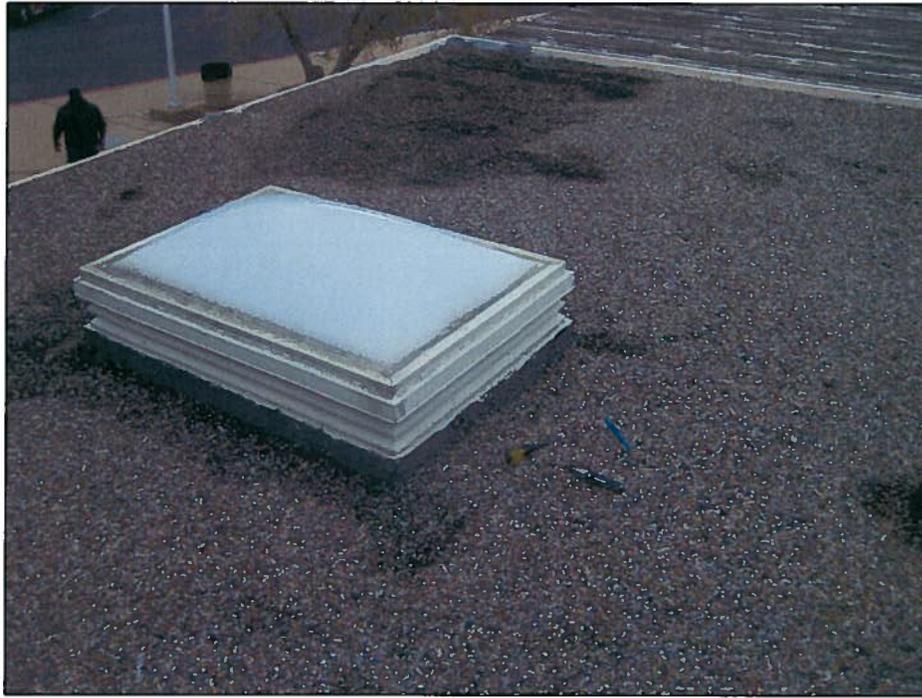
- Black roof penetration mastic noted on the skylight and vent pipe roof penetrations of the comfort building roof (Sample Nos. BSRA-2A, BSRA-2B, BSRA-2C, and BSRA-2D) contains 2-3% chrysotile asbestos. This material appeared to be in good condition and is estimated to encompass approximately 156 square feet. This material is classified as Category I non-friable ACM.

**BSRA-2A SAMPLE LOCATION-NORTH ROOF SKYLIGHT PENETRATION MASTIC.**

- Prior to building demolition or renovations, the property owner should retain a State of California-licensed asbestos abatement contractor to perform the abatement of the ACMs at the buildings. The general contractor for the demolition project may be a source for local licensed abatement contractors. Kleinfelder can also provide names of licensed and qualified abatement contractors in the area upon request. ACMs should be removed and disposed of

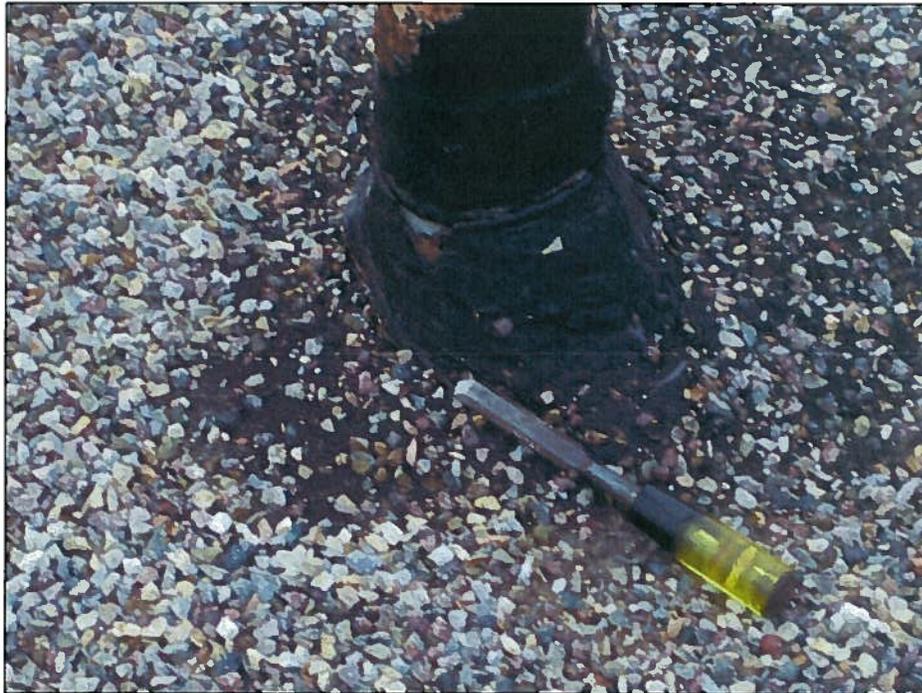
**BSRA-2B SAMPLE LOCATION-NORTH ROOF VENT PIPE PENETRATION MASTIC.**

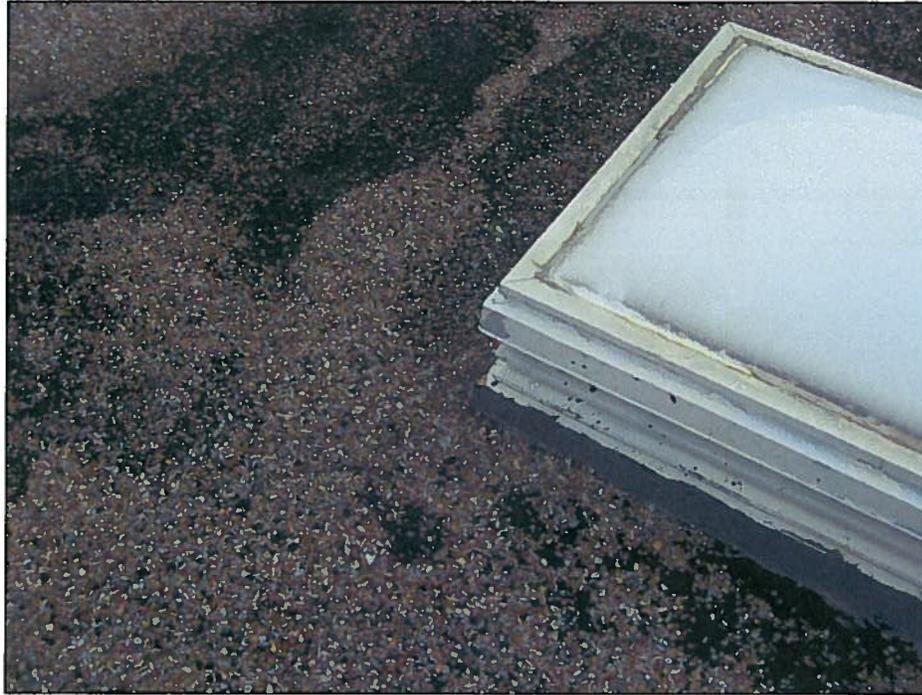
**BSRA-2C SAMPLE LOCATION-SOUTH ROOF SKYLIGHT PENETRATION MASTIC.**

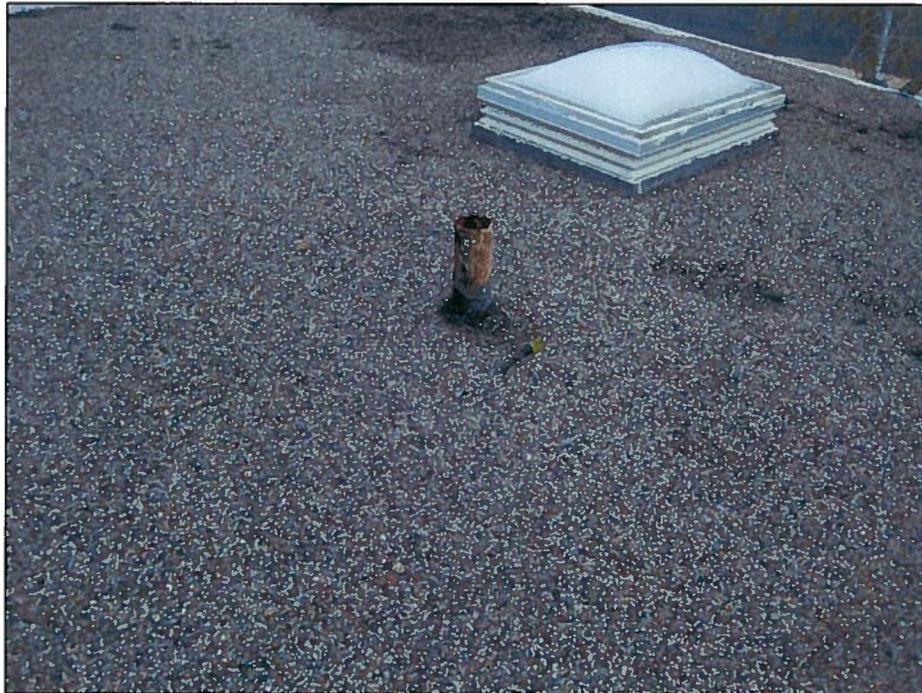
**BSRA-2D SAMPLE LOCATION-SOUTH ROOF VENT PIPE PENETRATION MASTIC.**

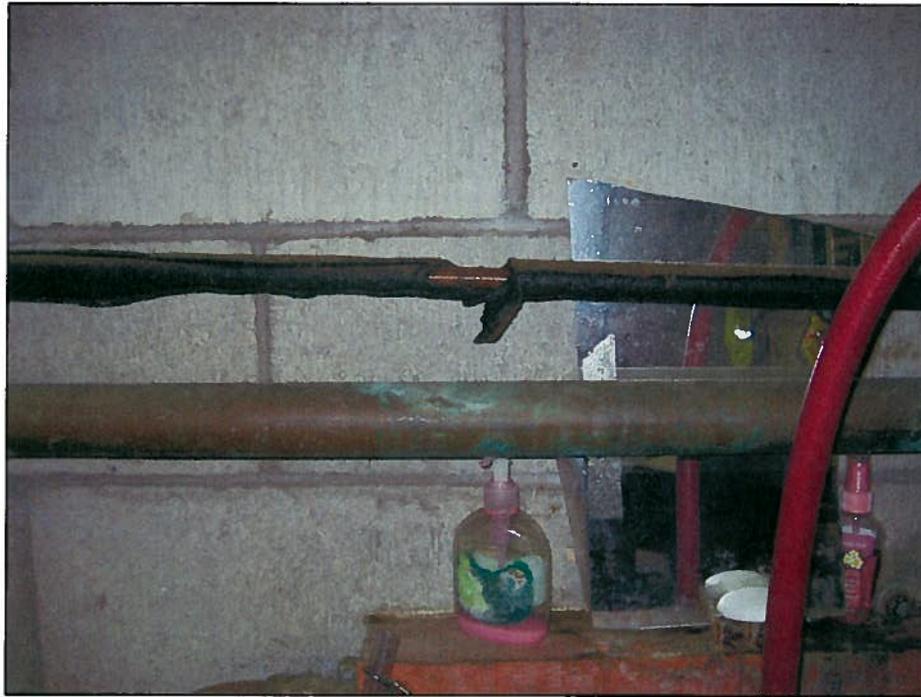
**BSRA-3A SAMPLE LOCATION- PIPE WRAP IN SOUTH UTILITY CLOSET.**

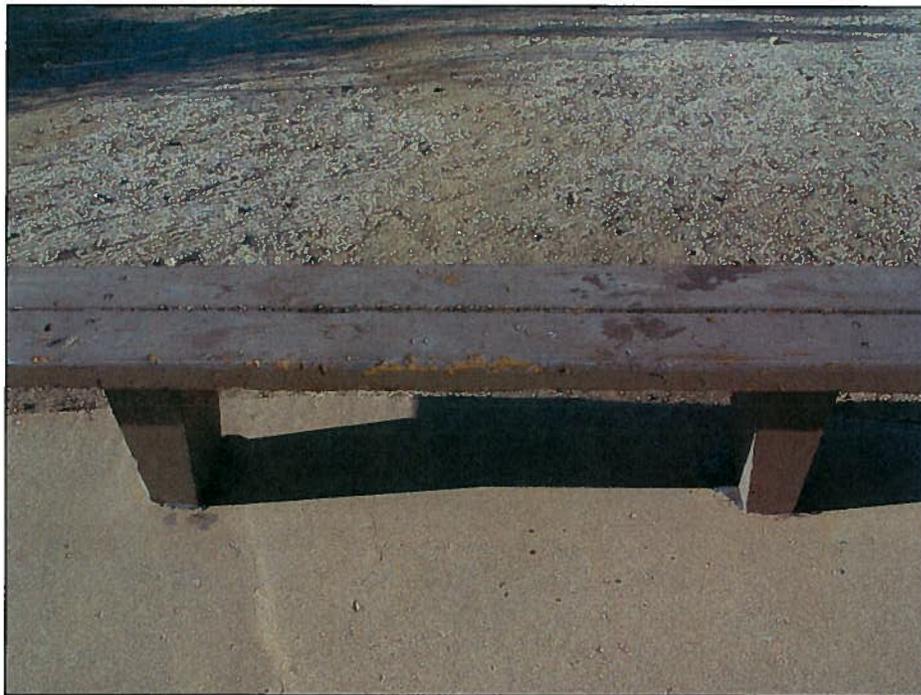
**BSRA-4A SAMPLE LOCATION-BENCH WEST OF NORTH WOMEN'S ROOM.**

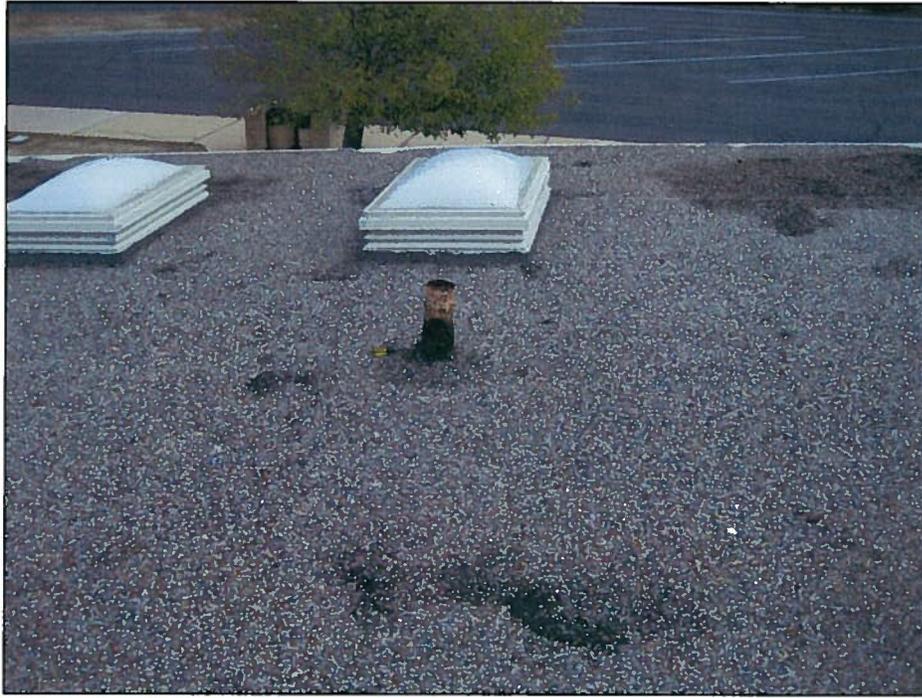
TYPICAL ROOF PENETRATIONS WITH ASBESTOS CONTAINING MASTICS.

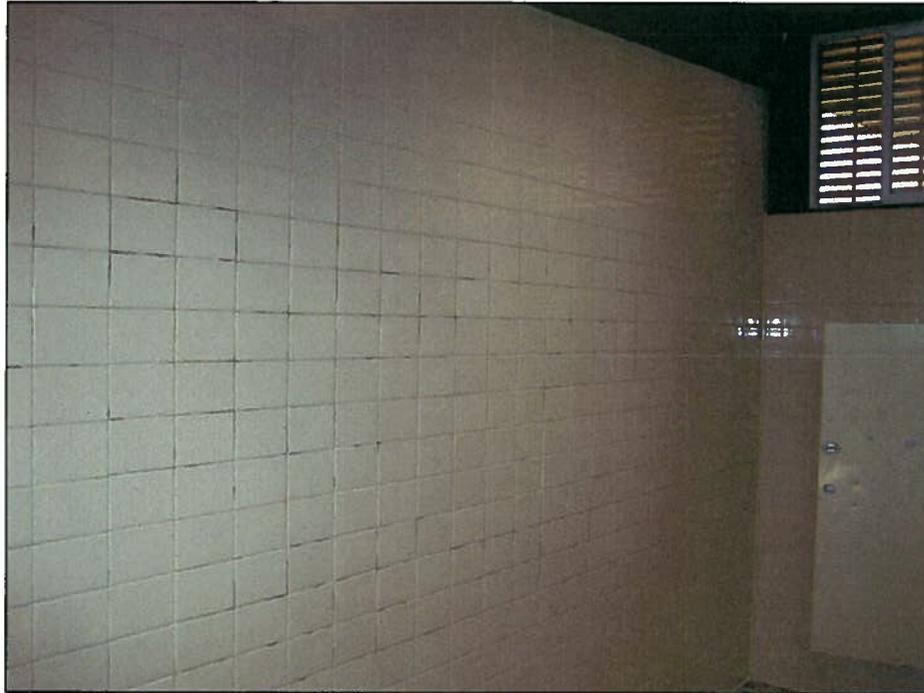
- The glaze noted on the beige ceramic tiles located on the walls and bathroom stall walls in each of the four restrooms (two men's restrooms and two women's restrooms), on the restroom walls, and bathroom stall walls, contained between 11.4 and 13.2 milligrams per square centimeter ( $\text{mg}/\text{cm}^2$ ) of lead by XRF measurement. This glaze was noted to be intact and in good condition and is estimated to encompass approximately 3,100 square feet throughout the four restrooms.
- The glaze noted on the mop sink in the south utility room contained 29.7  $\text{mg}/\text{cm}^2$  of lead by XRF measurement. The glaze was noted to be intact and in good condition and is estimated to encompass approximately 12 square feet.

TYPICAL RESTROOM WALL WITH LEAD CONTAINING WALL TILES.

- Ceramic tiles located on bathroom walls and bathroom stall walls in each of the four restrooms of the site building are coated with a lead-based glaze. Laboratory analyses of bulk samples of the ceramic tiles indicate that the ceramic tiles, as a whole, contain lead in concentrations ranging from 190 to 490 mg/kg. The total threshold limit concentration (TTLC) for lead (as presented in Title 22, CCR), which determines whether a lead-containing waste is hazardous or not, is 1,000 mg/kg. If the ceramic tiles are to be removed prior to building demolition, they should be removed by a State of California-licensed lead abatement contractor, due to the lead content in the glaze of the ceramic tiles. However, the ceramic tiles may remain in place during building demolition, provided that the building demolition is performed by mechanical means (e.g., using bulldozers or excavators). Wastes generated from either abatement of the ceramic tiles prior to building demolition or building demolition by mechanical means with the ceramic tiles in place would be considered non-hazardous based on the analytical results of the ceramic tile bulk samples being below the TTLC, and could be disposed of as general construction debris.

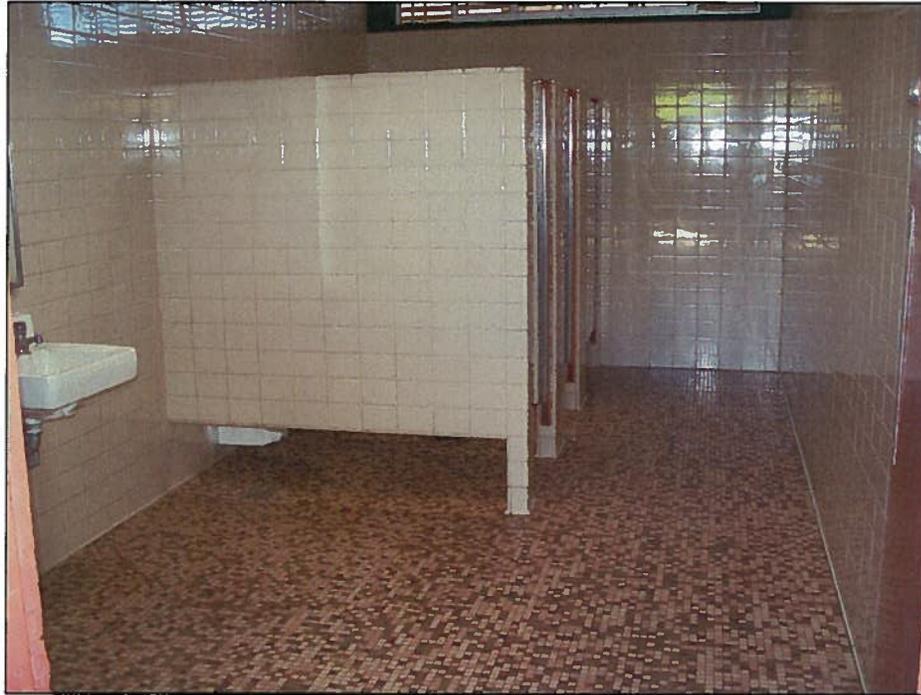
TYPICAL RESTROOM WITH LEAD-CONTAINING WALL TILES.

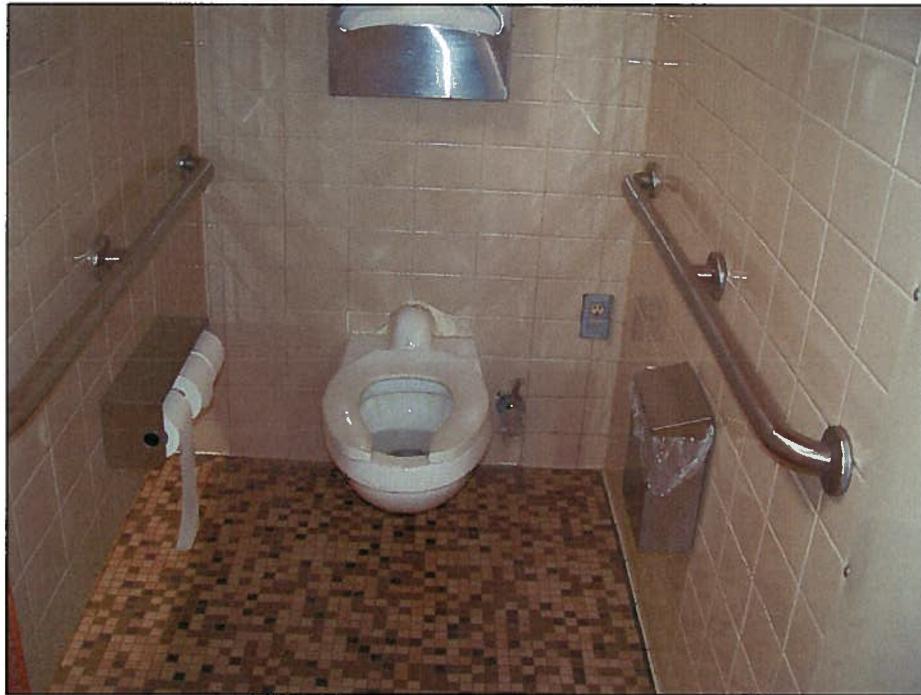
TYPICAL RESTROOM STALL WITH LEAD-CONTAINING WALL TILES.

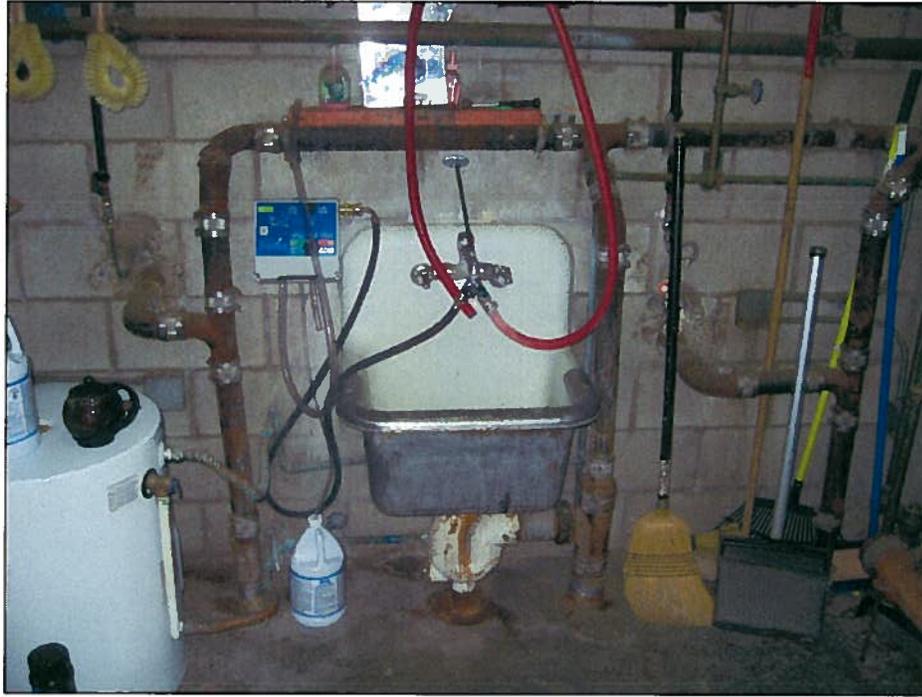
LEAD-CONTAINING MOP SINK IN SOUTH UTILITY ROOM.
