INFORMATION HANDOUT

LIMITED ASBESTOS AND LEAD-BASED PAINT SURVEY REPORT

ROUTE: 11-SD-5-R59.4/R60.0

CALIFORNIA COASTAL COMMISSION

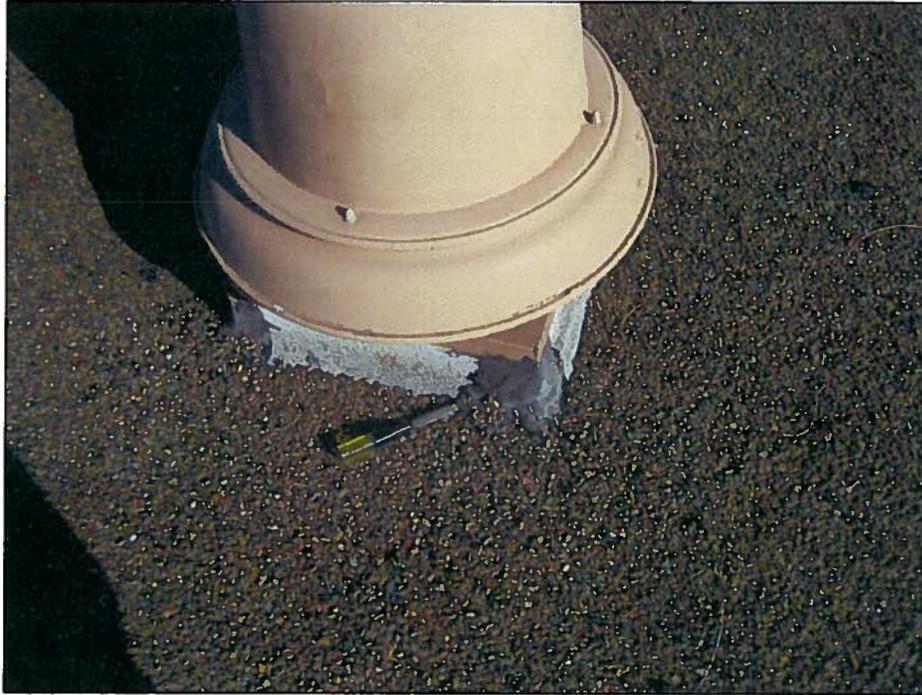
- Black roof penetration mastic noted on the skylight and vent pipe roof penetrations of the comfort building roof (Sample Nos. ACS-2A and ACS-2B) contains less than 1% ("trace") chrysotile asbestos by PLM analysis and 0.41% chrysotile asbestos by point count analysis. This material appeared to be in good condition and is estimated to encompass approximately 40 square feet. This material is classified as an ACCM by Cal-OSHA, but is not regulated by NESHAPS.

ACS-2A SAMPLE LOCATION-BUILDING 2 ROOF PENETRATION MASTIC.

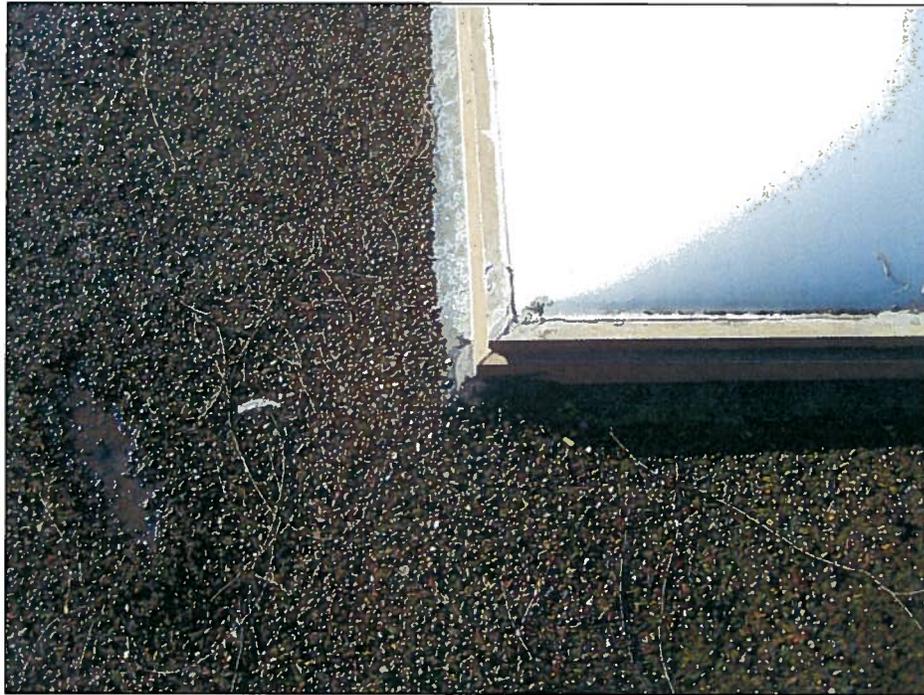
ACS-2B SAMPLE LOCATION-BUILDING 2 ROOF PENETRATION MASTIC.

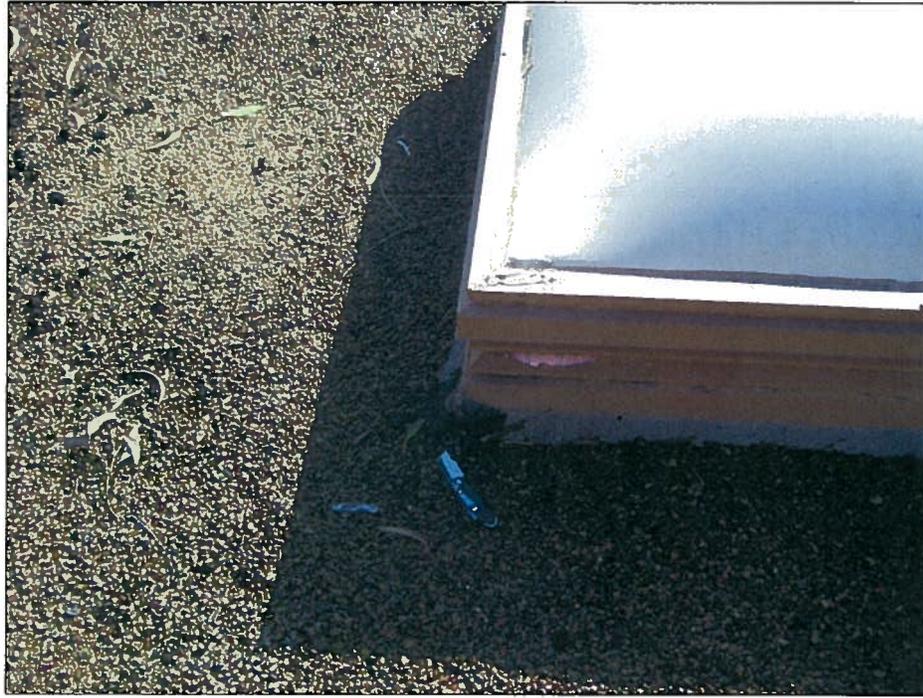
- Black roof penetration mastic noted on the skylight and vent pipe roof penetrations of the comfort building roof (Sample Nos. ACS-2C and ACS-2D) contains less than 1% (“trace”) chrysotile asbestos by PLM analysis and 0.12% chrysotile asbestos by point count analysis. This material appeared to be in good condition and is estimated to encompass approximately 40 square feet.

This material is classified as an asbestos-containing construction material (ACCM) by Cal-OSHA, but is not regulated by the National Emission Standard for Hazardous Air Pollutants (NESHAPS).

ACS-2C SAMPLE LOCATION-BUILDING 1 ROOF PENETRATION MASTIC.

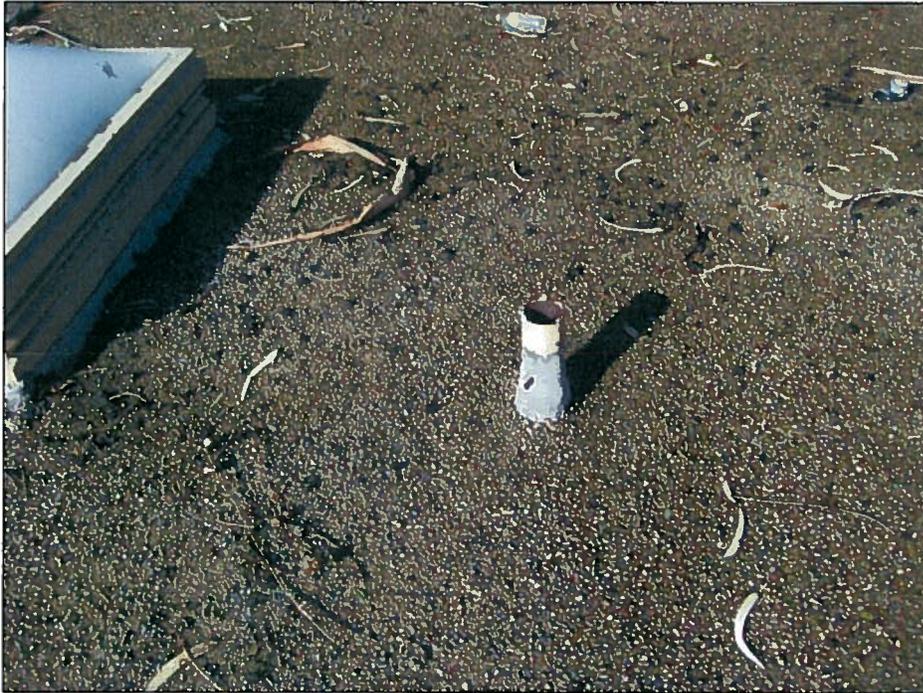
ACS-2D SAMPLE LOCATION-BUILDING 1 ROOF PENETRATION MASTIC.

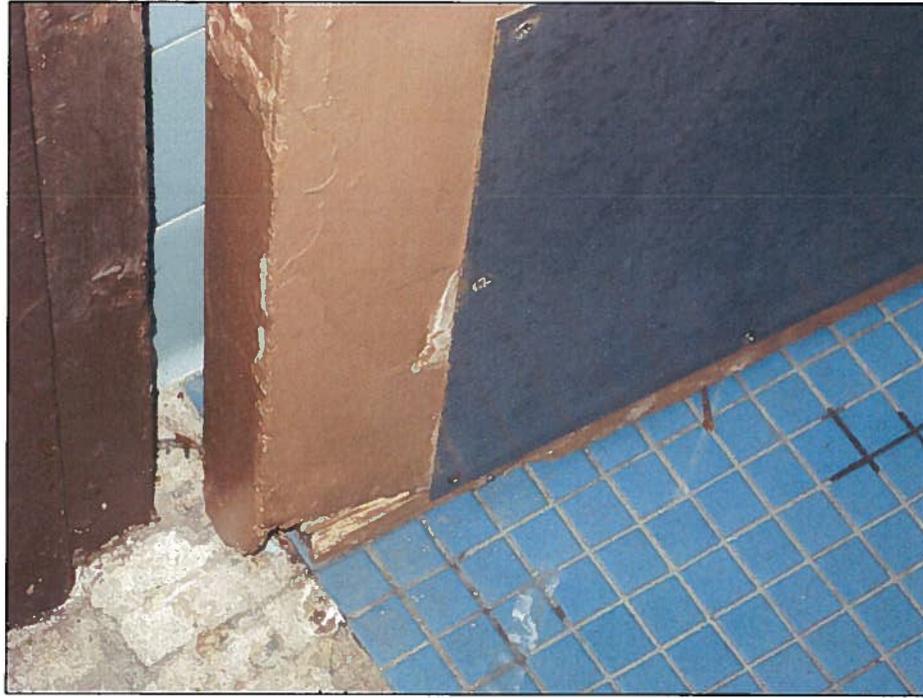
- The brown paint noted on the door of the women's restroom contained 1.7 mg/cm² of lead by XRF by measurement. Further analysis by paint chip sampling indicated the paint contains 1.9% lead by weight (19,000 parts per million [ppm]). This paint was noted to be intact and in good condition, and is estimated to encompass approximately 40 square feet.

ACS-P1 SAMPLE LOCATION-BUILDING 1 WOMEN'S RESTROOM DOORACS-2C SAMPLE.

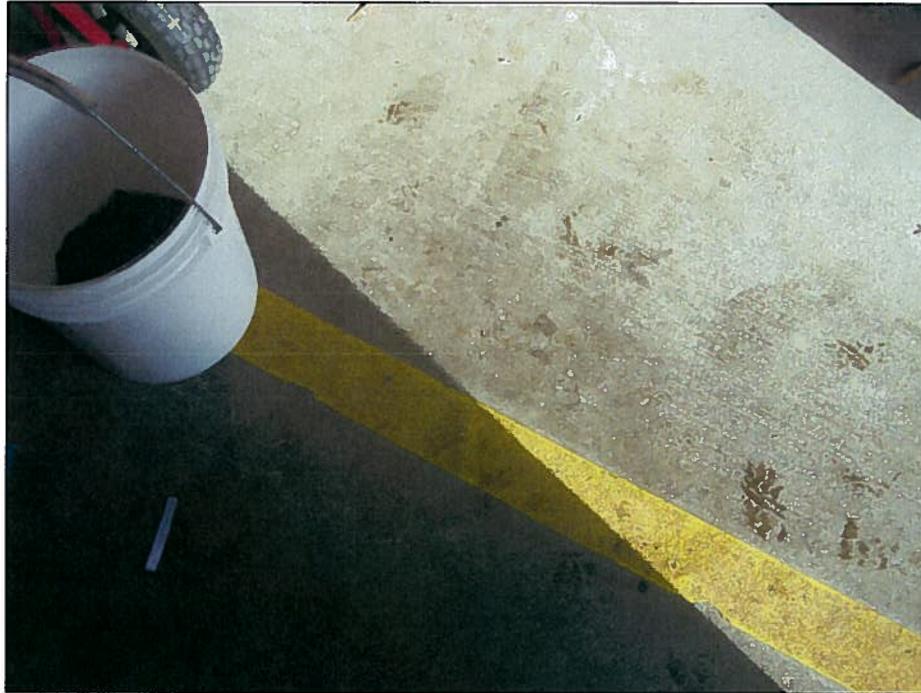
- The yellow thermoplastic floor stripe located in the utility room contained 4.0 mg/cm² of lead by XRF measurement. Further analysis by paint chip sample indicated the thermoplastic contains 4.3% lead by weight (43,000 ppm). The thermoplastic striping was noted to be intact and in good condition, and is estimated to encompass approximately 6 linear feet.

ACS-P2 SAMPLE LOCATION-TERMOPLASTIC STRIPE IN BUILDING 2 UTILITY ROOM.

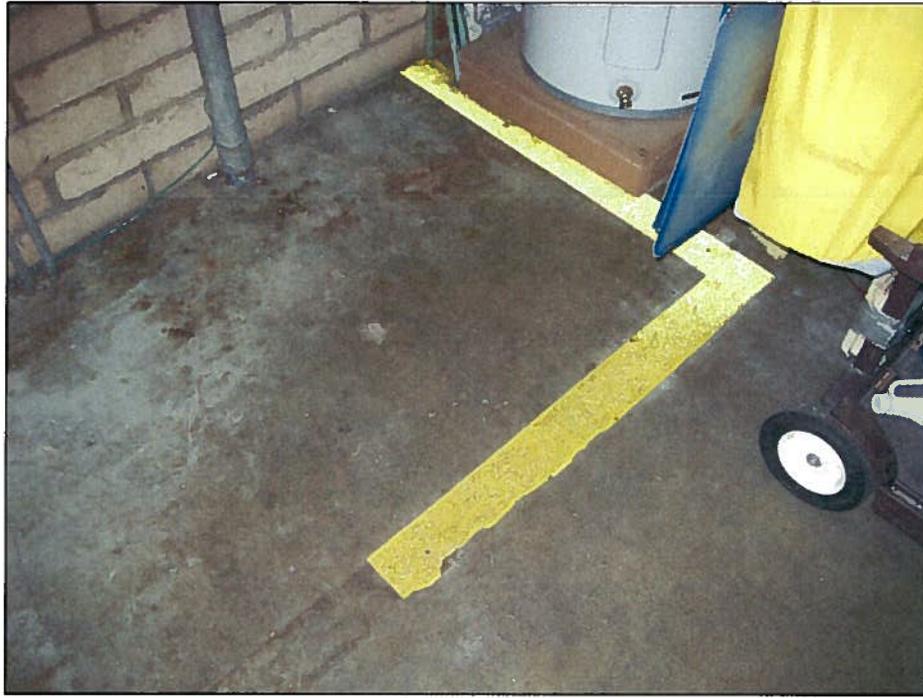
- The yellow thermoplastic floor stripe located in the utility room contained 4.8 mg/cm² of lead by XRF measurement. Further analysis by paint chip sample indicated the thermoplastic contains 4.4% lead by weight (44,000 ppm). The thermoplastic striping was noted to be intact and in good condition, and is estimated to encompass approximately 6 linear feet.

ACS-P3 SAMPLE LOCATION-THERMOPLASTIC STRIP IN BUILDING 1 UTILITY ROOM.

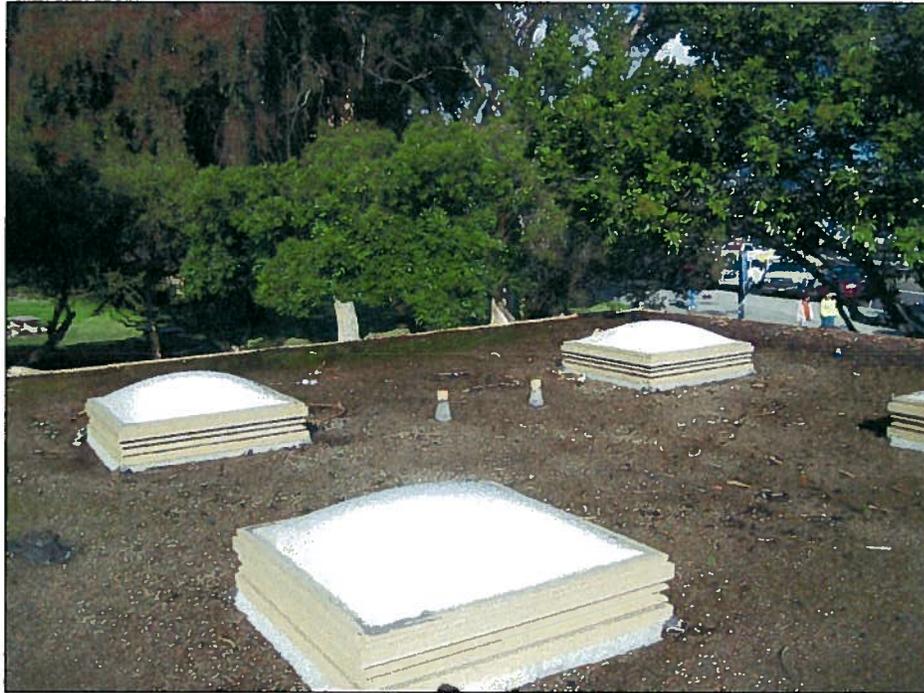
BUILDING 1 ROOF WITH VIEW OF ROOF PENETRATIONS.

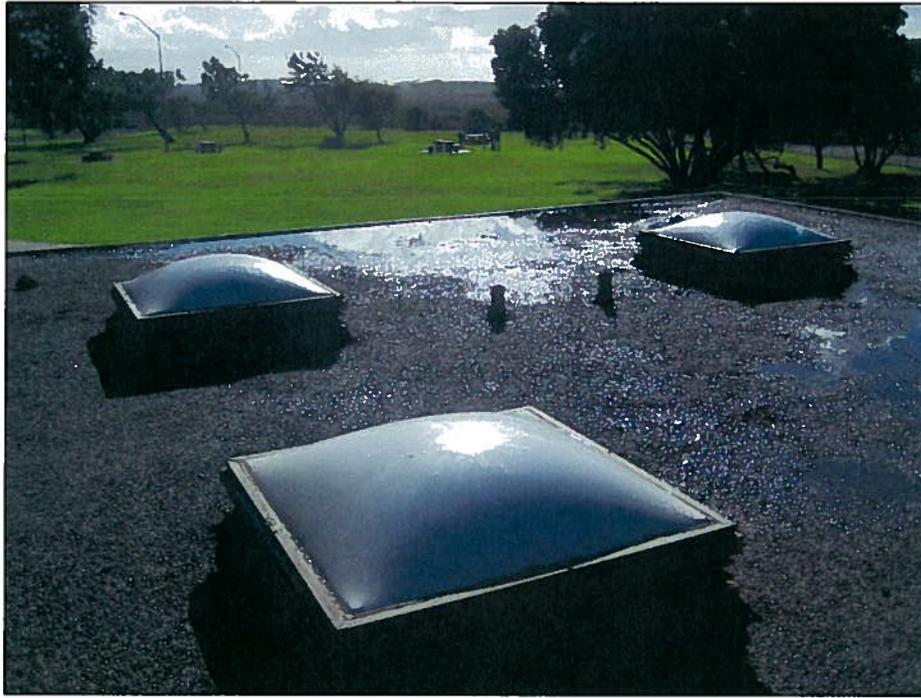
BUILDING 2 ROOF WITH VIEW OF ROOF PENETRATIONS.

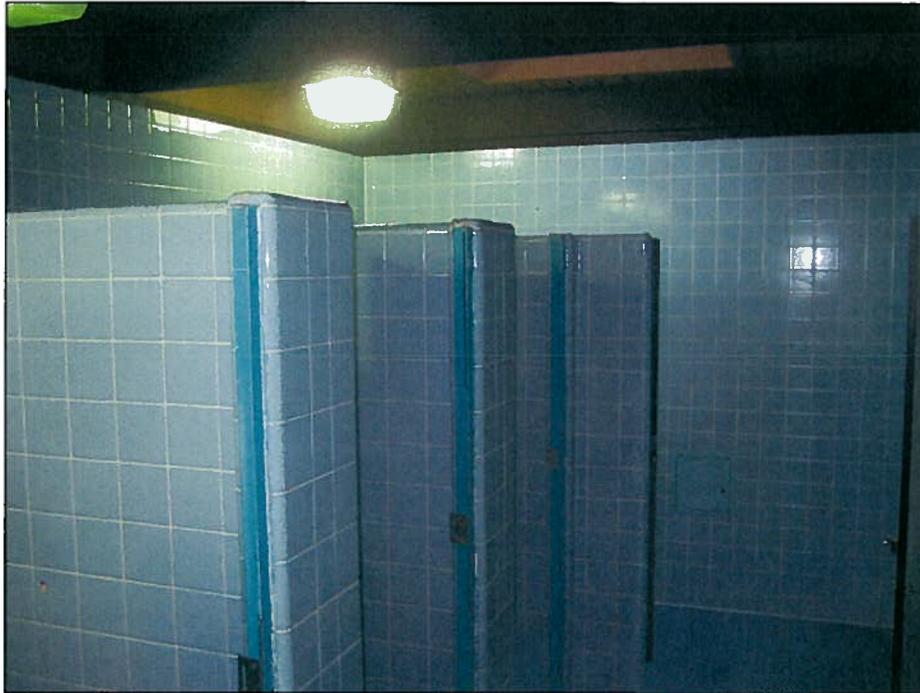
TYPICAL RESTROOM WALLS WITH LEAD-CONTAINING WALL TILES.

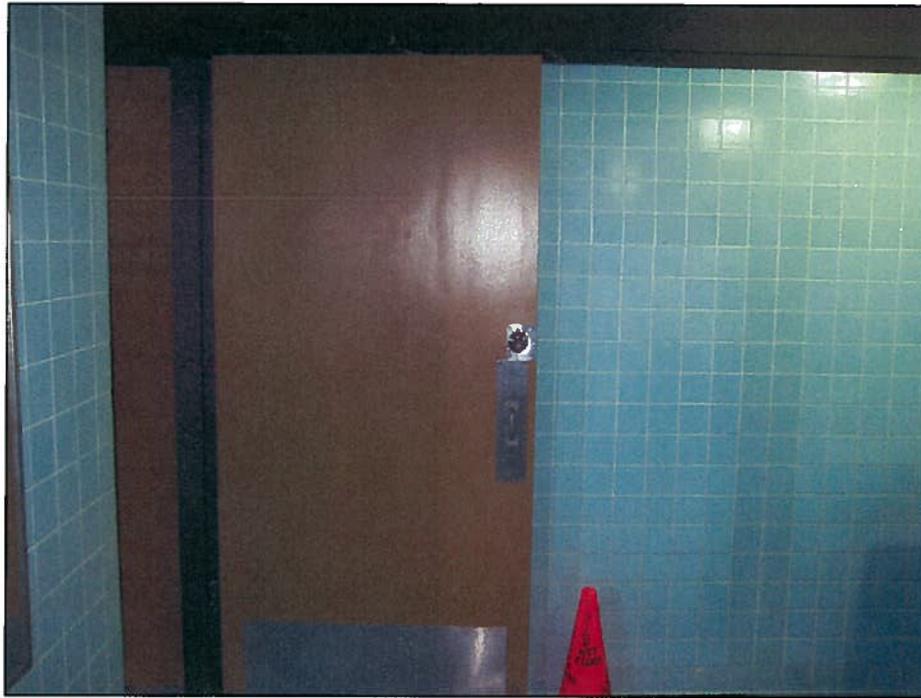
BUILDING 1 WOMEN'S RESTROOM DOOR WITH LEAD-CONTAINING BROWN PAINT.

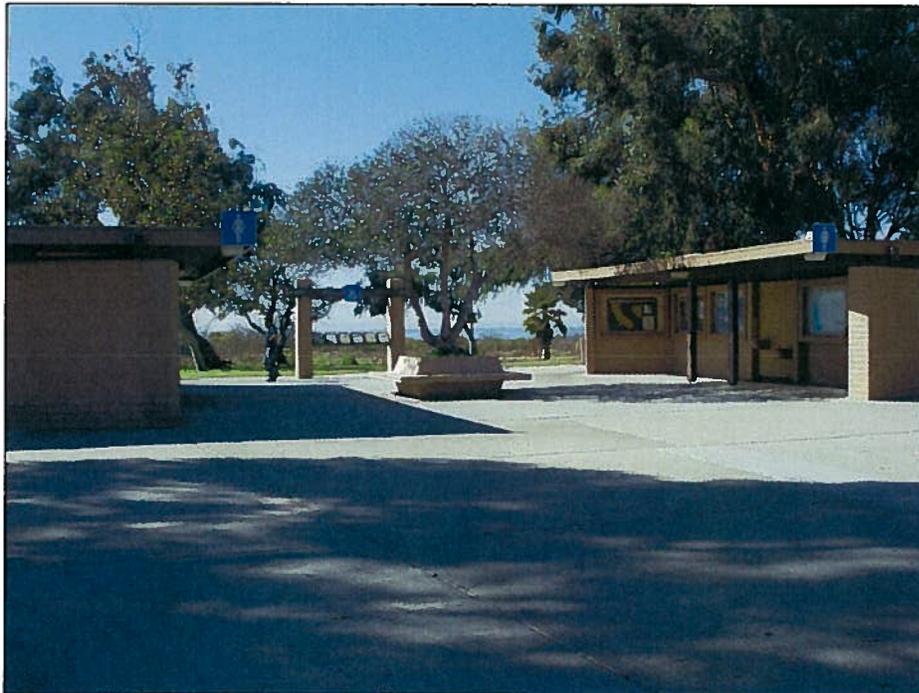
- The glaze noted on the yellow ceramic decorative wall tiles located on the east side of the building's exterior contained 10.2 mg/cm² of lead by XRF measurement. This glaze was noted to be in intact and in good condition and is estimated to encompass approximately 40 square feet.

VIEW OF BUILDING 1 TO THE RIGHT WITH VIEW OF LEAD-CONTAINING YELLOW WALL
 TILES AROUND DRINKING FOUNTAINS.

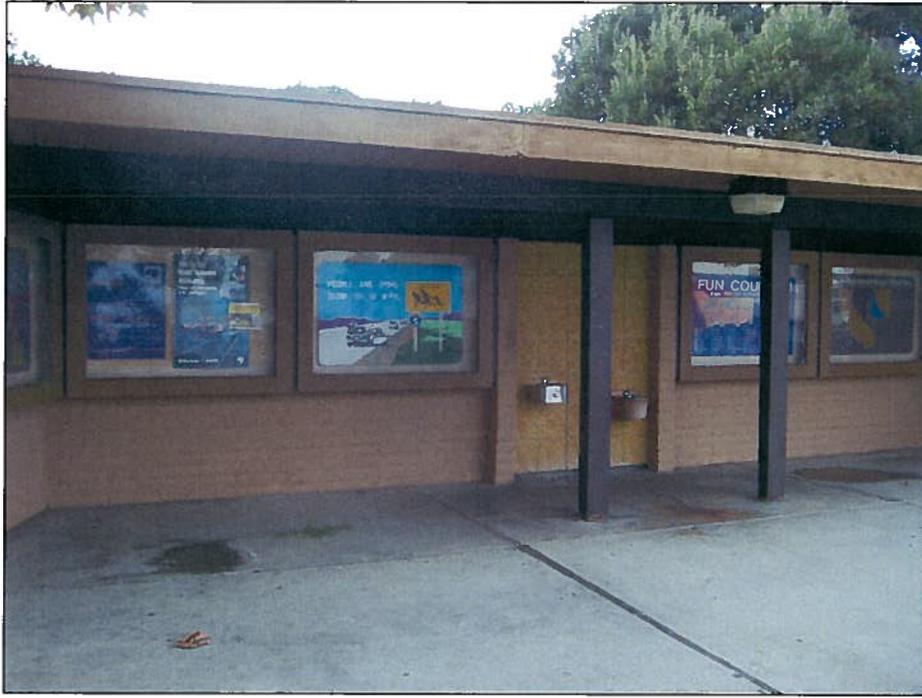
VIEW OF BUILDING 3 WITH VIEW OF LEAD-CONTAINING YELLOW WALL TILES AROUND DRINKING FOUNTAINS.

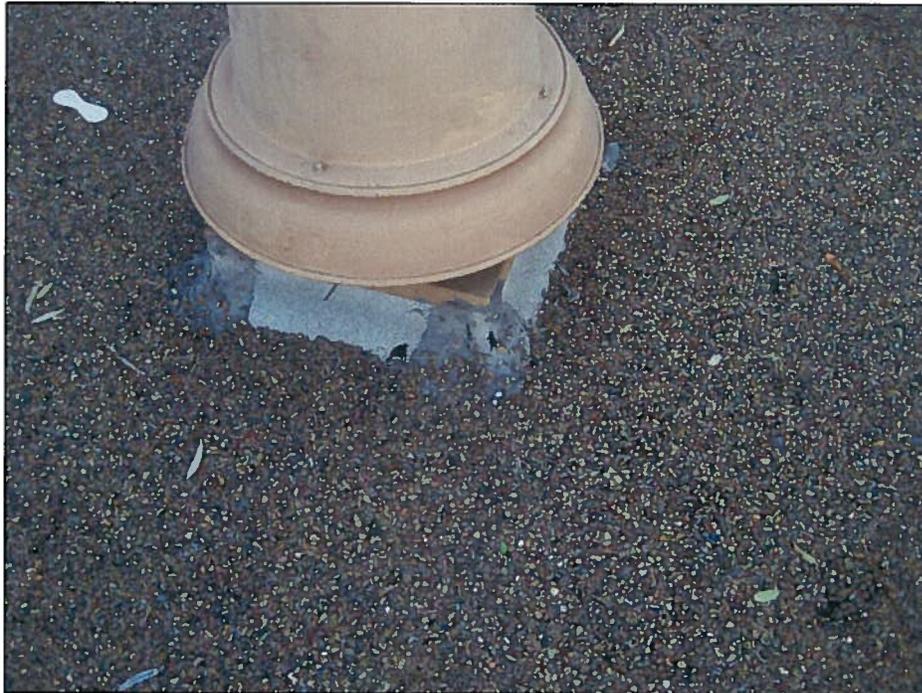
ACN-1D AND ACN-2D SAMPLE LOCATIONS-BUILDING 4 ROOF AND ROOF PENETRATION.

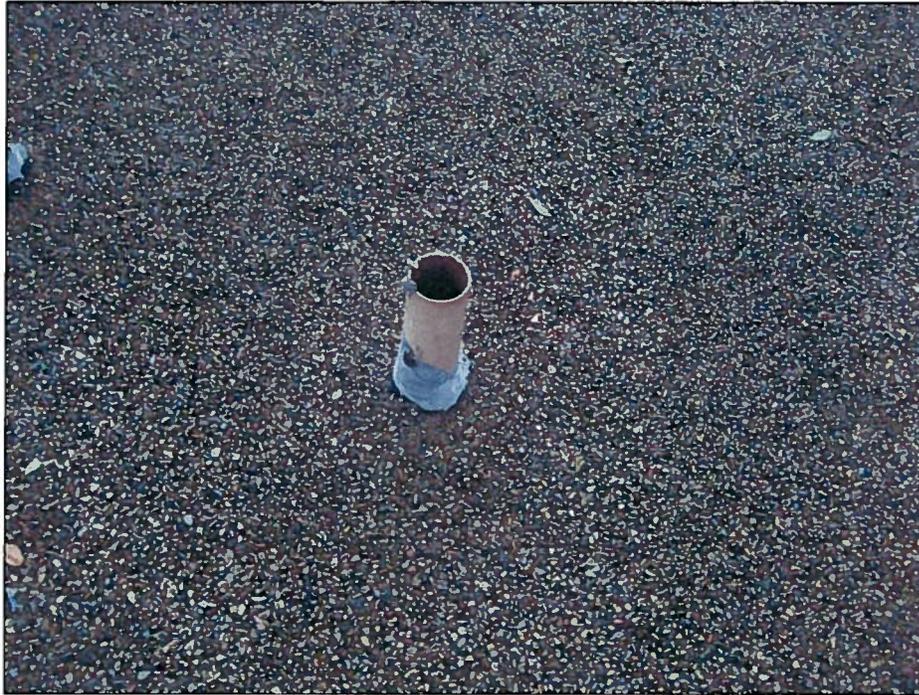
- Black roof penetration mastic noted on the skylight and vent pipe roof penetrations of the comfort building roof (Sample Nos. ACN-2A and ACN-2B) contains less than 1% ("trace") chrysotile asbestos by PLM analysis and 0.02% chrysotile asbestos by point count analysis. This material appeared to be in good condition and is estimated to encompass approximately 36 square feet. This material is not classified as either an ACM or ACCM, and is not regulated by NESHAPS.

ACN-2A SAMPLE LOCATION-BUILDING 3 ROOF PENETRATION.

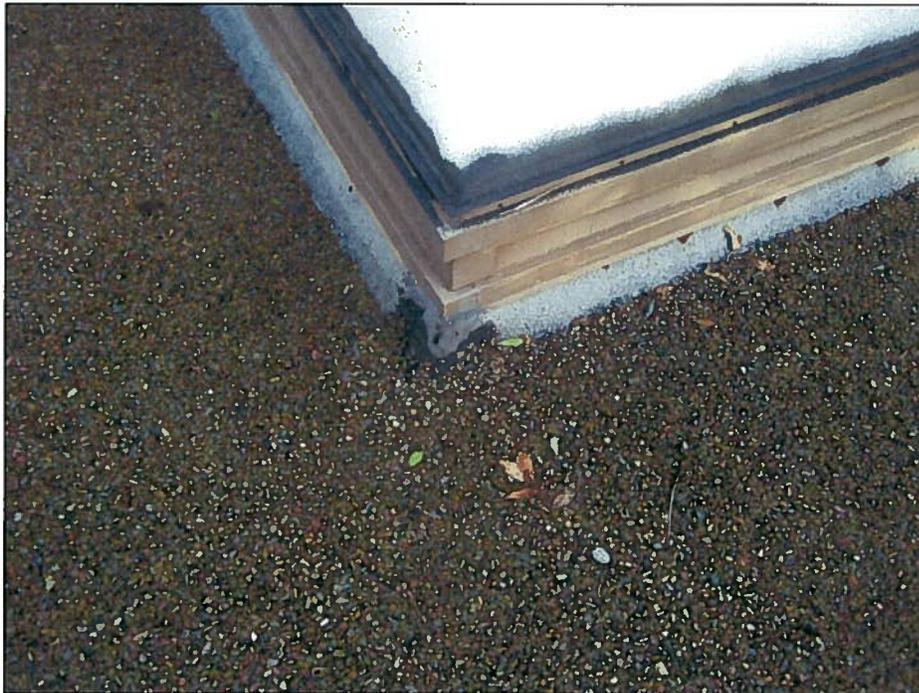
ACN-2B SAMPLE LOCATION-BUILDING 3 ROOF PENETRATION.

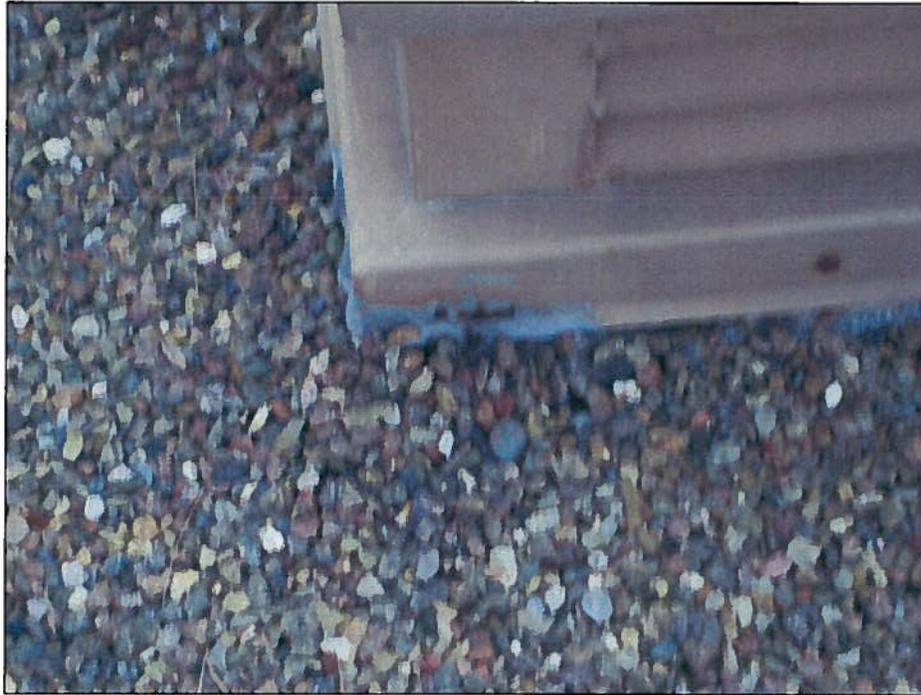
ACN-2C SAMPLE LOCATION-BUILDING 4 ROOF PENETRATION.

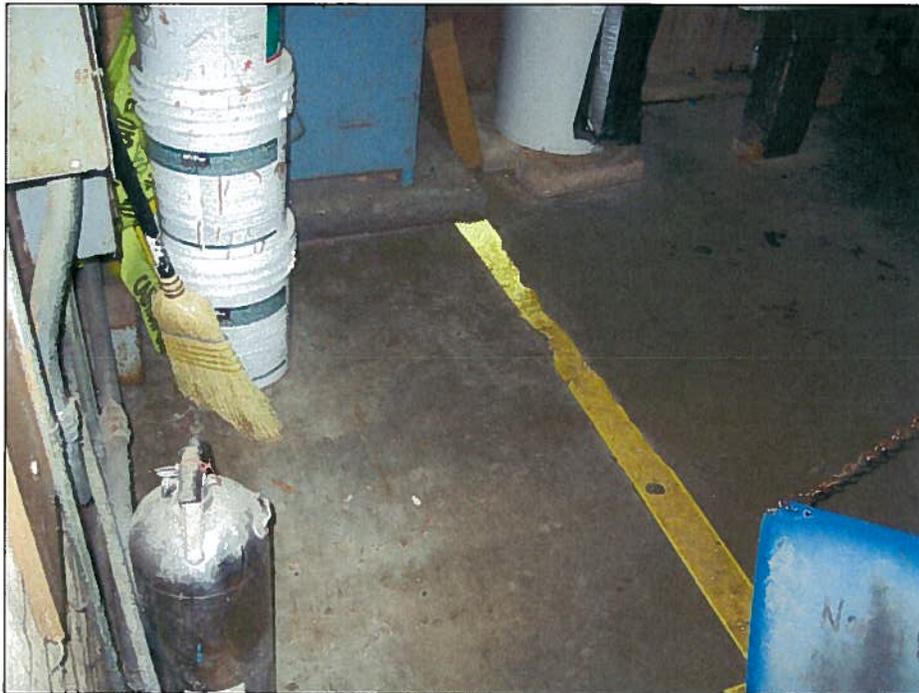
ACN-P1 SAMPLE LOCATION-YELLOW THERMOPLASTIC STRIPE IN BUILDING 3 UTILITY ROOM.

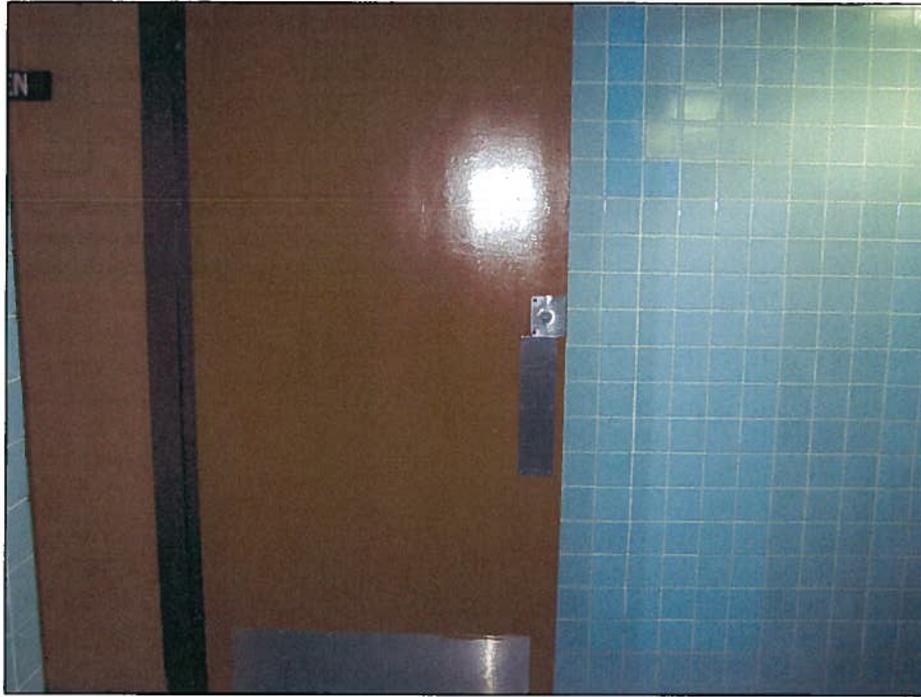
ACN-P2 SAMPLE LOCATION-BUILDING 3 WOMEN'S RESTROOM 1 BROWN DOOR PAINT.

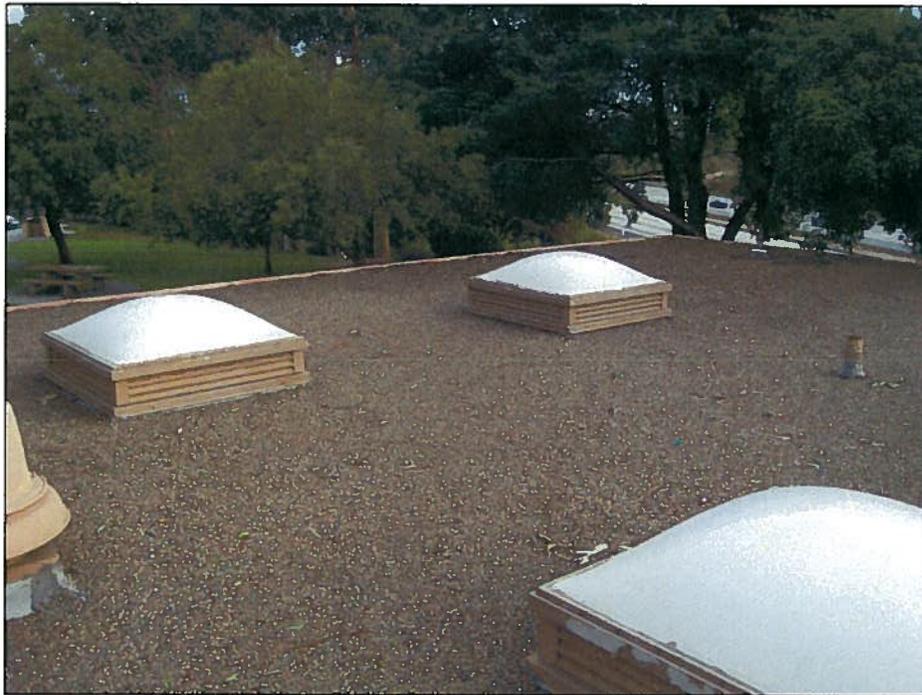
VIEW OF BUILDING 4 ROOF AND ROOF PENETRATIONS.

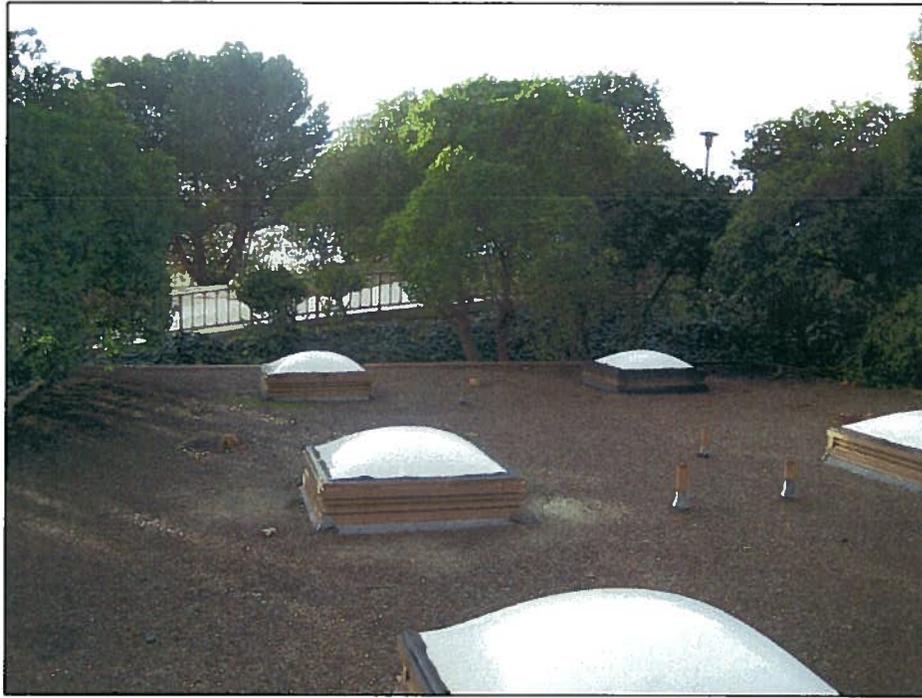
VIEW OF BUILDING 3 ROOF AND ROOF PENETRATIONS.

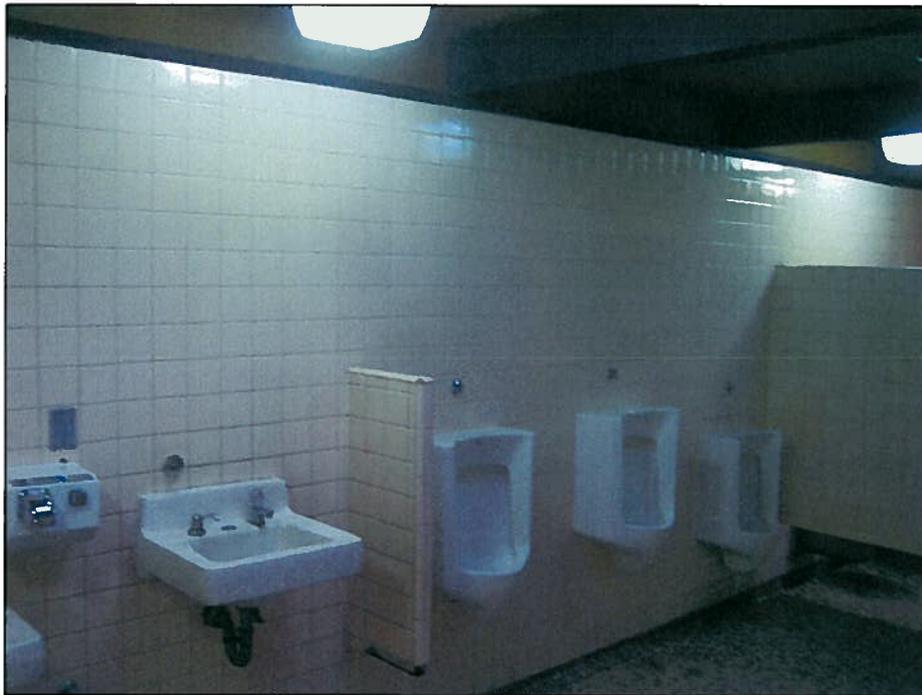
VIEW OF TYPICAL RESTROOM WITH BEIGE LEAD-CONTAINING CERAMIC WALL TILES.

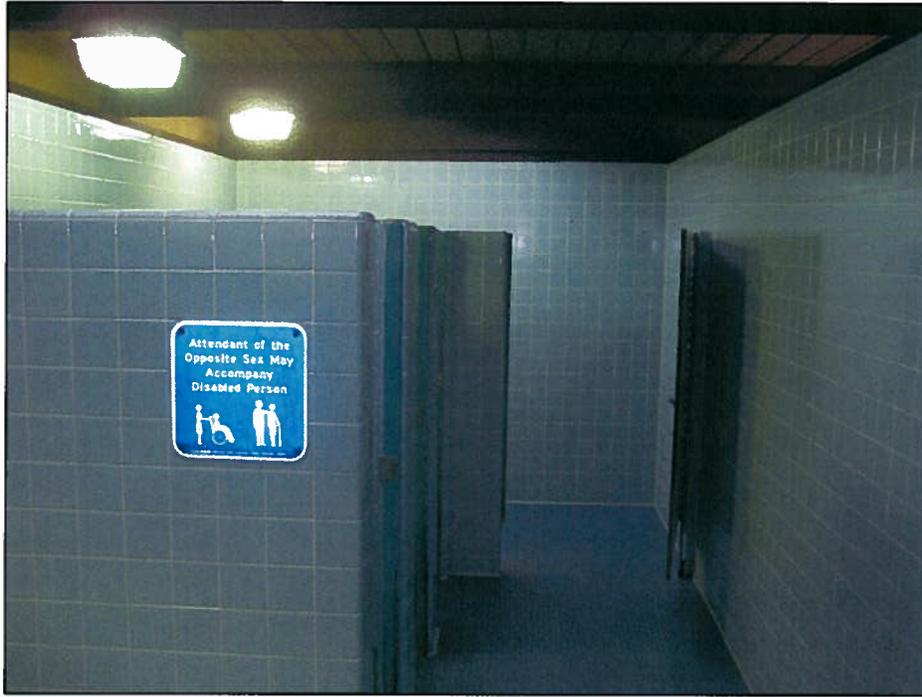
- The glaze noted on the blue ceramic tiles located in each of the two men's restrooms, on the restroom walls and bathroom stall walls, contained between 4.0 and 16.3 mg/cm² of lead by XRF measurement. This glaze was noted to be in intact and in good condition and is estimated to encompass approximately 1,310 square feet.

- The glaze noted on the blue ceramic tiles located in each of the two women's restrooms, on the restroom walls and bathroom stall walls, contained between 8.8 and 17.8 mg/cm² of lead by XRF measurement. This glaze was noted to be in intact and in good condition and is estimated to encompass approximately 1,430 square feet.

VIEW OF TYPICAL RESTROOM WITH BLUE LEAD-CONTAINING CERAMIC WALL TILES.
