ASBESTOS AND LEAD-CONTAINING SURFACES SURVEY

LIMITED ASBESTOS SURVEY REPORT

**ASBESTOS AND LEAD-CONTAINING
SURFACES SURVEY
KEARNY MESA MAINTENANCE STATION
LABORATORY BUILDING REMODEL
7177 OPPORTUNITY ROAD
SAN DIEGO, CALIFORNIA
TASK ORDER NO. 20, EA NO. 11-287700
CONTRACT NO. 11A1023**

January 18, 2008
Project No. 105388020

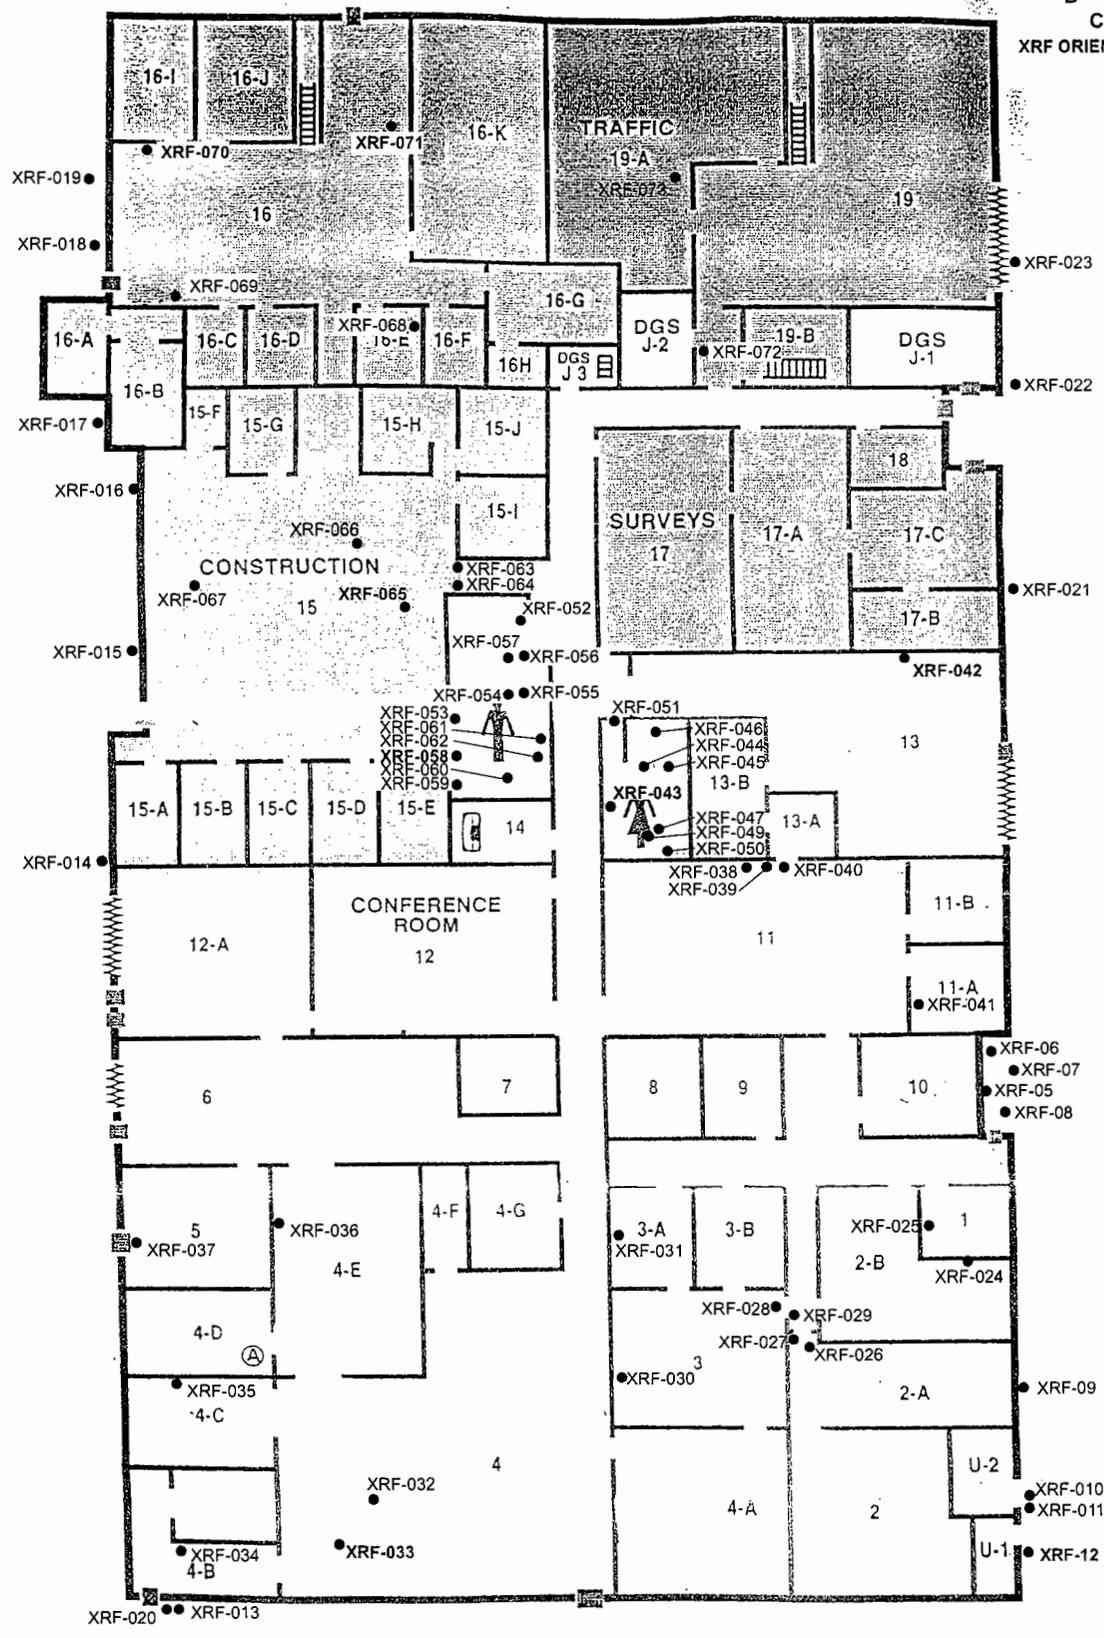
Ninyo & Moore		XRF SAMPLE LOCATION MAP	FIGURE
PROJECT NO.	DATE	7177 OPPORTUNITY ROAD SAN DIEGO, CALIFORNIA	3
105388020	1/08

indicated on Figure 3. Surfaces found to contain lead concentrations in excess of 1.0 milligrams per square centimeter (mg/cm^2), which is the regulatory standard for lead in surface coatings, are summarized in Table 4, including the locations of the surfaces.

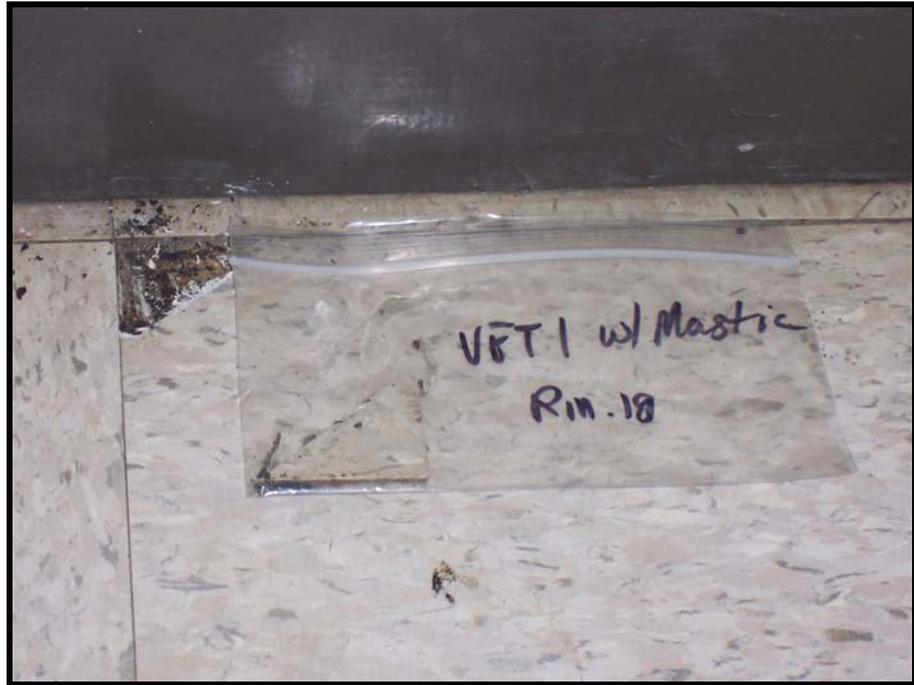
- The beige/grey, one-foot by one-foot, vinyl floor tile, located throughout the interior of the laboratory maintenance facility contained two percent Chrysotile asbestos. The black mastic associated with this floor tile contained five percent Chrysotile. These materials were non-friable and in good to fair condition at the time of survey activities.

Photograph No. 1: View of the 1-square-foot, beige and grey vinyl floor tile and black mastic located throughout the interior of the Laboratory Maintenance Building.

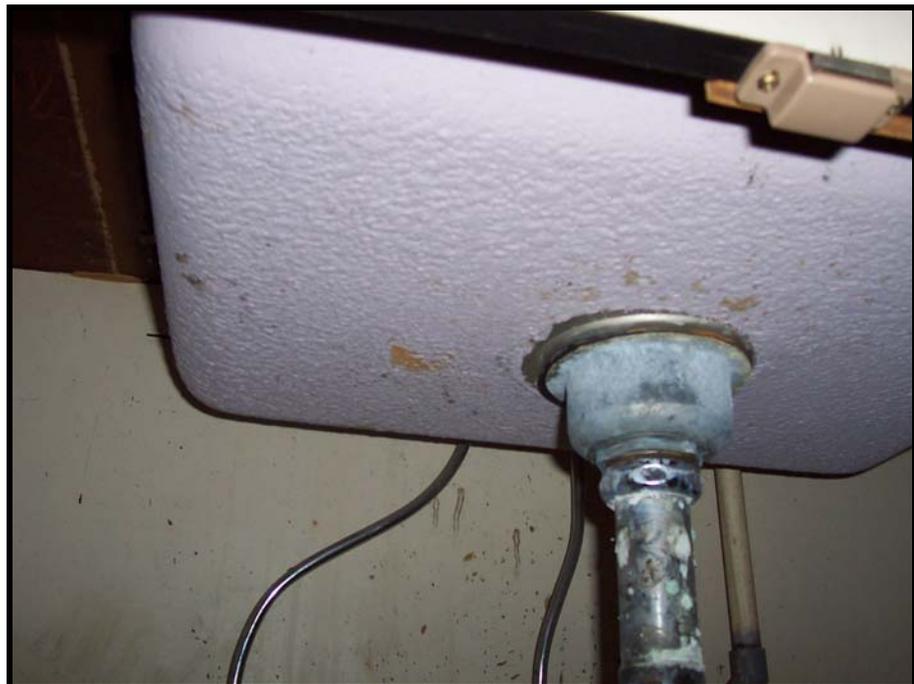
- The purple sink lining found beneath the sinks in Room 4 and Room 17 contains three percent Chrysotile asbestos. This material was non-friable and in good condition at the time of survey activities.

Photograph No. 2: View of the purple sink lining found beneath the sinks in Room 4.

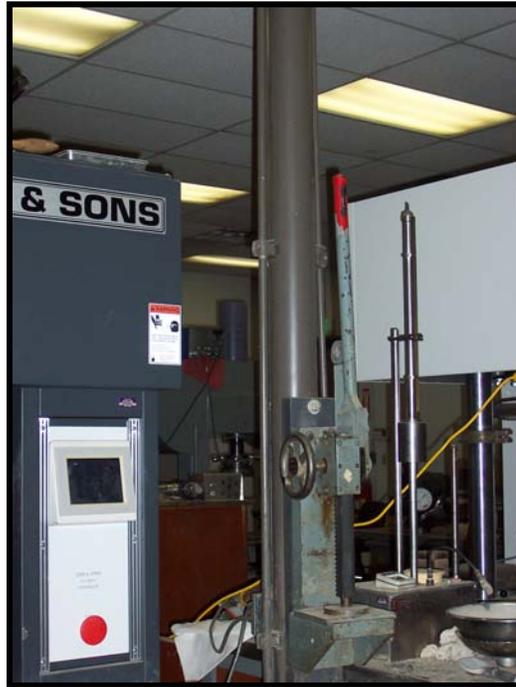
Photograph No. 3: View of the brown, metal vertical post located in Room 4.

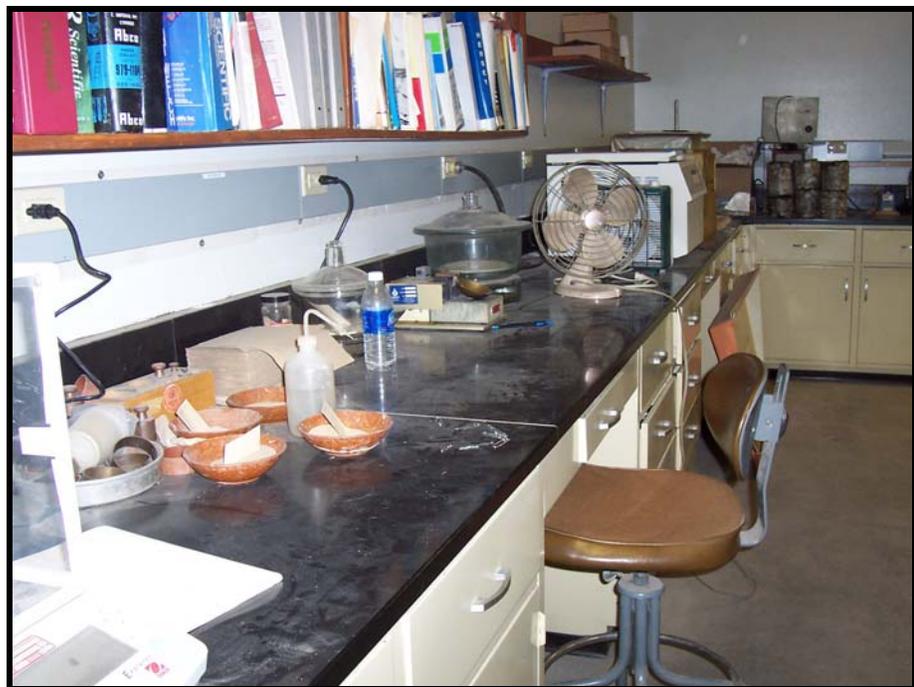
- In Room 4-A, the black laboratory countertops, contained 10 percent Chrysotile asbestos. This material was non-friable and in good condition at the time of survey activities.

Photograph No. 4: View of the black laboratory countertop found in Room 4-A.

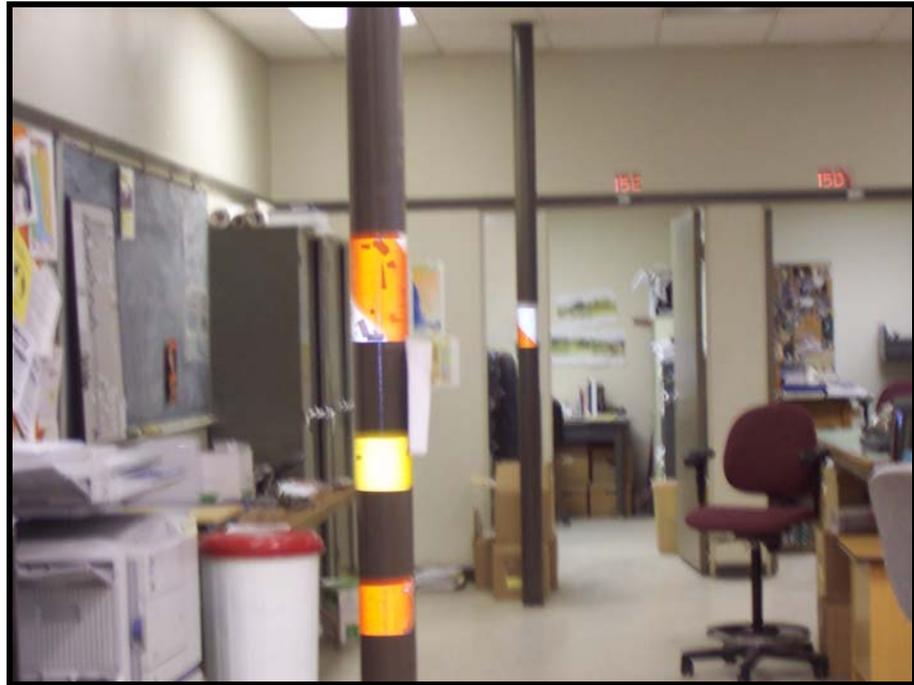
Photograph No. 5: View of the two brown, metal posts located in Room 15 of the Laboratory Maintenance Building.

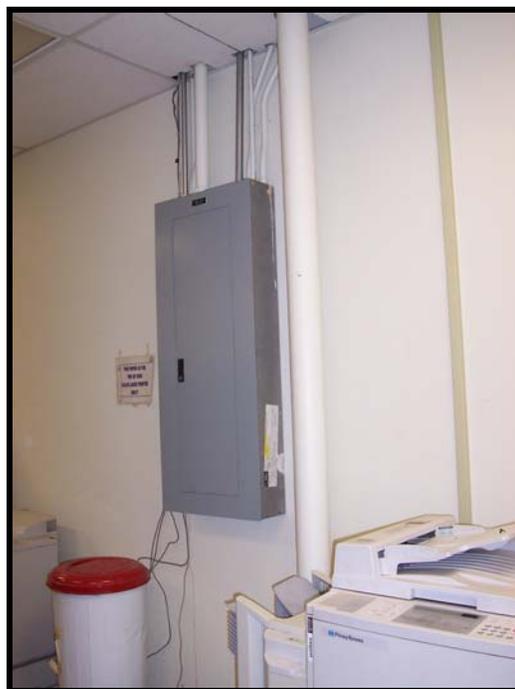
Photograph No. 6: View of the white, vertical post located in Room 16 of the Laboratory Maintenance Building.

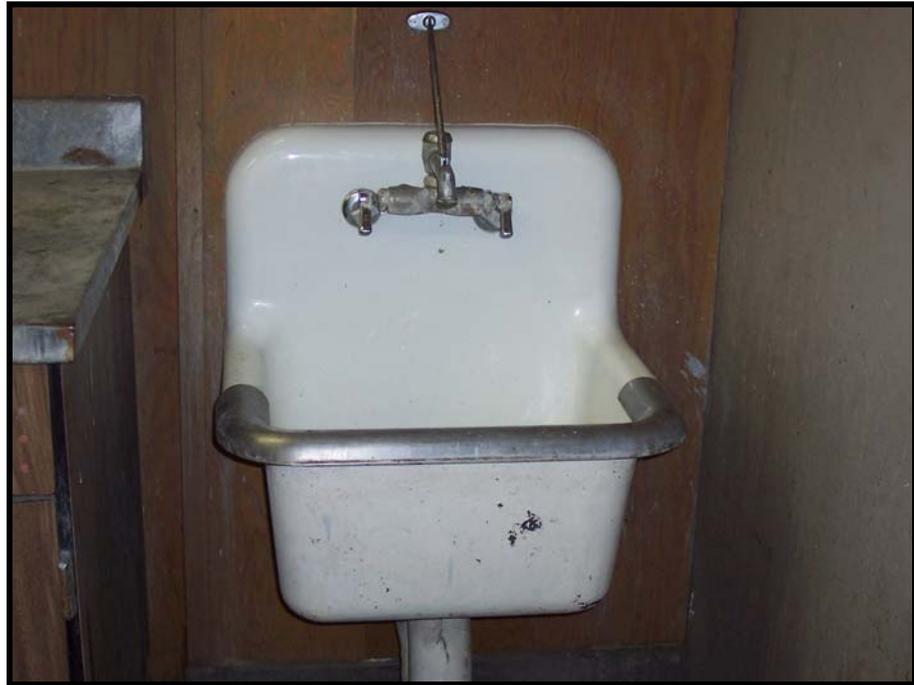
Photograph No. 7: View of a white, porcelain deep sink found in Room 13 and Room 16.

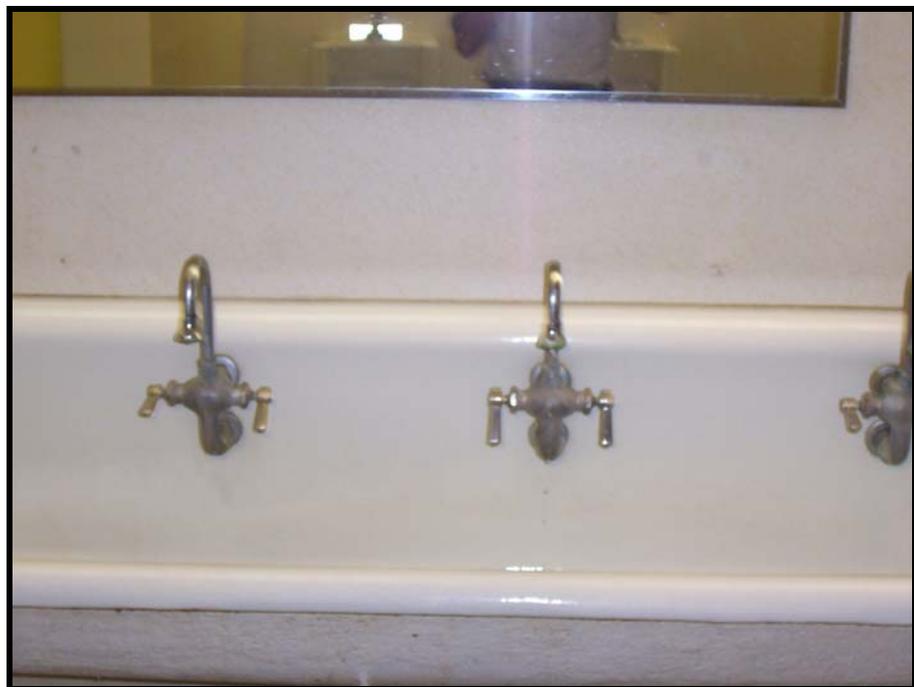
Photograph No. 8: View of one of the two white, porcelain trough sinks located in the men's restroom.

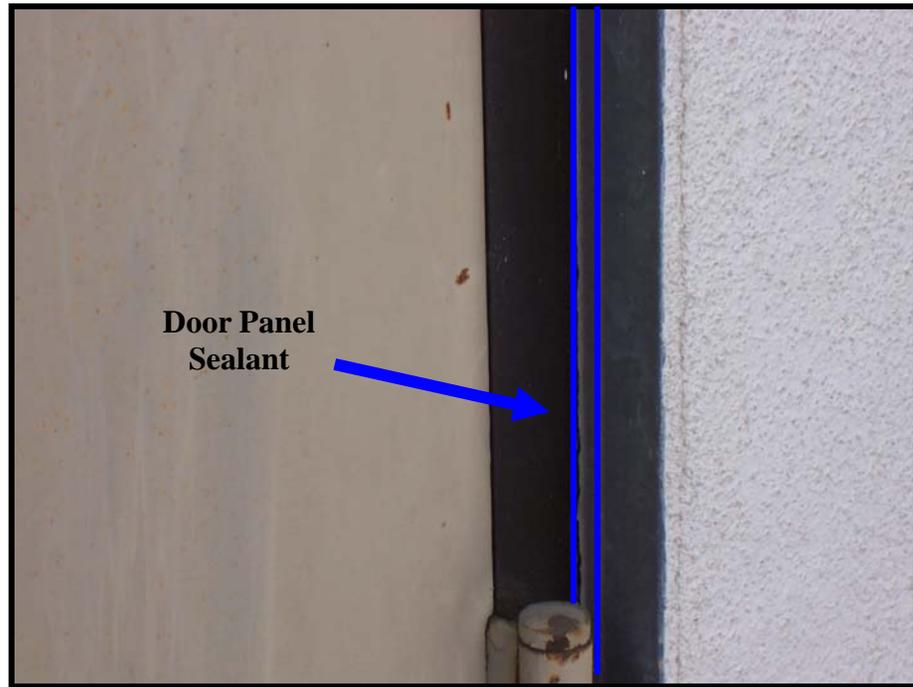
- The brown exterior door sealant found between the doors and exterior walls contain three percent Chrysotile asbestos. This material was non-friable and in good condition at the time of survey activities.

Photograph No. 9: View of the grey, exterior door panel sealant located on the exterior doors outside Rooms 6, 15 and 16-B.

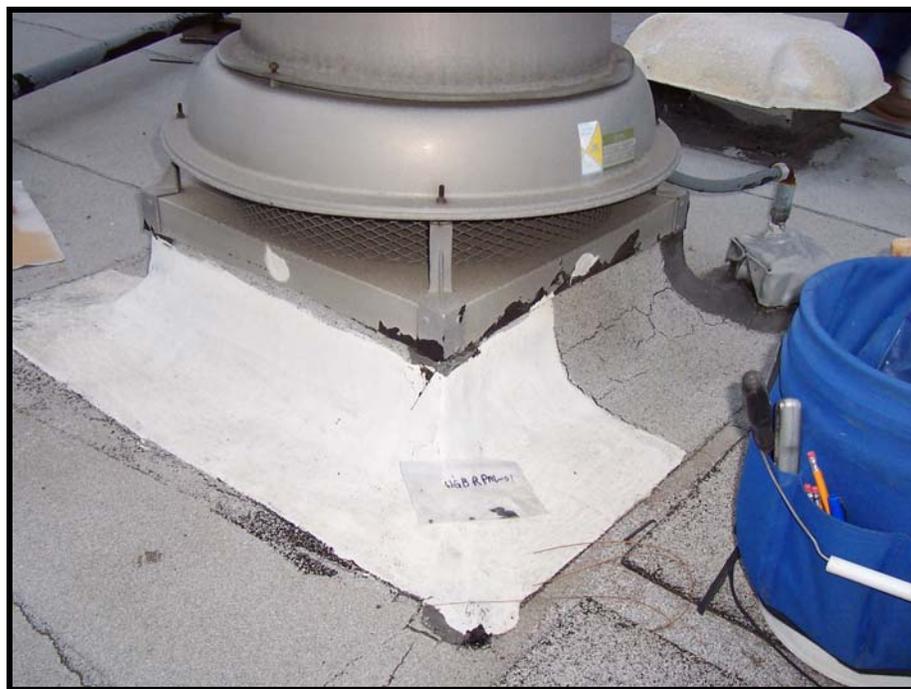
Photograph No. 10: View of the beige and black roof penetration mastic found around the roof penetrations of the Laboratory Maintenance Building.

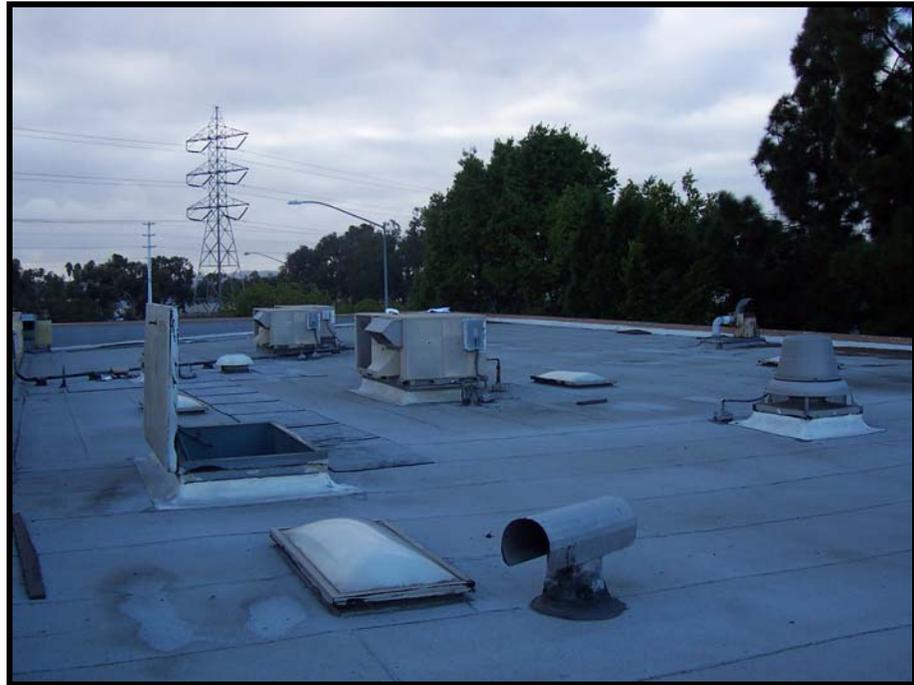
Photograph No. 11: View of the roof penetrations and roof penetration mastic located on the northern portion of the roof of the Laboratory Maintenance Building, view looking northwest.

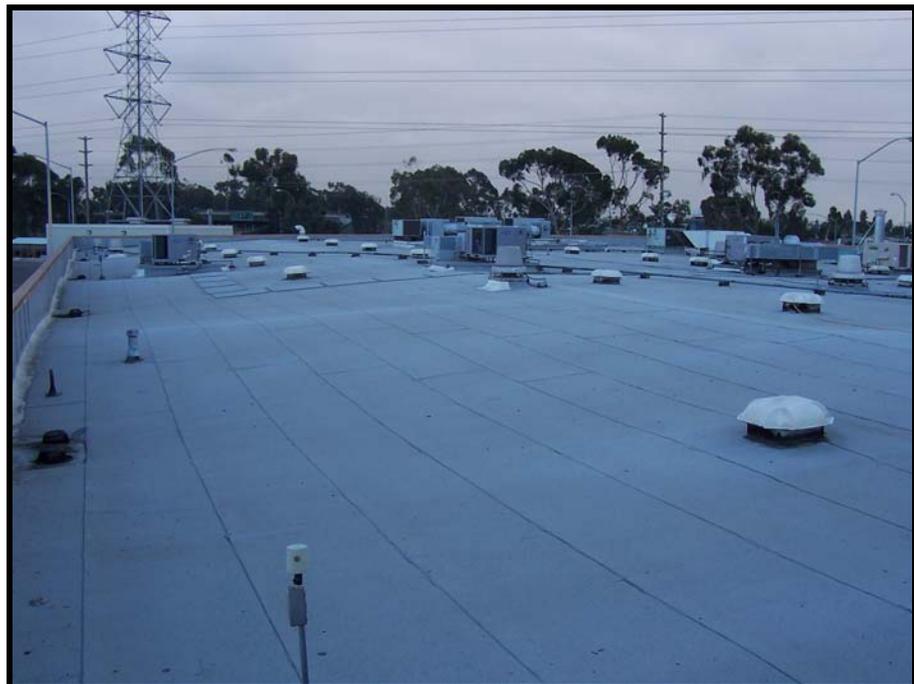
Photograph No. 12: View of the southern portion of the roof of the Laboratory Maintenance Building, looking southwest.

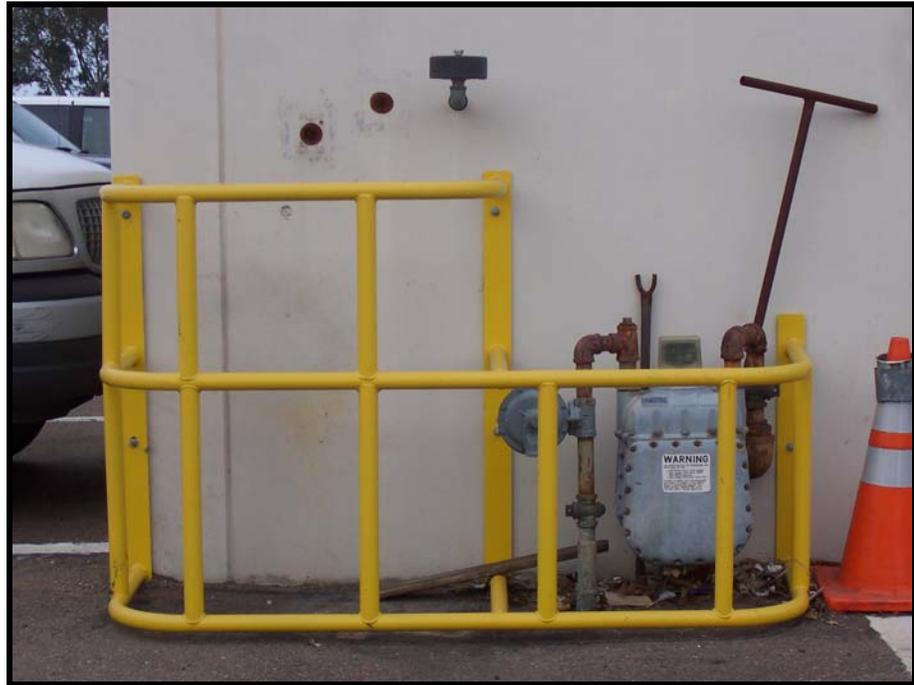
Photograph No. 13: View of the yellow, metal guardrail located on the exterior southeast corner of the Laboratory Maintenance Building, looking west.

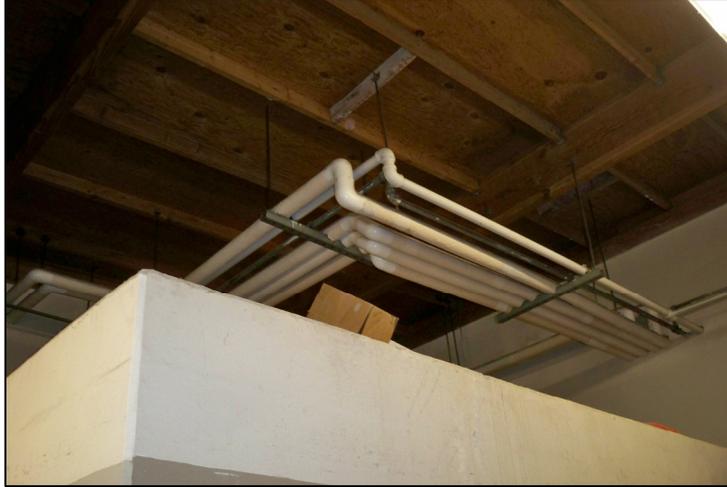
PHOTO 1

VIEW OF
TYPICAL INSULATION ON WATER PIPING

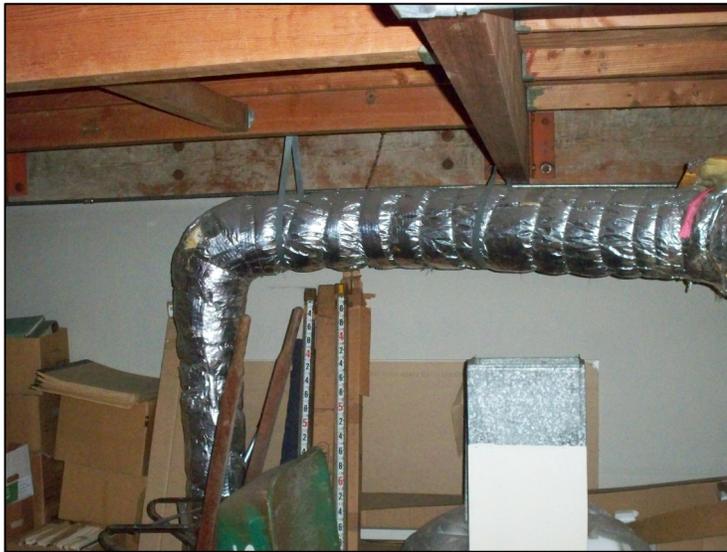
PHOTO 2

VIEW OF
TYPICAL INSULATION ON HVAC DUCTS

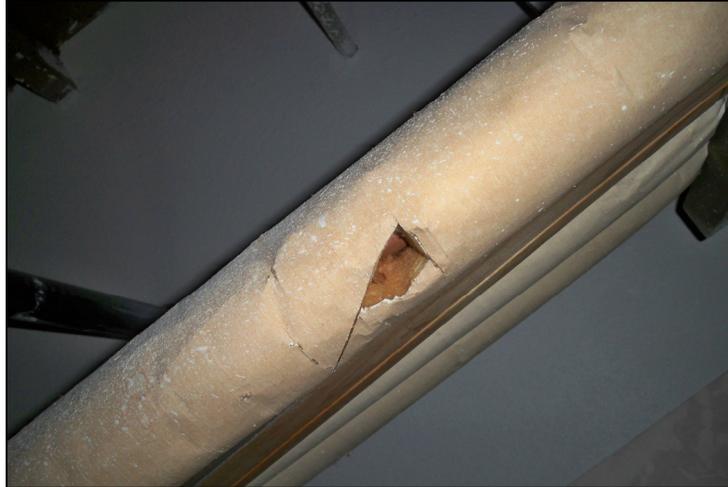
PHOTO 3

VIEW OF
 INSULATION ON WATER PIPES
 (SAMPLE KLF-1B)

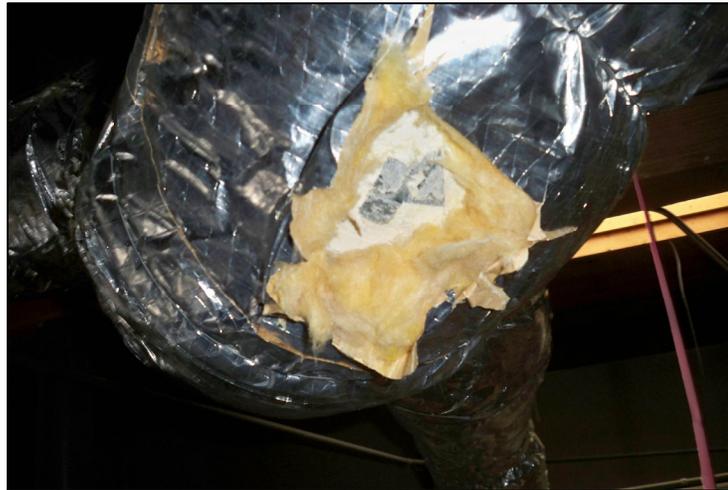
PHOTO 4

VIEW OF
 INSULATION MATERIALS AND DUCT TAPE ON HVAC DUCT
 (SAMPLES KLF-3A AND KLF-5A)

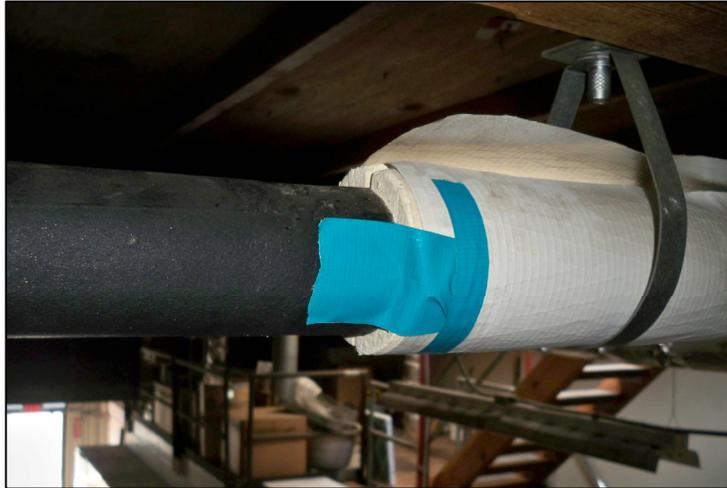
PHOTO 5

VIEW OF SECTION OF PIPE INSULATION AT WATER PIPE HANGER (SAMPLE KLF-4A)

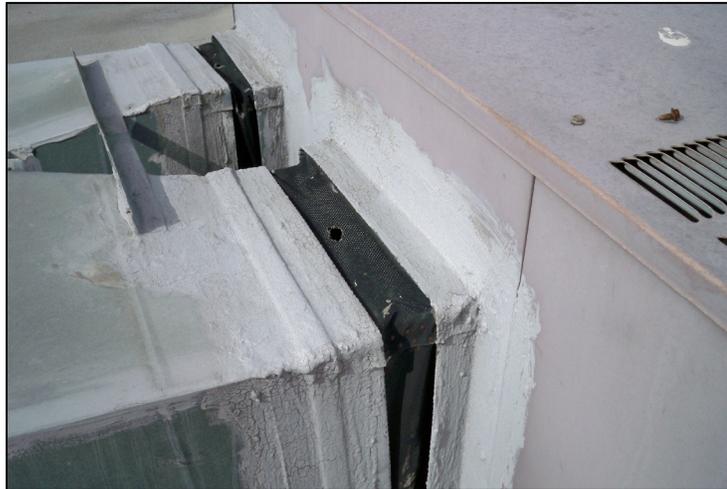
PHOTO 6

VIEW OF DUCT SEALANT AND VIBRATION CLOTH ON ROOF-MOUNTED AIR CONDITIONING UNIT (SAMPLES KLF-6B AND KLF-7A)
