Office of Safety

Proven Safety Countermeasures

These nine countermeasures address crashes that occur in the focus areas of intersections, pedestrians, and roadway departure.

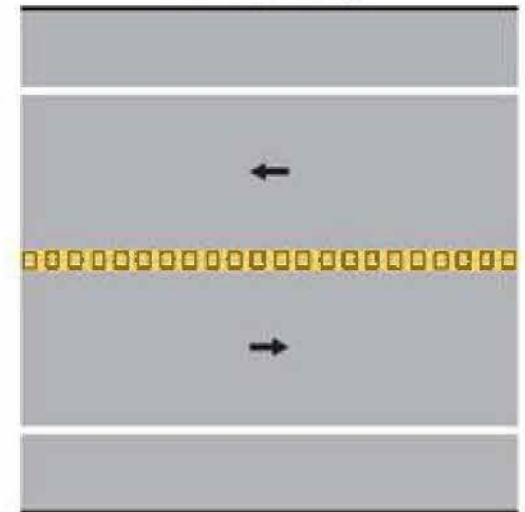
C - Center line on rumble strip

Note: Edge line may be located alongside the rumble strip (Option A) or on the rumble strip (Option B). Center line markings may also be located on a center line rumble strip (Option C).

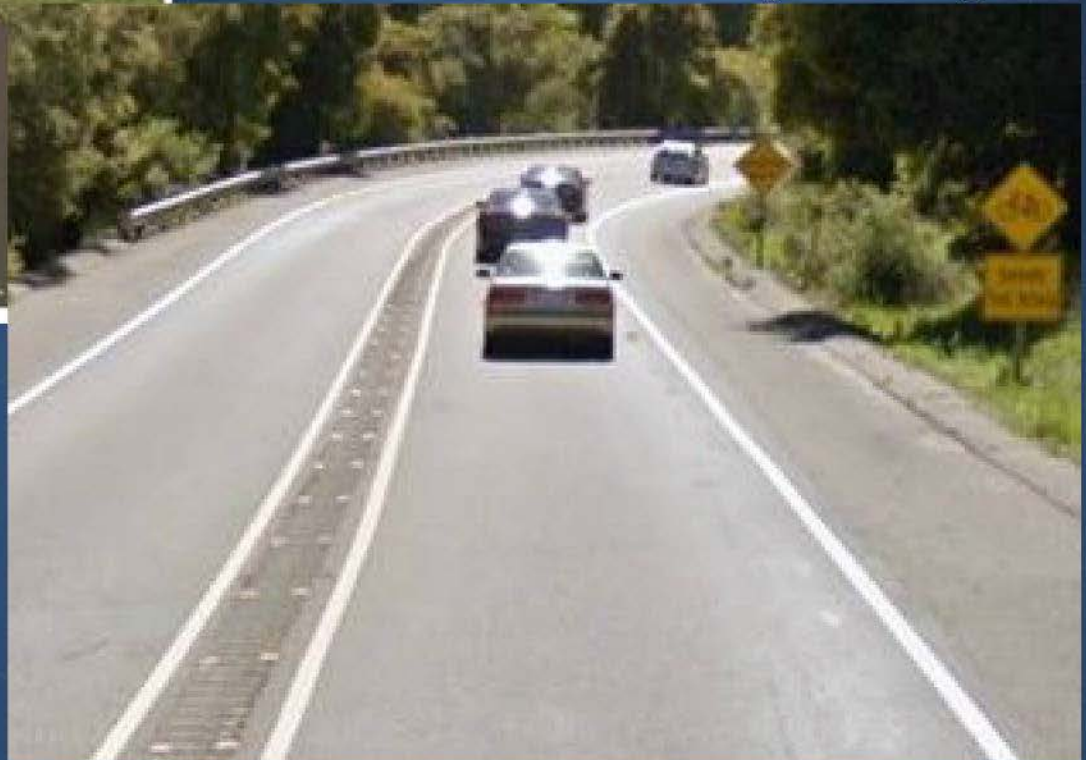
Shoulder Rumble Stripe

SR 84 in bay area
Courtesy of Google

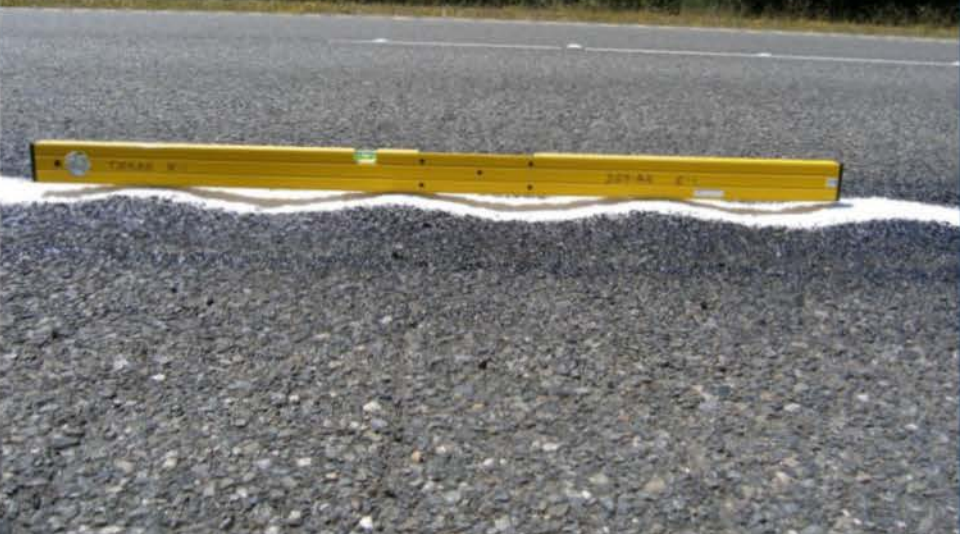
"Mumble" strip: 14" O.C., sinusoidal profile, p-p depth 5/16"

Caltrans (patent pending) Mumble Strip Evaluation

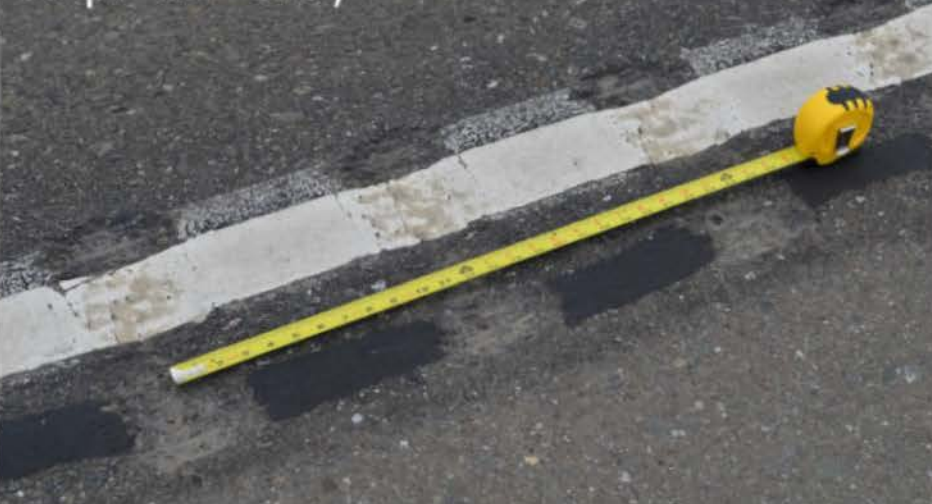
Conventional ground rumble strip: 12" O.C.,

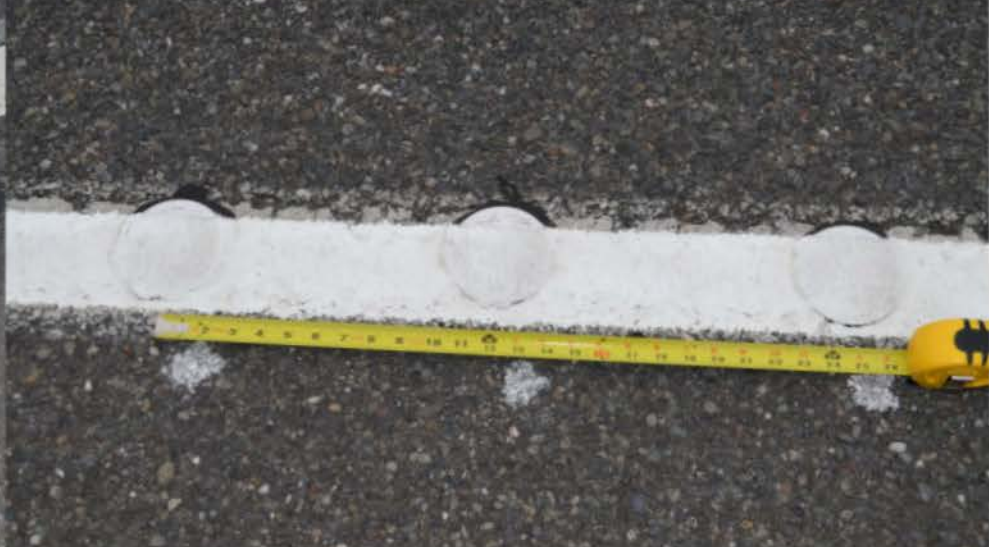
4" Dia Dots: 12" O.C.,

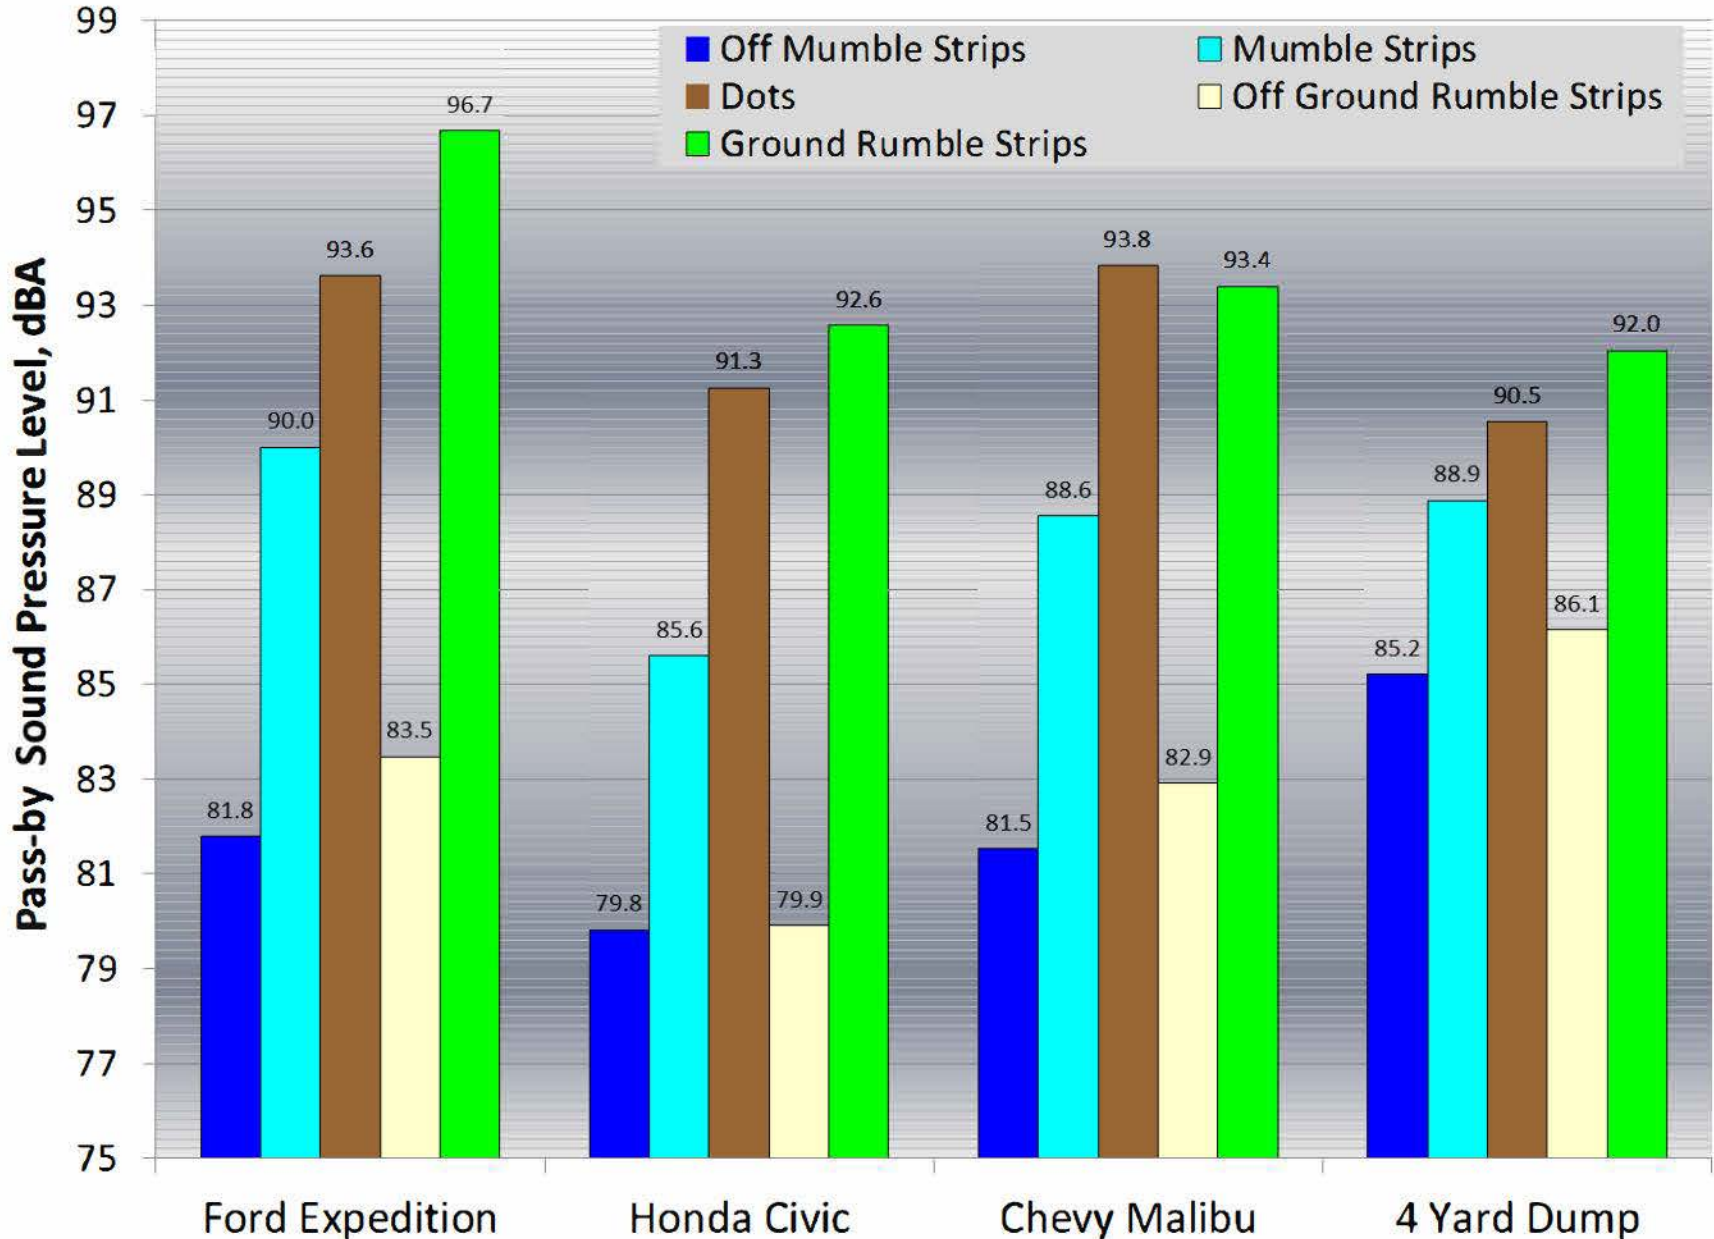
Overall Pass-by Noise Levels

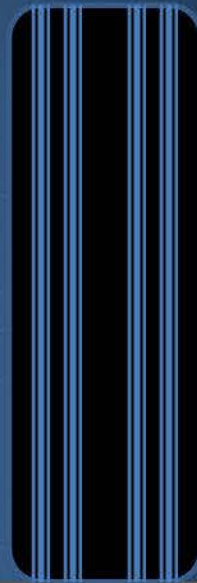
Basic Principle

With Safety Edge

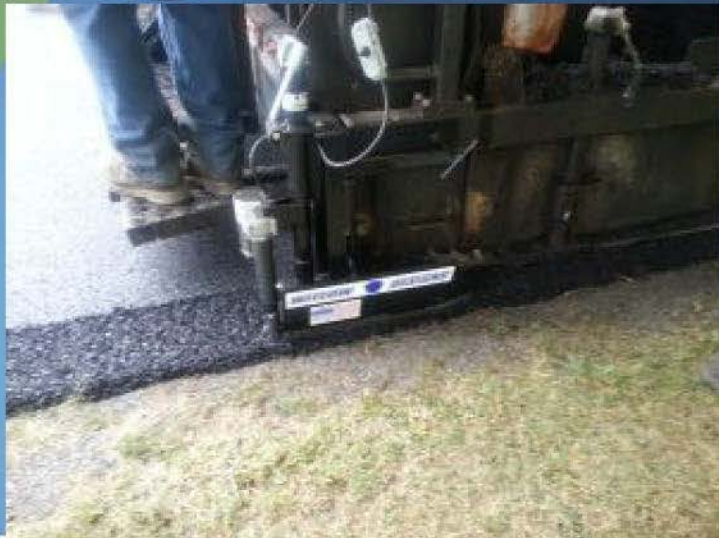
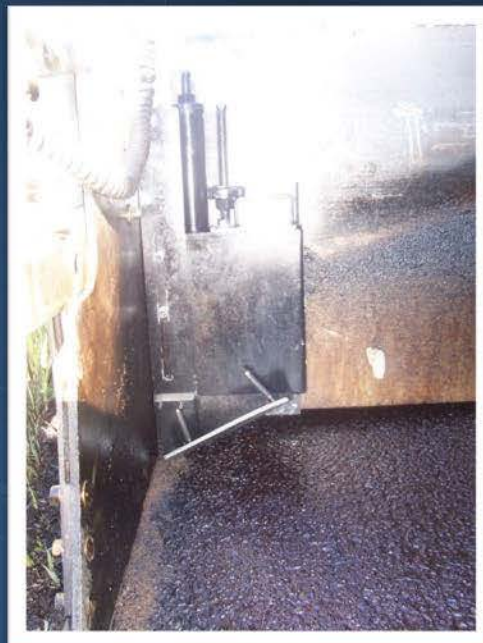
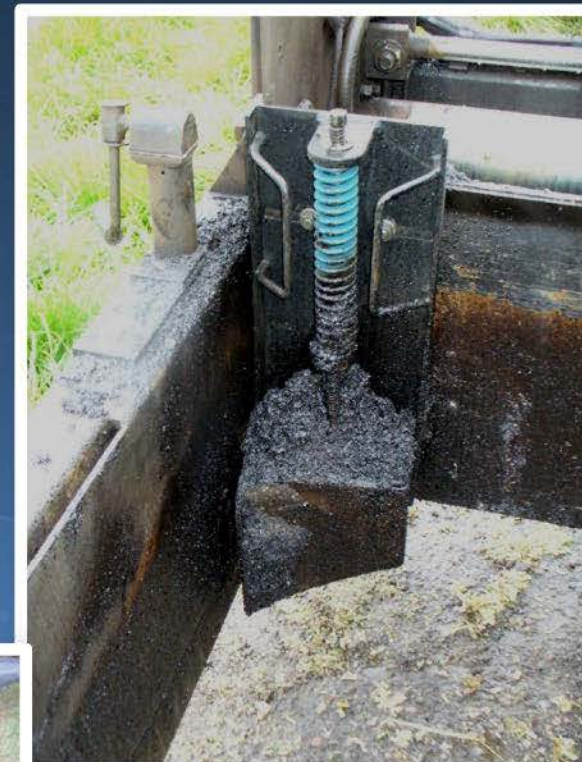
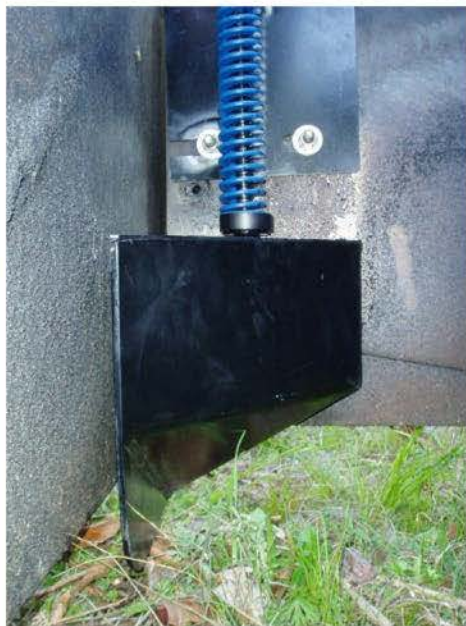
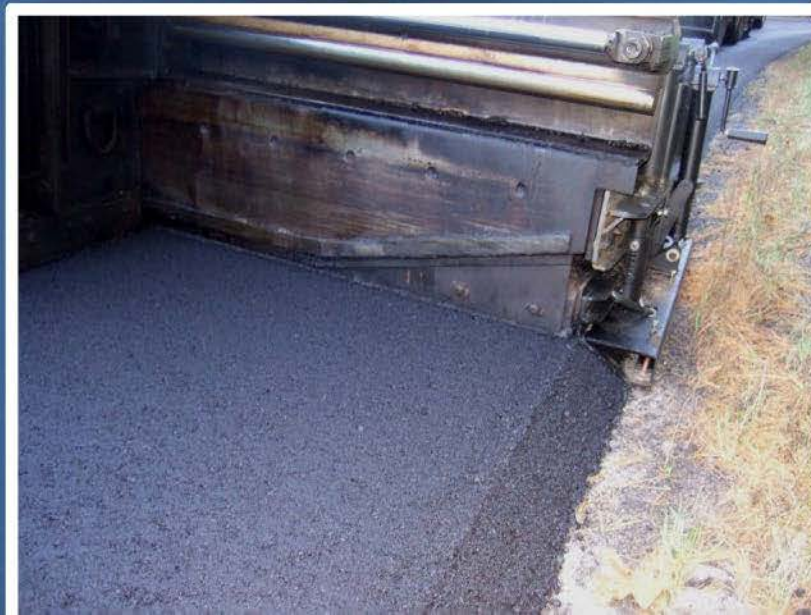
The Hardware

- Hardware
 - Approximately \$1400-\$4500 per device
 - Reusable
- Material
 - Minor additional asphalt (depends on shoulder condition)
- Paving Process
 - No change in paving speed or rolling patterns
 - No additional operation
 - Minimal monitoring
- Surface Details
 - No change in smoothness/ride quality

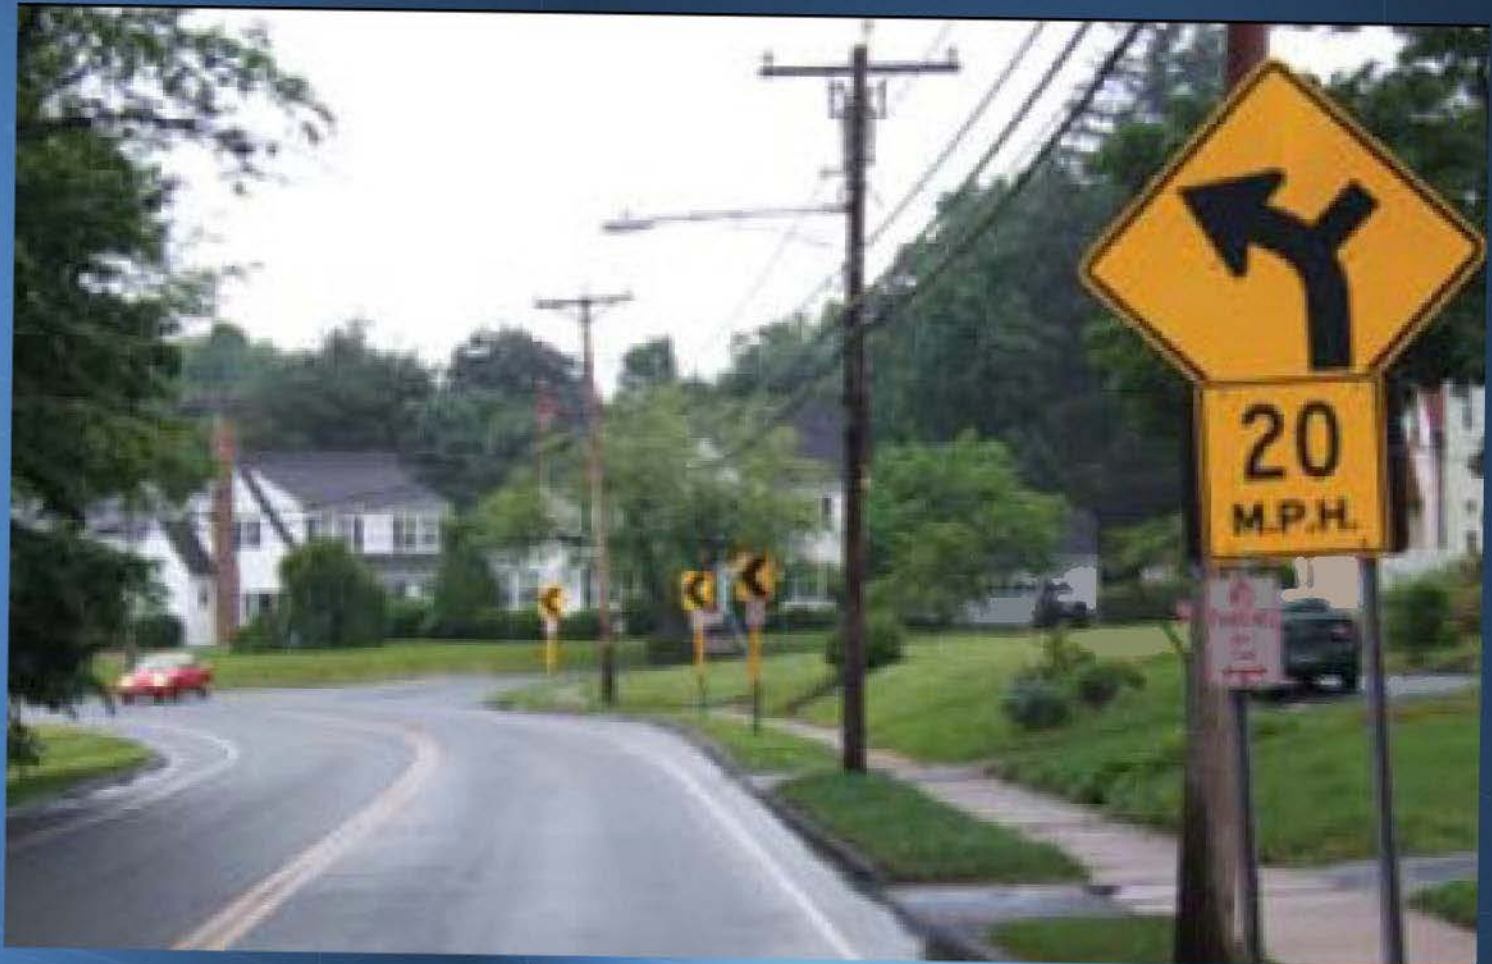
Example of Enhanced Delineation

- Data collected from states of Connecticut and Washington
- Delineation improvements for horizontal curves on two-lane rural roads
- 117 mile/years of before and after data (228 sites total)
- Chevron, curve ahead, horizontal or suggested speed limit signs
- Fluorescent sheeting, increased size or additional signs

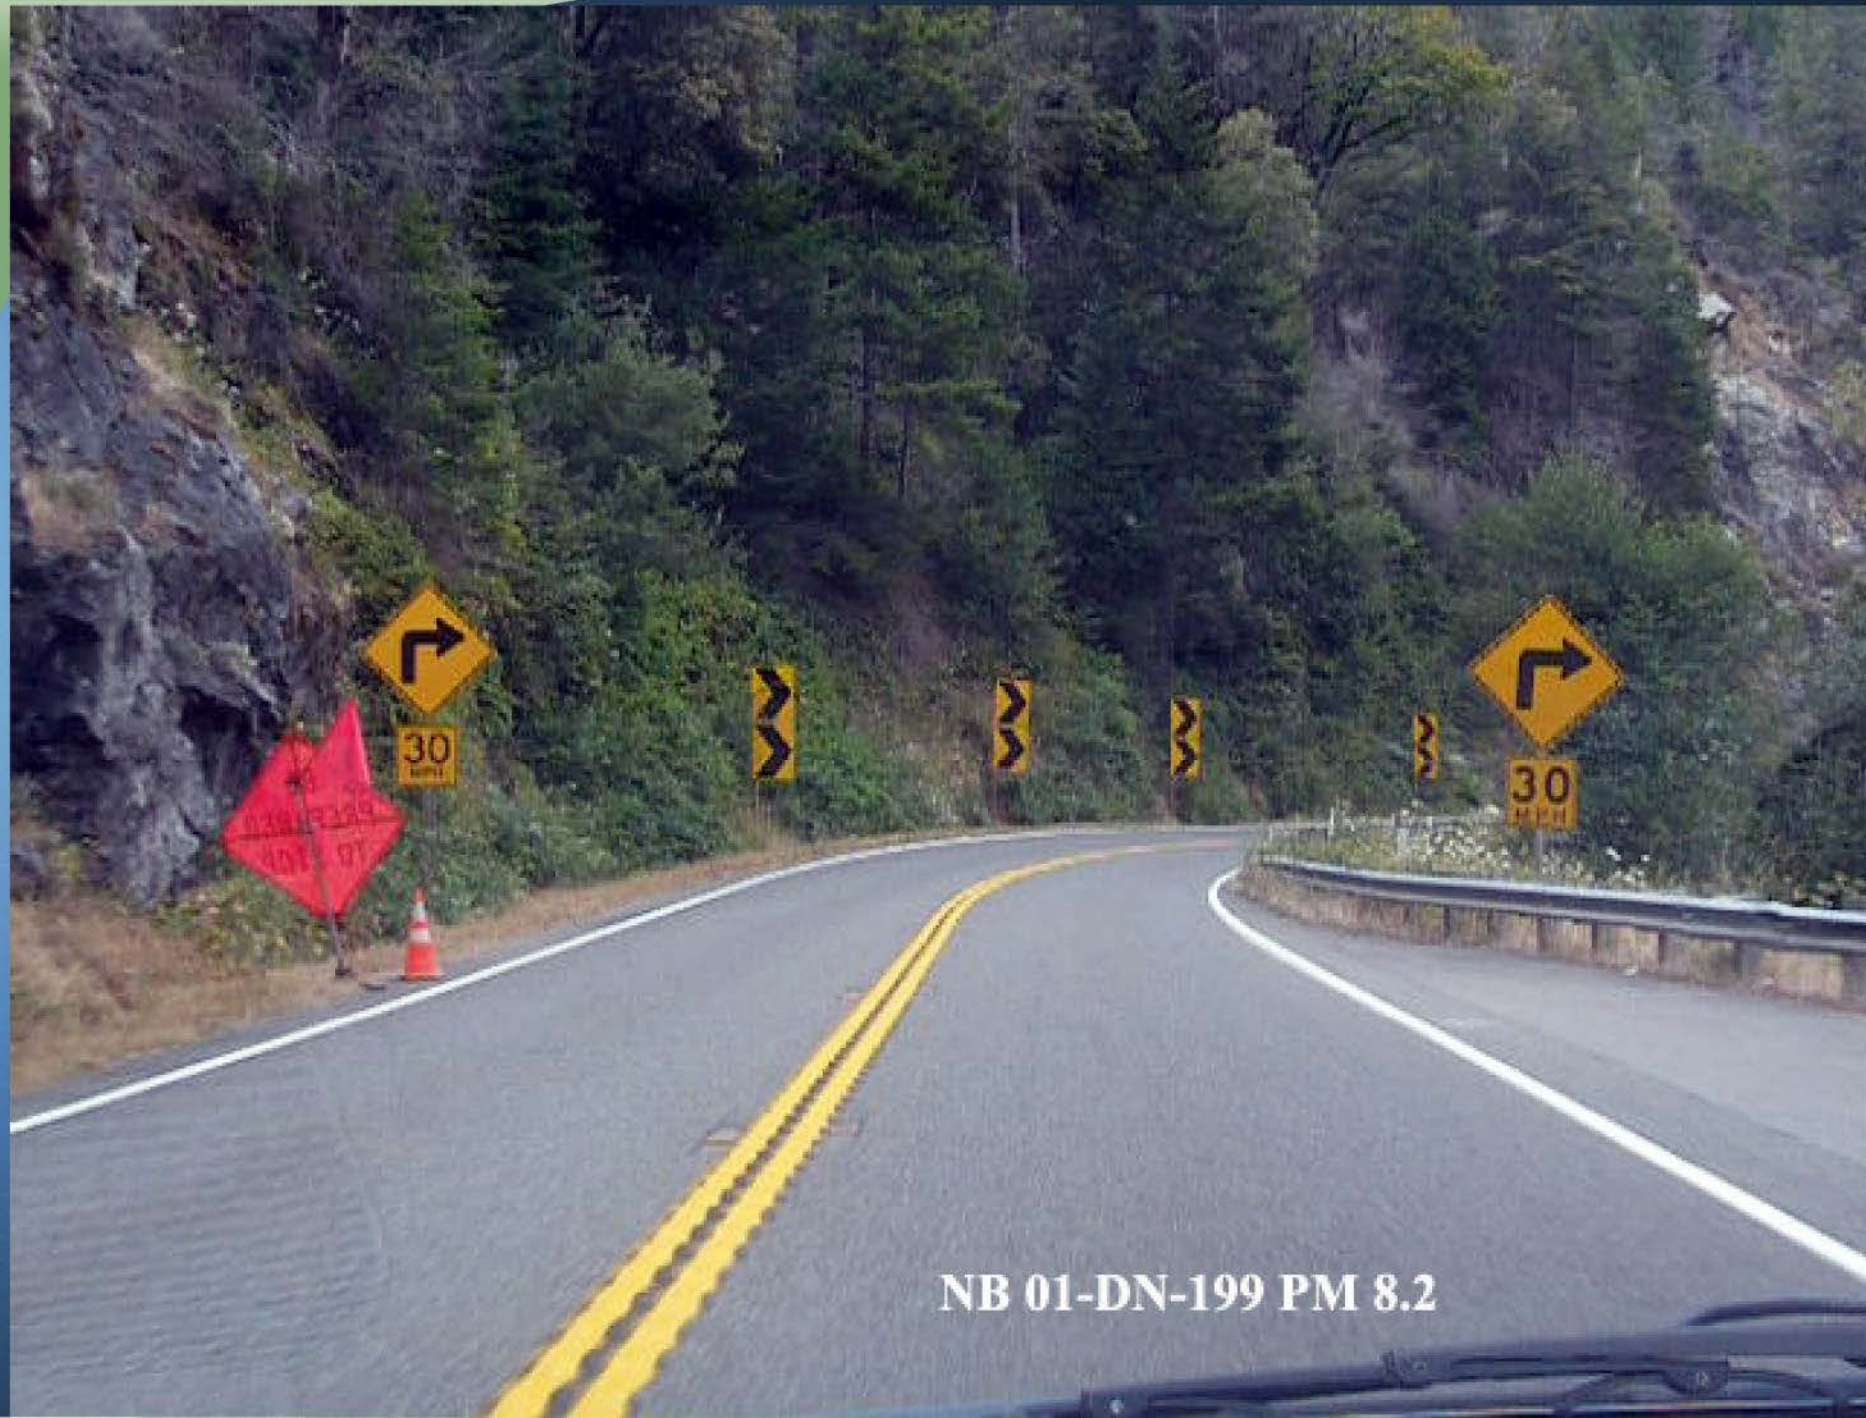
NB 01-DN-199 PM 8.2

- All 28 collisions in 3 years occurred under wet pavement conditions.
- District had used many low cost countermeasures with little change in collision pattern.
- District proposed curve realignment.

- Initial proposed project was to realign curve.
 - \$14 M project; approx. 5 years to get through environmental, design and construction
- Realignment project put on hold to install HFST
 - \$250 K project; approx. 6 months to get through environmental, design and construction
 - ▣ No crashes since installation (Summer 2012)
