## Nine Proven Safety Countermeasures

# Shoulder and center line rumble strips

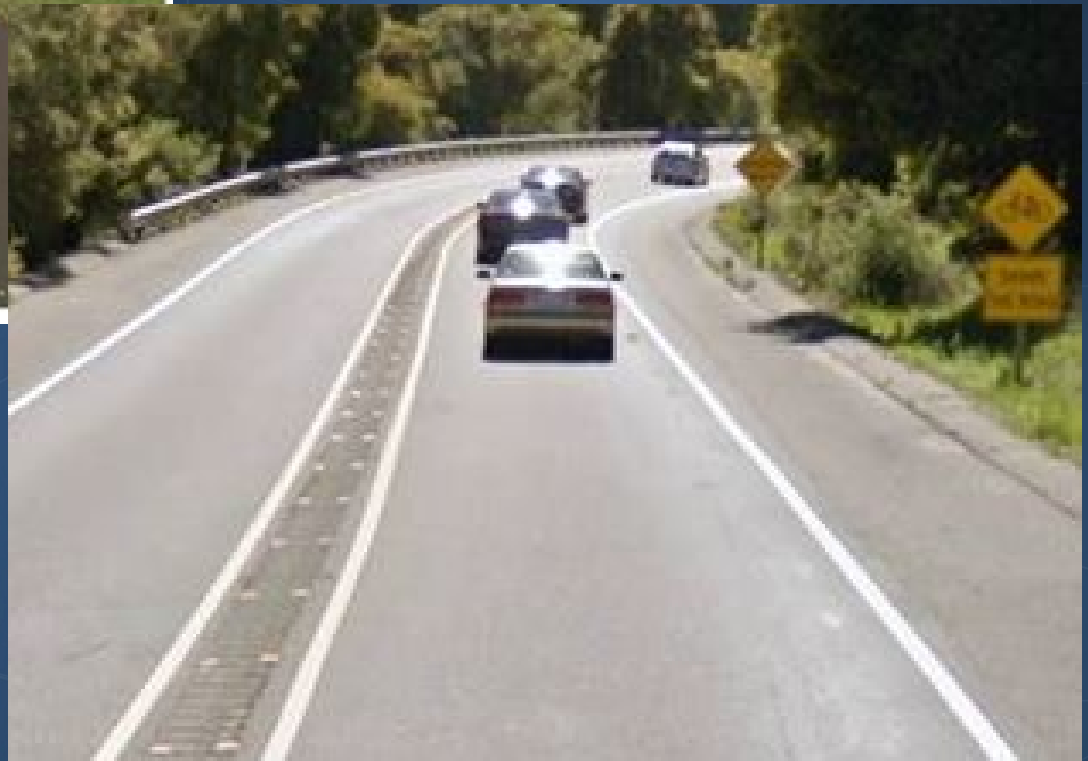
Shoulder Rumble Stripe

SR 84 in bay area  
Courtesy of Google

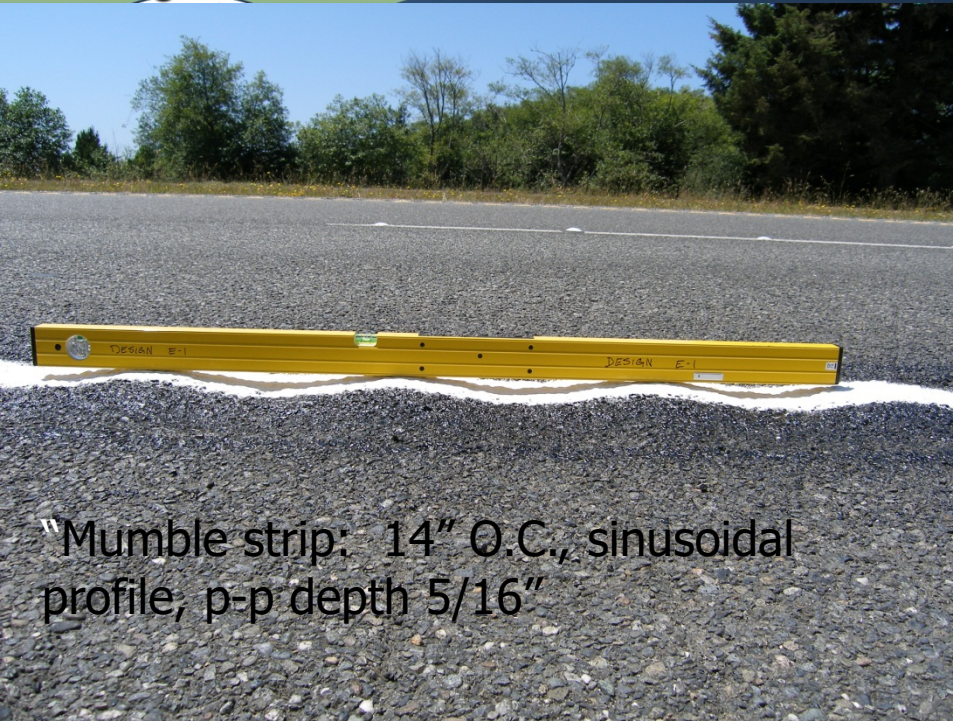
"Mumble strip: 14" O.C., sinusoidal profile, p-p depth 5/16"

- Rumble strips can help reduce sideswipe, head-on collisions, and run-off-road crashes
- Caltrans mumble strips achieved goals
  - Lower exterior dB A-weighted levels
  - Provide sufficient driver warning input
- Interior noise & vibration response varied with vehicle type

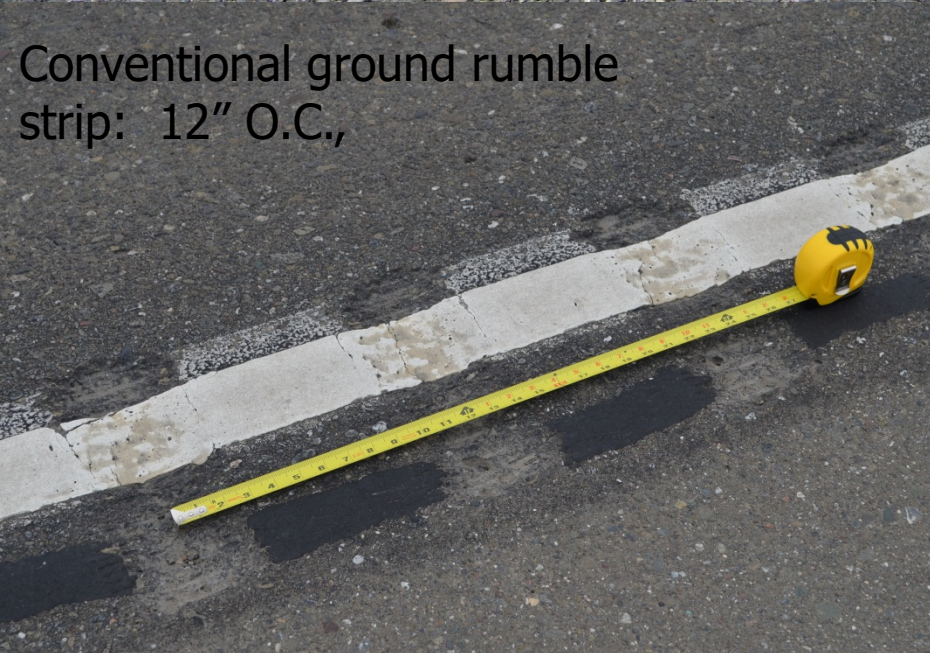
Conventional ground rumble strip: 12" O.C.,

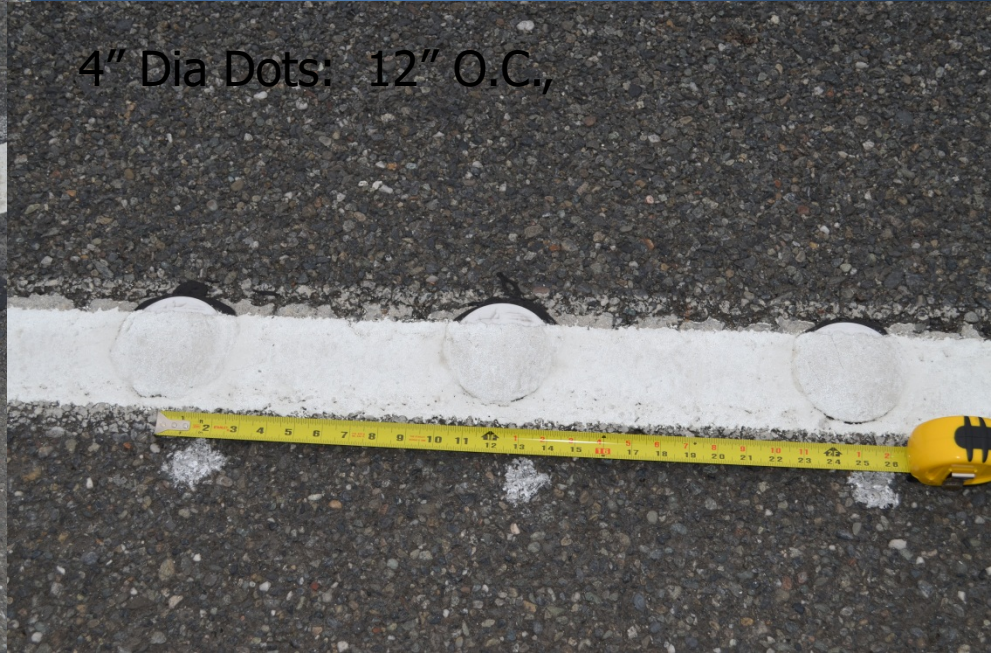
4" Dia Dots: 12" O.C.,

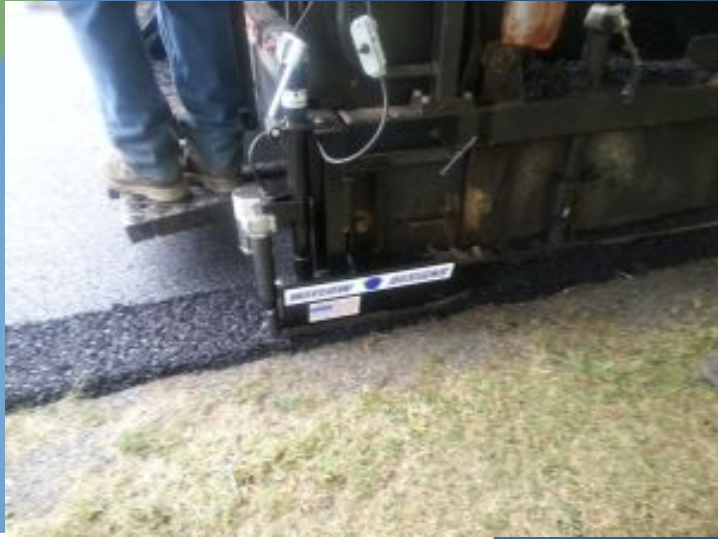
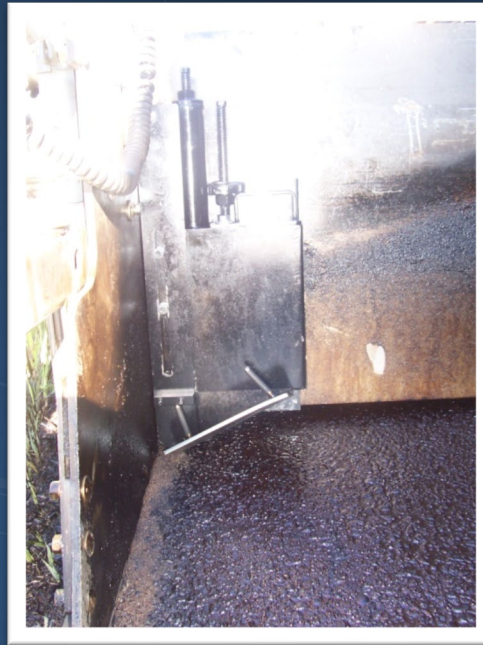
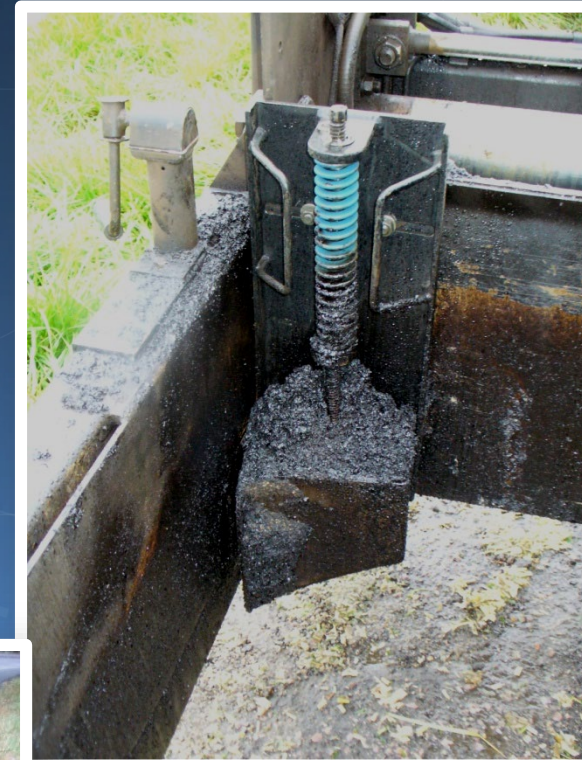
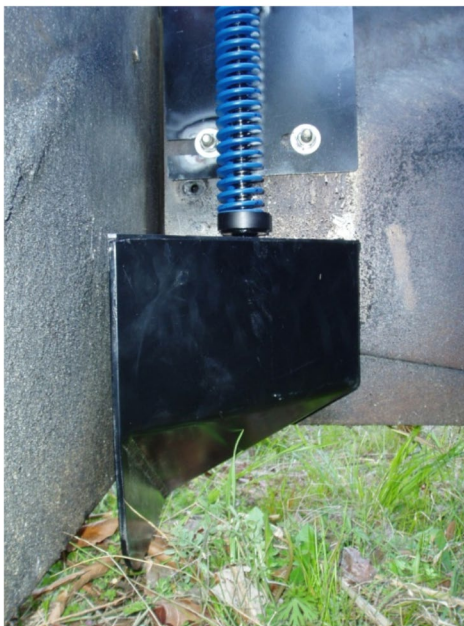
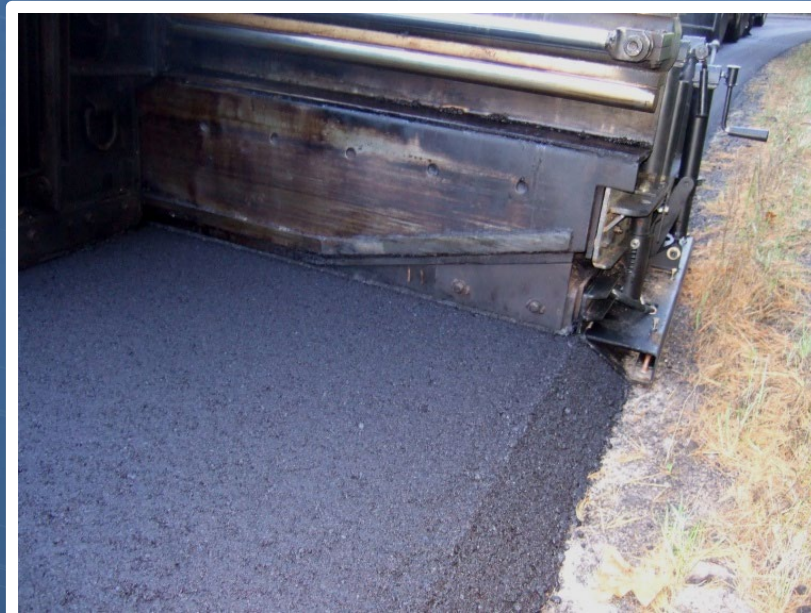
# The Hardware

- Hardware
  - Approximately \$1400-\$4500 per device
  - Reusable
- Material
  - Minor additional asphalt (depends on shoulder condition)
- Paving Process
  - No change in paving speed or rolling patterns
  - No additional operation
  - Minimal monitoring
- Surface Details
  - No change in smoothness/ride quality

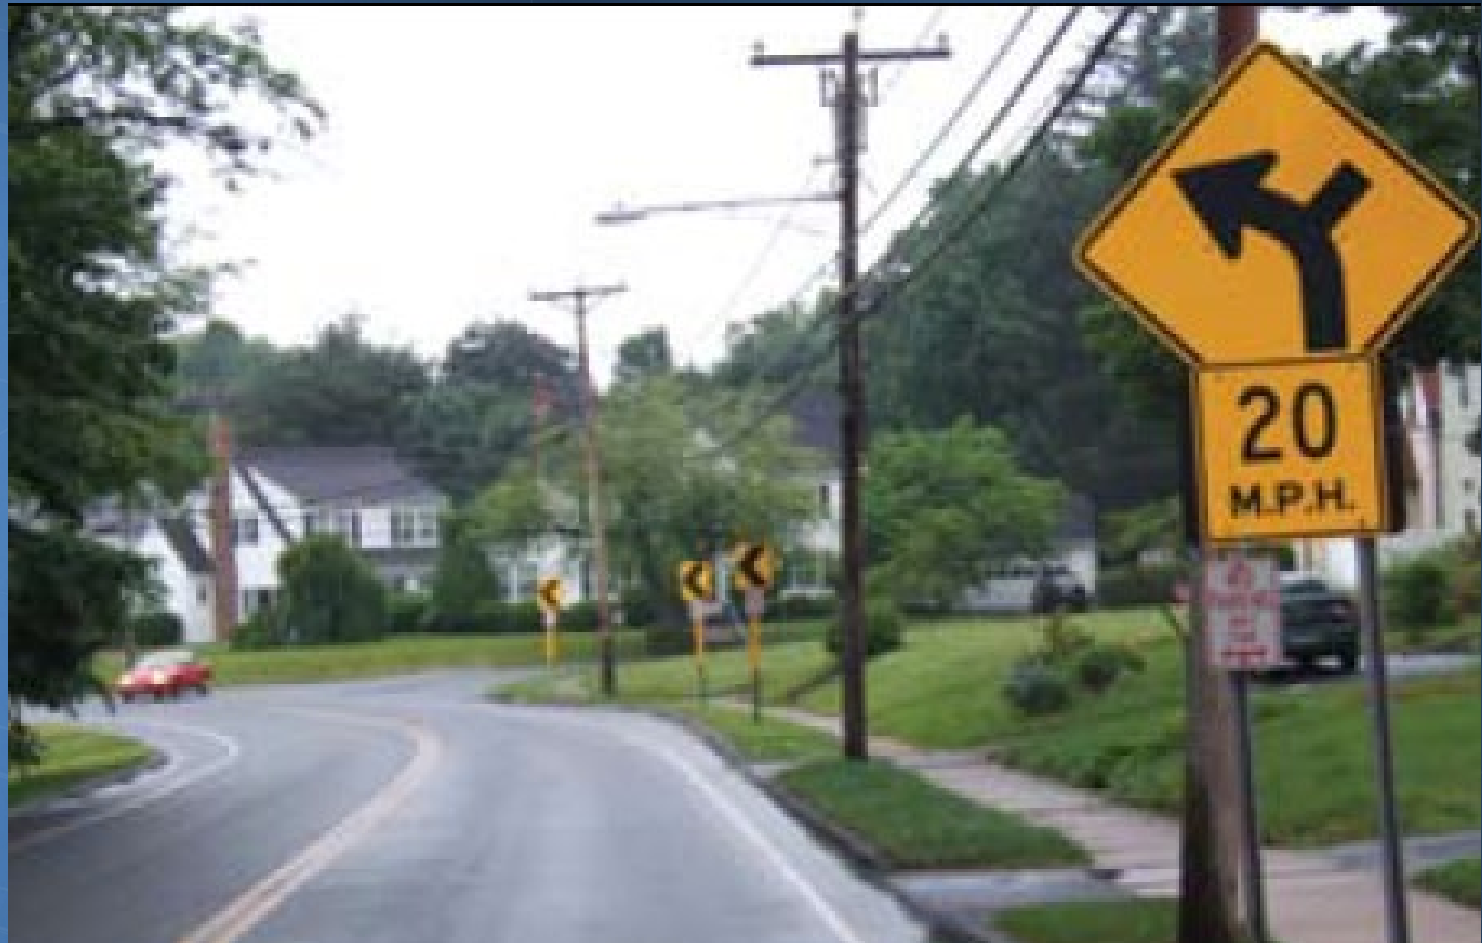
# Example of Enhanced Delineation

- Data collected from states of Connecticut and Washington
- Delineation improvements for horizontal curves on two-lane rural roads
- 117 mile/years of before and after data (228 sites total)
- Chevron, curve ahead, horizontal or suggested speed limit signs
- Fluorescent sheeting, increased size or additional signs

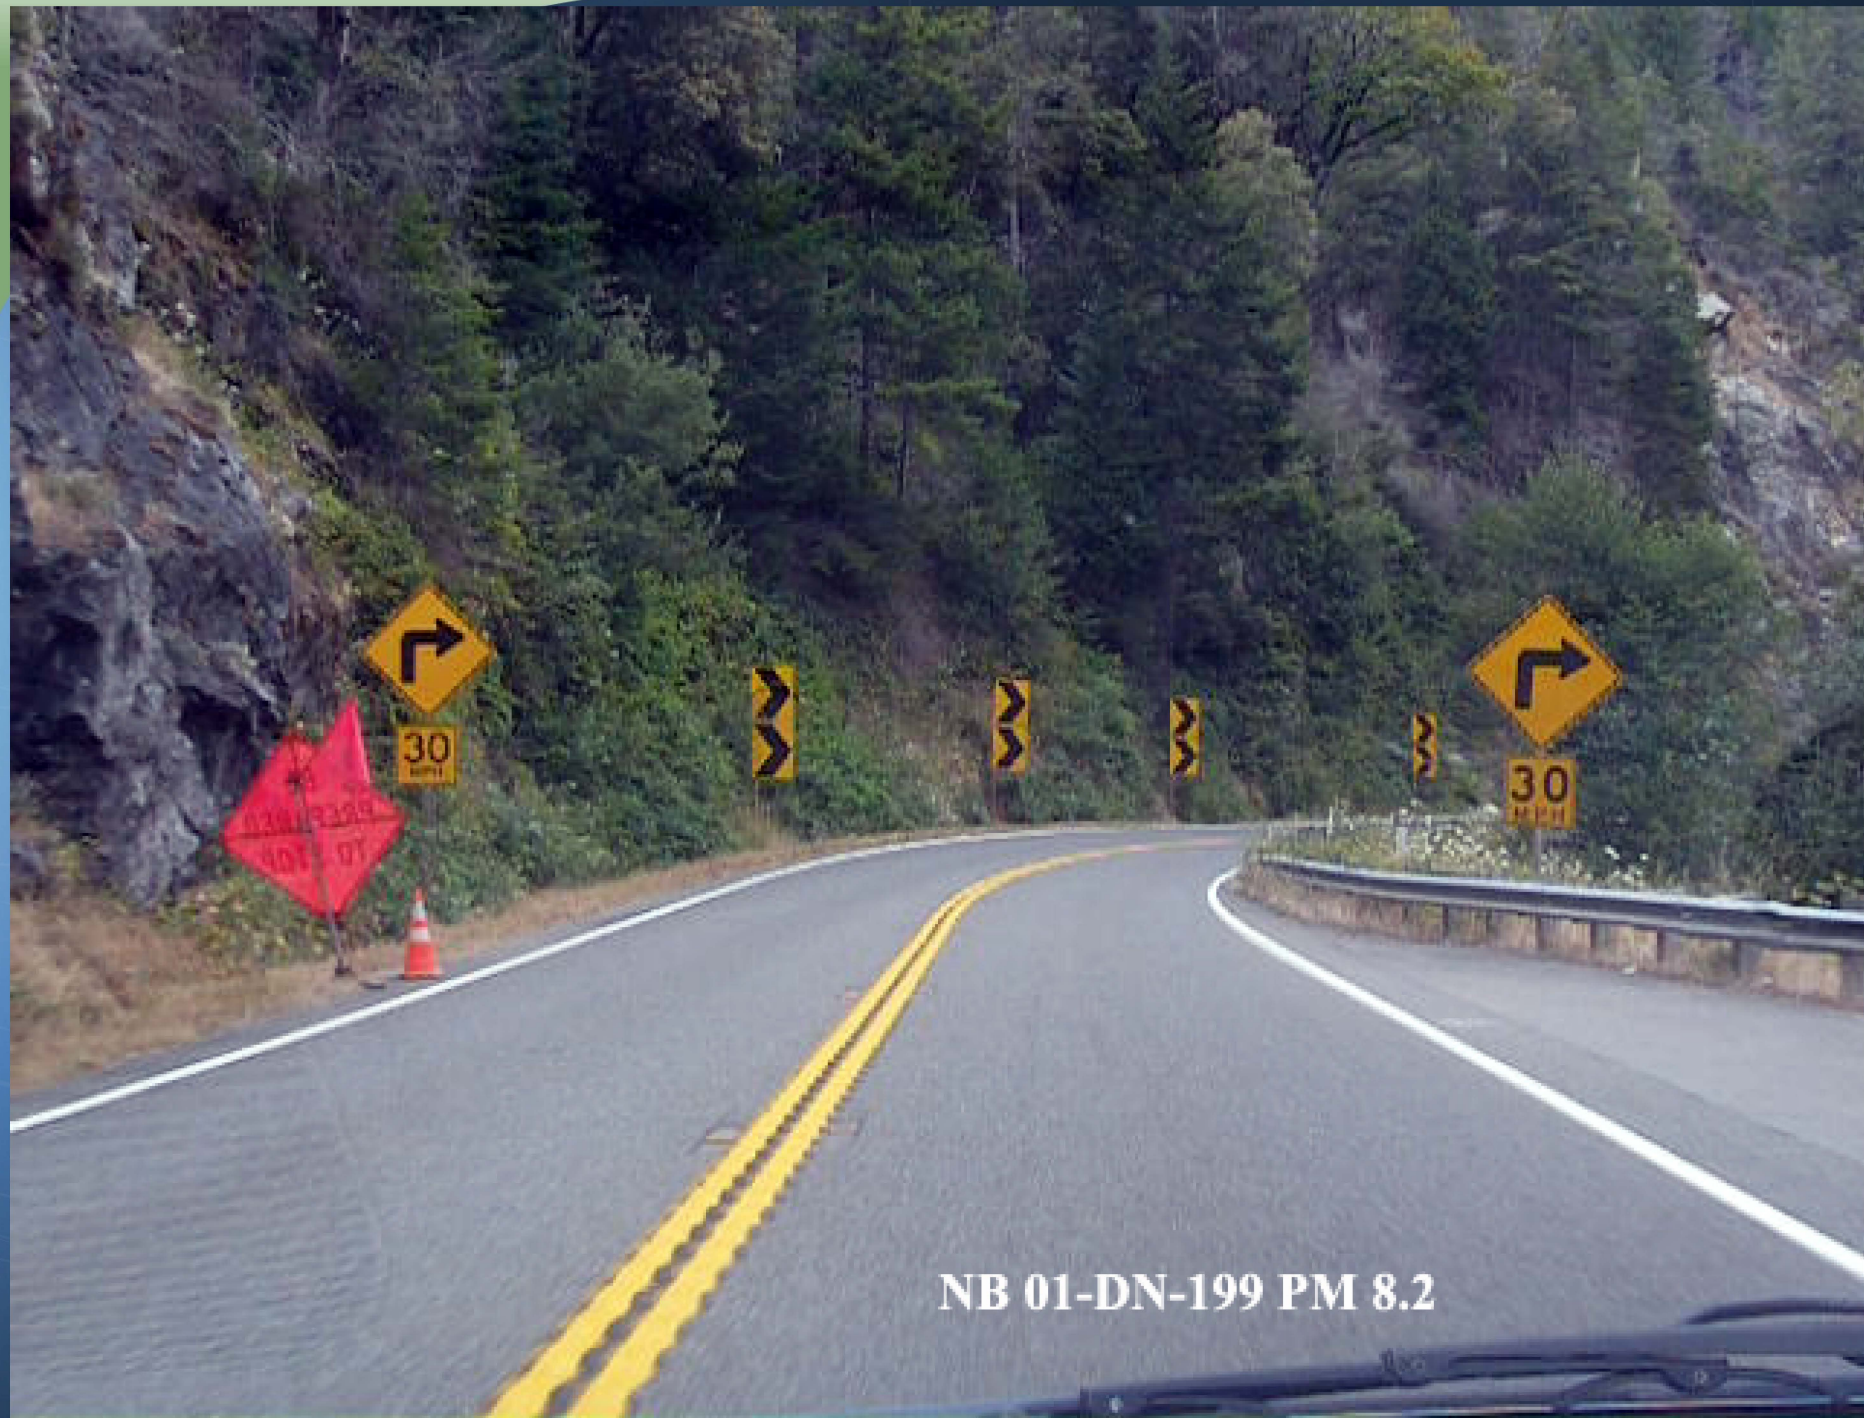
NB 01-DN-199 PM 8.2

- All 28 collisions in 3 years occurred under wet pavement conditions.
- District had used many low cost countermeasures with little change in collision pattern.
- District proposed curve realignment.

- Initial proposed project was to realign curve
  - \$14 M project; approx. 5 years for environmental, design and construction
- Realignment project put on hold to install HFST
  - \$250 K project; approx. 6 months for environmental, design and construction
- No crashes since installation (Summer 2012)
