RESPONSE OF SAN JOAQUIN KIT FOXES TO ROAD CONSTRUCTION SITES

Contract Number 65A0903

**Prepared for the
California Department of Transportation**

November 2023

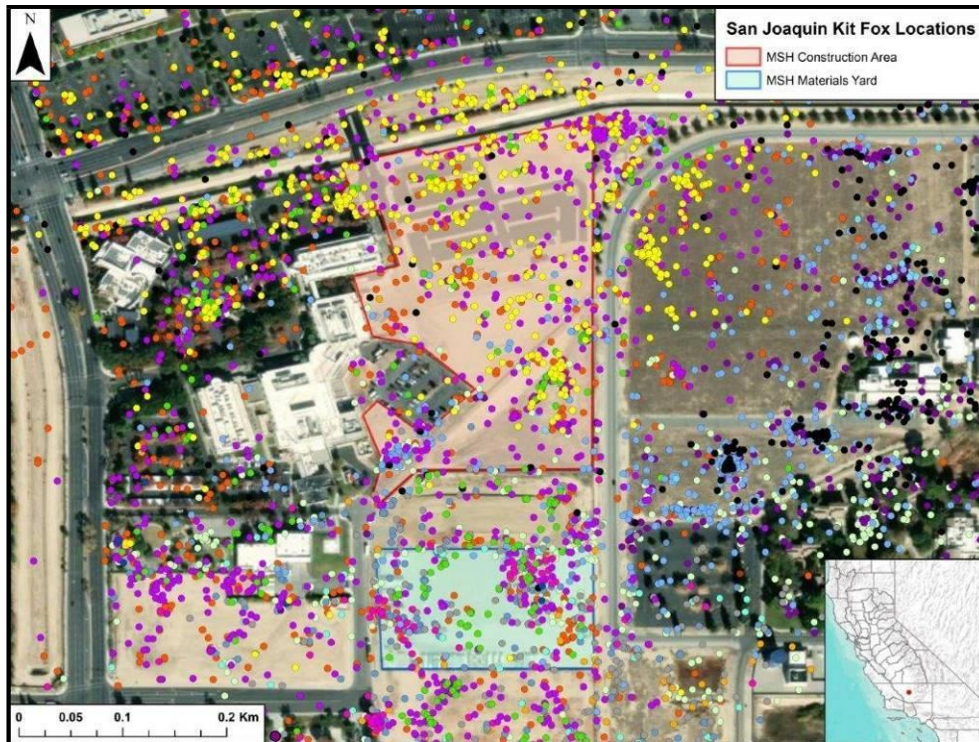
Figure 11. Telemetry locations for twenty San Joaquin kit foxes (each a different color) on the Mercy Southwest Hospital study site, Bakersfield, CA, June 2023-May 2024.

On the MSH study site, 15,379 locations were collected on 20 collared kit foxes. Of these locations, 1,194 (7.8%) were on the study site (Fig. 11). Of the 20 foxes, 15 had a least one location on the study site. The mean proportion of locations on the site for the 15 foxes was $10.3 \pm 0.1\%$ (range 0.6-26.8%). All of the locations on site were in the active construction area or the materials yard; the study site boundary did not include areas where work was not being conducted.

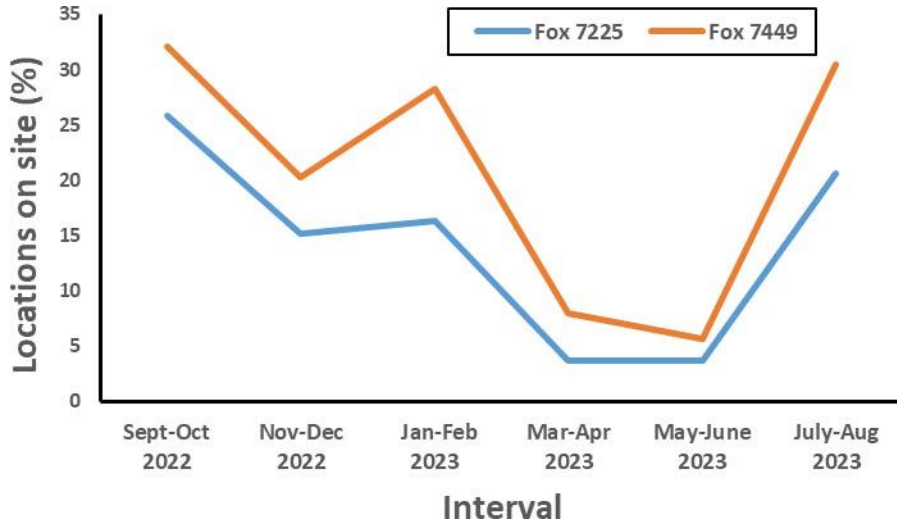
Figure 18. Proportion of locations on the Mercy Southwest Hospital construction site for two San Joaquin kit foxes during six two-month time intervals in Bakersfield, CA.

Two foxes using the MSH site were tracked for almost the entirety of the study. The proportions of locations for these two foxes that were on the construction site varied over time (Fig. 12-17). The proportions declined over time as construction activities increased, but then the proportions suddenly increased toward the end of the study (Fig. 18).

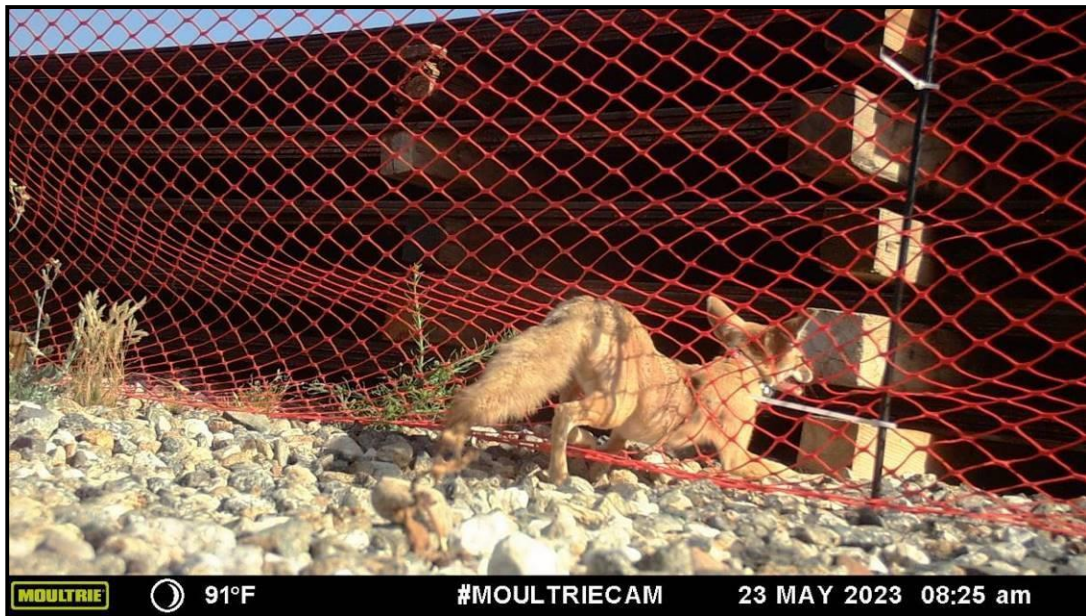
Figure 25. San Joaquin kit fox accessing construction materials through a chewed hole in the plastic fencing around the materials on the Mercy Southwest Hospital study site, Bakersfield, CA, January 2024. (Photo by E. Noel)

Two strategies to prevent foxes from using and occupying materials have had some success. One strategy is to attempt to place fencing around materials or at least to cover up openings. This might require a considerable amount of fencing depending on the dimensions of the staged materials. Then fencing should be at least 4 ft high to prevent foxes from jumping over. Several types of plastic safety fencing (e.g., PVC Vinyl Safety Fence or Heavy Duty Ridged Diamond Safety Fence) were tried around staged materials at the MSH site (Figs. 22-24). However, foxes were able to push under or chew through this fencing (Fig. 25). The addition of a second layer of more rigid material (e.g., chicken wire or hardware cloth) seemed to reduce breaching of the fence by foxes. Experimentation with other types of fencing may identify more effective designs. Small mesh size (Fig. 26) may help reduce incidents of foxes chewing holes in the fencing. For bundles of materials that are sufficiently small (e.g., items on pallets), completely wrapping the bundle in plastic or other material will help exclude access by foxes. The bottom of the fence should be anchored to the ground (e.g., sandbags or stakes) or even buried several inches if feasible to discourage kit foxes from digging under.

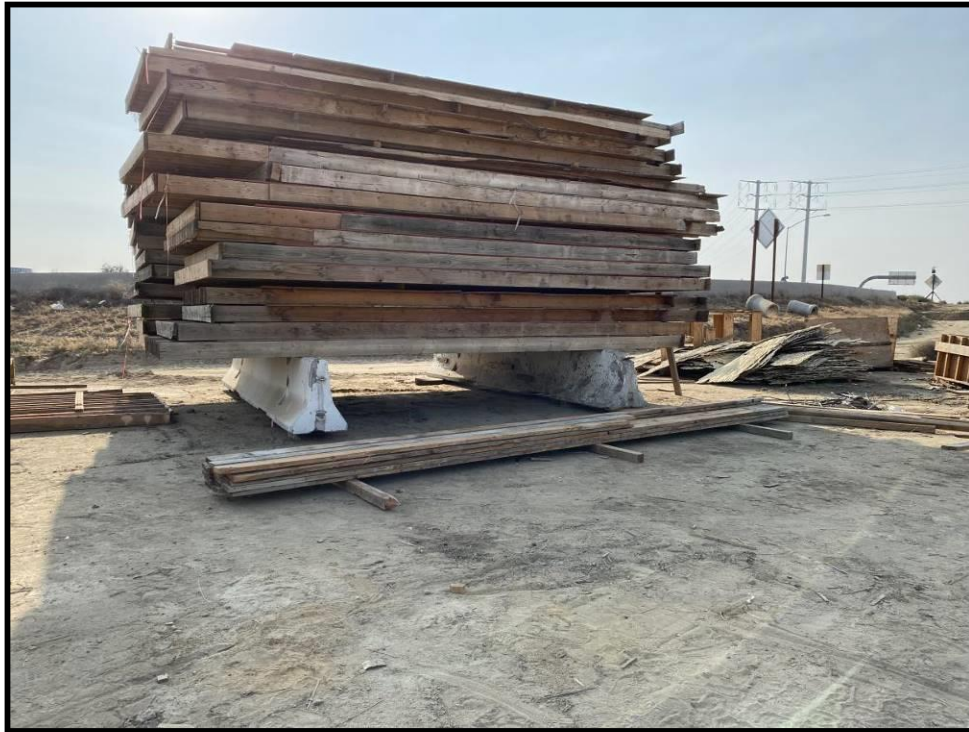
Figure 6. Construction materials placed up on K-rails on the Centennial Corridor road construction site in Bakersfield, CA. (Photo by E. Noel)
