Ready to Chop, Chip, Blast Away Winter

Memory of Last Season's Deluge Fresh, Caltrans Crews Ready for Battle Again

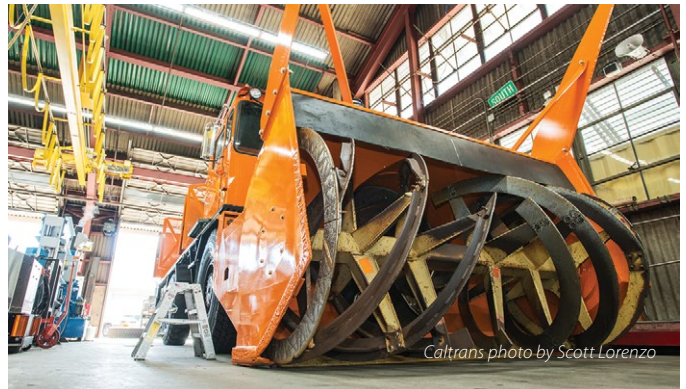
The arrival of storm season means extra duties for Caltrans' mechanics who must tune up the arsenal of snow-fighting equipment.

On the to-do list: Mechanics in Caltrans main equipment shop in Sacramento spent weeks refurbishing eight huge diesel-powered snow blowers, which can blast up to 5,000 cubic tons of snow per hour off roadways. Mechanics refurbished blower boxes, engines, and hydraulic and electrical systems, and applied fresh paint.

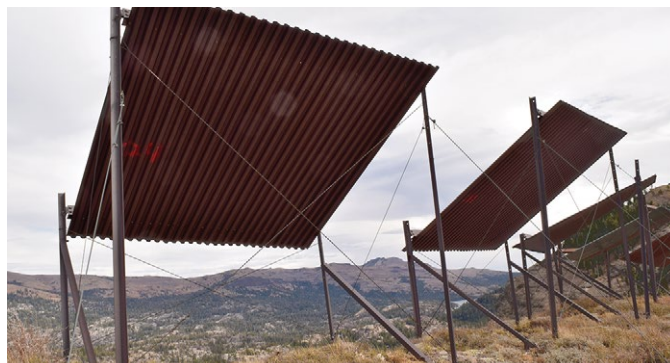
Metal panels called “jet roofs” line a section of a Central Sierra ridge above Highway 88 to keep potentially deadly cornices from forming.

Part of Caltrans' winter preparation in the central Sierra Nevada involves fine-tuning “jet roofs” — metal panels carefully positioned on snowy summits to redirect wind and prevent the formation of overhanging slabs of ice. If allowed to form, these deposits pose a danger to passing motorists if dislodged.

A jet roof acts as an aerodynamic structure, placed on the crest of a ridge where snow buildups known as cornices form on the leeward side. Supported by angled iron legs and staked to the ground, the 10 foot-by-10 foot panels direct wind downward, discouraging such formations.

Caltrans maintains 142 of these structures along the ridge lines above Highway 88, in an avalanche-prone area known as the Carson Spur. Caltrans also maintains 65 wind fence installations, each 8 feet by 10 feet, on the windward side of lower passes near the Kirkwood Ski Resort. The total length of the system protects .63 miles of exposed ridge line from cornice buildup.

District 10 Maintenance crews inspect the jet roof stock every summer. Because the climate is inhospitable during the winter months, wear and tear is expected. This year, 23 units required repairs, such as new legs, wires or metal panels, or, in some cases, entire replacement.

Heavy snow and howling winds last winter season buried and crushed sections of jet roofs. High winds can wreak havoc if panels aren't kept in tip-top shape.
