**HAZARDOUS WASTE INITIAL SITE
ASSESSMENT**

**LOWER SR-74 WIDENING PROJECT
CALLE ENTRADERO TO CITY/COUNTY LINE
SAN JUAN CAPISTRANO, CALIFORNIA**

12-ORA-74 PM 1.0/1.9

EA No. 086920

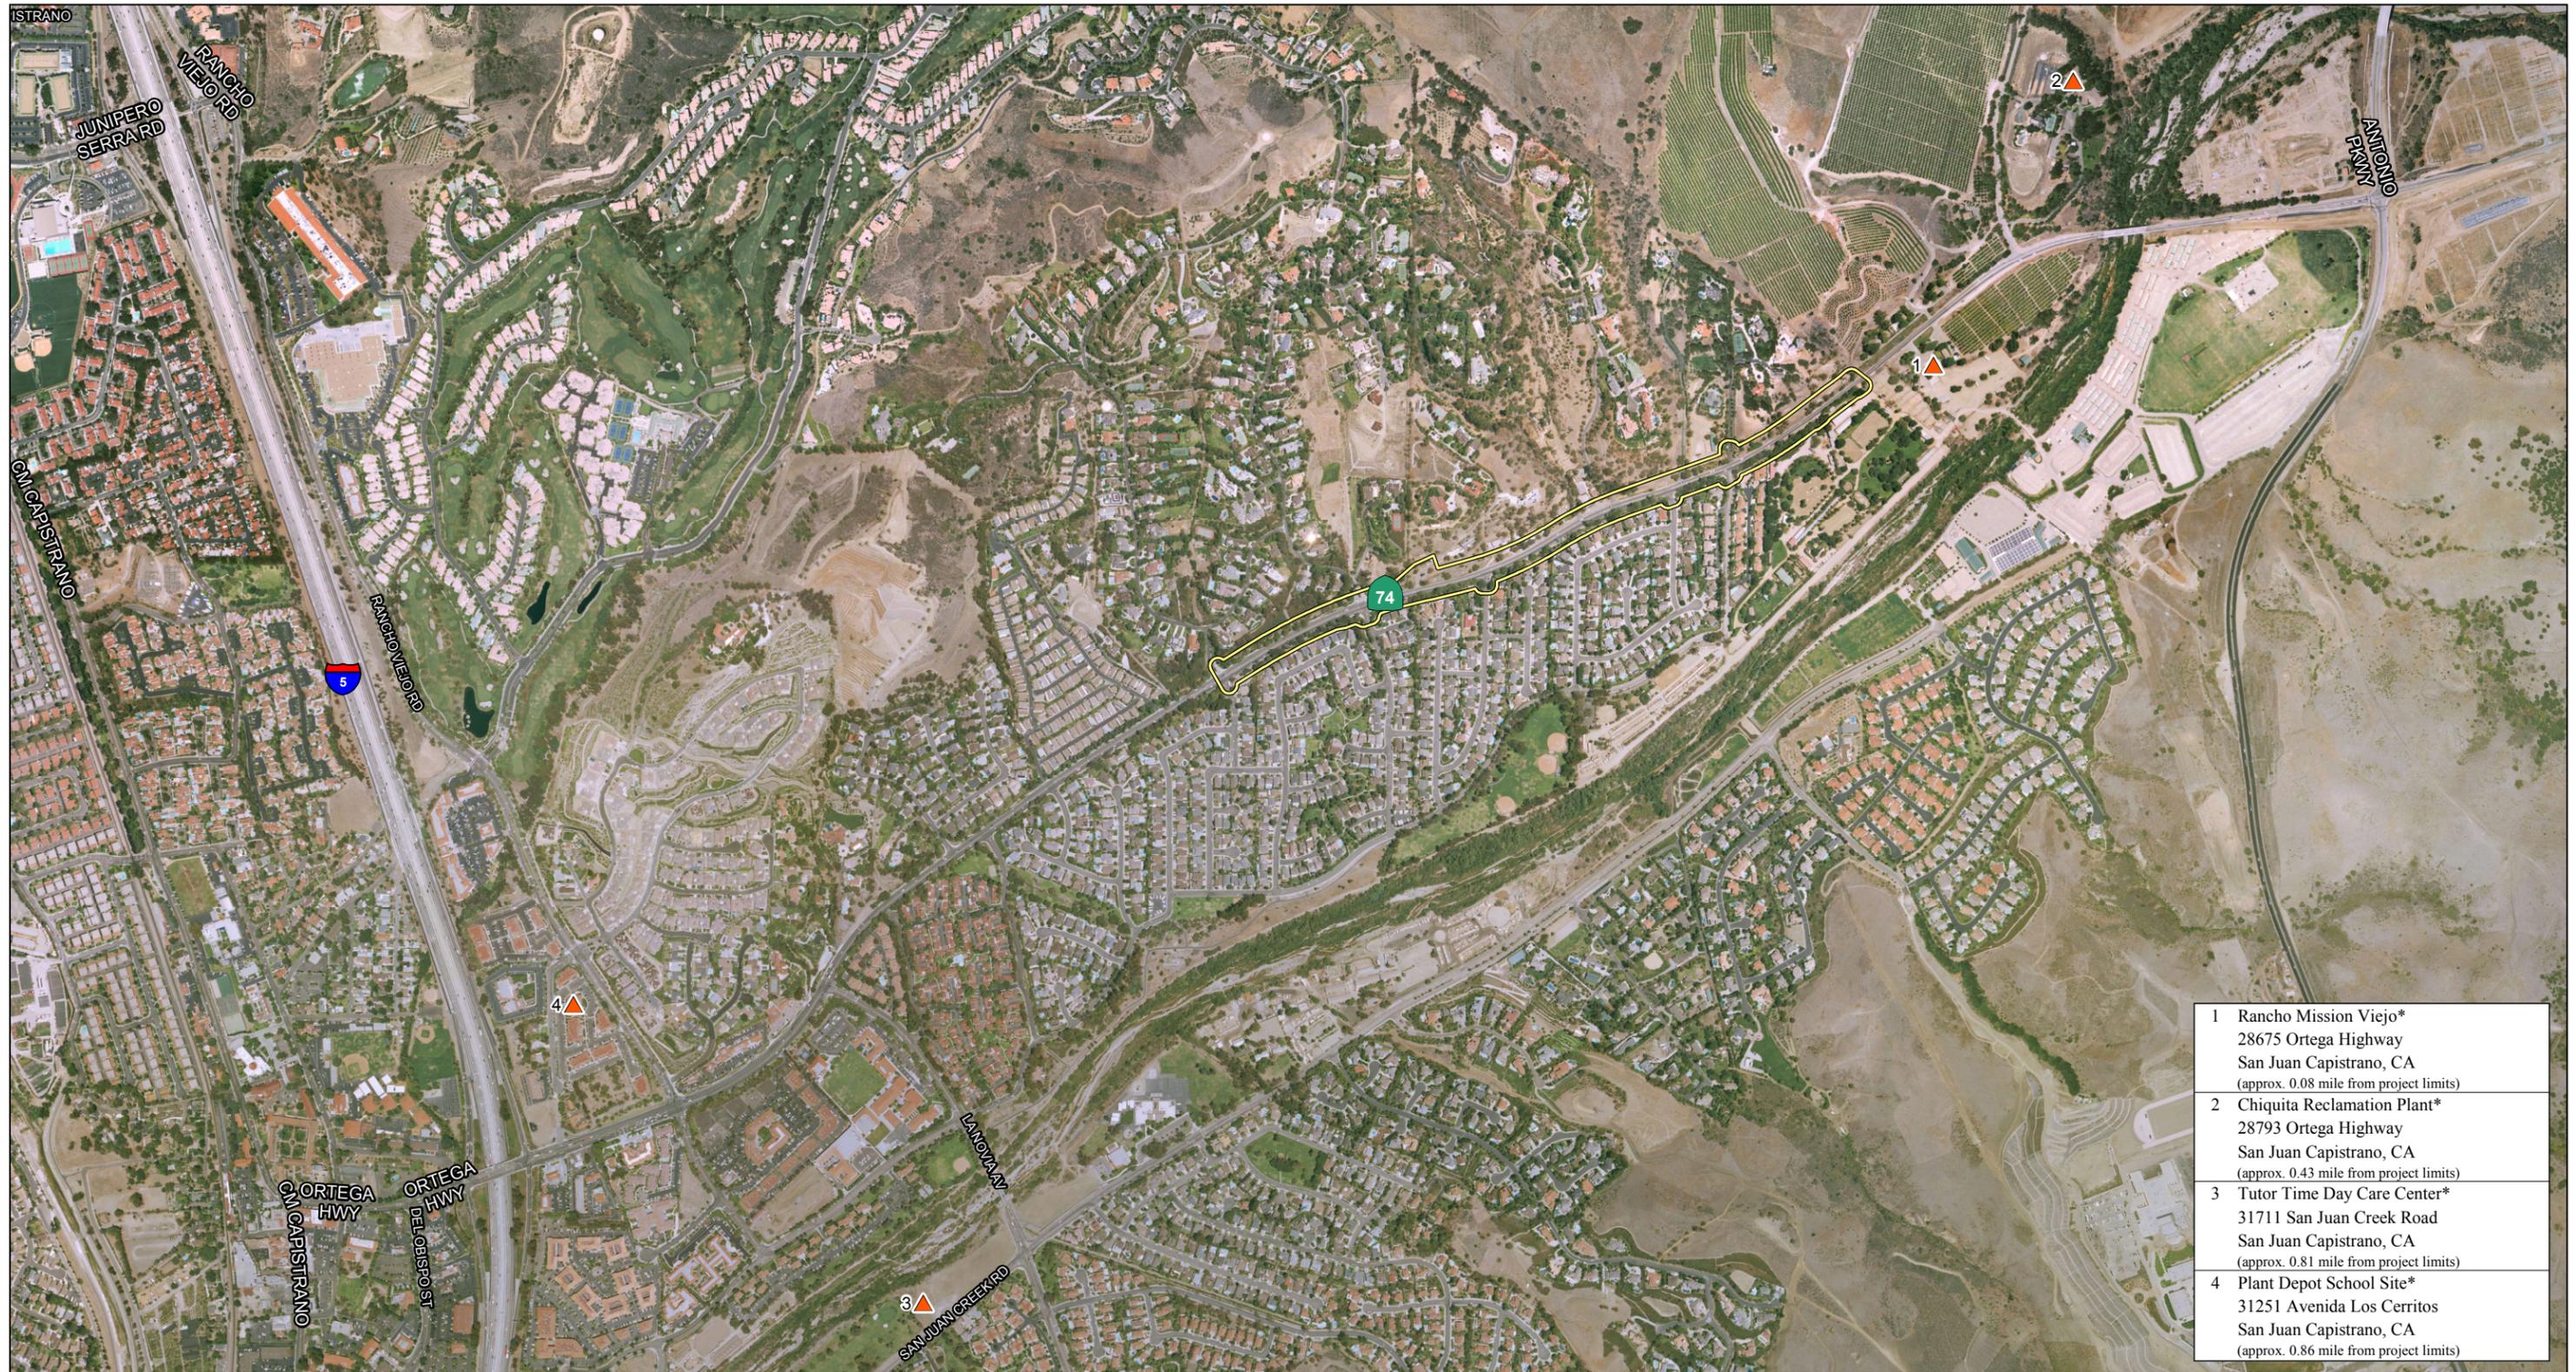
Lower SR-74 Widening Project
Hazardous Site Location Map

1	Rancho Mission Viejo* 28675 Ortega Highway San Juan Capistrano, CA (approx. 0.08 mile from project limits)
2	Chiquita Reclamation Plant* 28793 Ortega Highway San Juan Capistrano, CA (approx. 0.43 mile from project limits)
3	Tutor Time Day Care Center* 31711 San Juan Creek Road San Juan Capistrano, CA (approx. 0.81 mile from project limits)
4	Plant Depot School Site* 31251 Avenida Los Cerritos San Juan Capistrano, CA (approx. 0.86 mile from project limits)

* THESE SITES ARE UNLIKELY TO IMPACT THE PROJECT

Table A lists the databases that were searched for inclusion of the subject site and/or any surrounding facilities pursuant to ASTM E 1527-05 and Department requirements. Table B provides a summary of the hazardous releases within 0.75 mi of the project site. The locations of these facilities are shown in Figure 2.

No hazardous substance releases in the project area were noted during the site survey or review of historical aerial photographs or topographic maps. The database search report listed two LUST incidents and two State-listed facilities within 0.75 mi. Both LUST sites have received site closure and are unlikely to pose a concern to the proposed project.

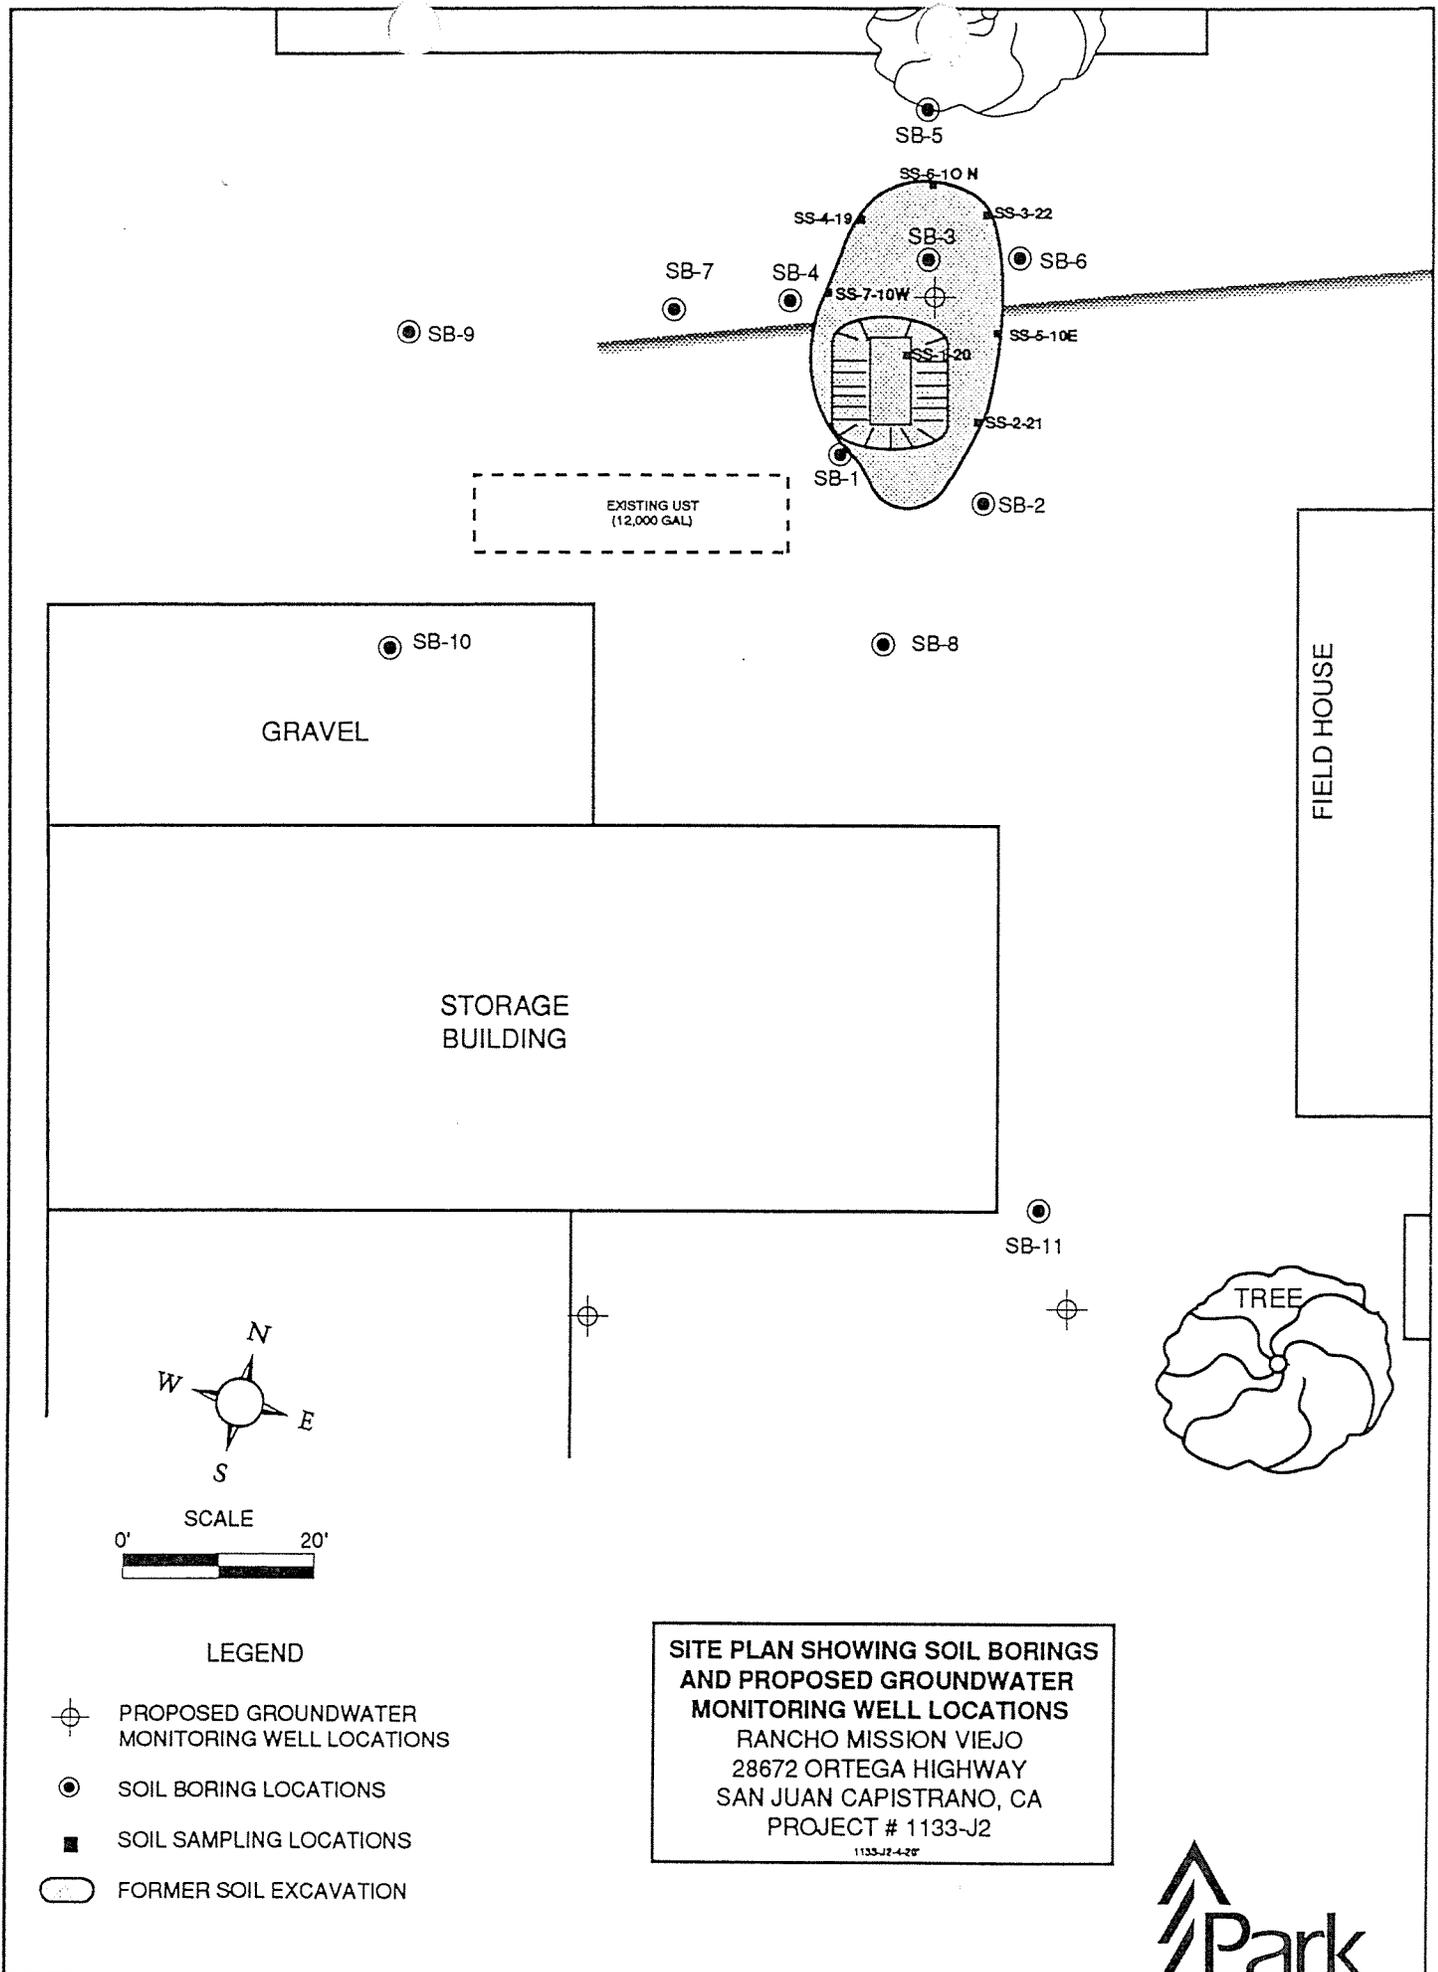
**SITE PLAN SHOWING SOIL BORINGS
AND PROPOSED GROUNDWATER
MONITORING WELL LOCATIONS**
 RANCHO MISSION VIEJO
 28672 ORTEGA HIGHWAY
 SAN JUAN CAPISTRANO, CA
 PROJECT # 1133-J2
 1133-J2-4-20

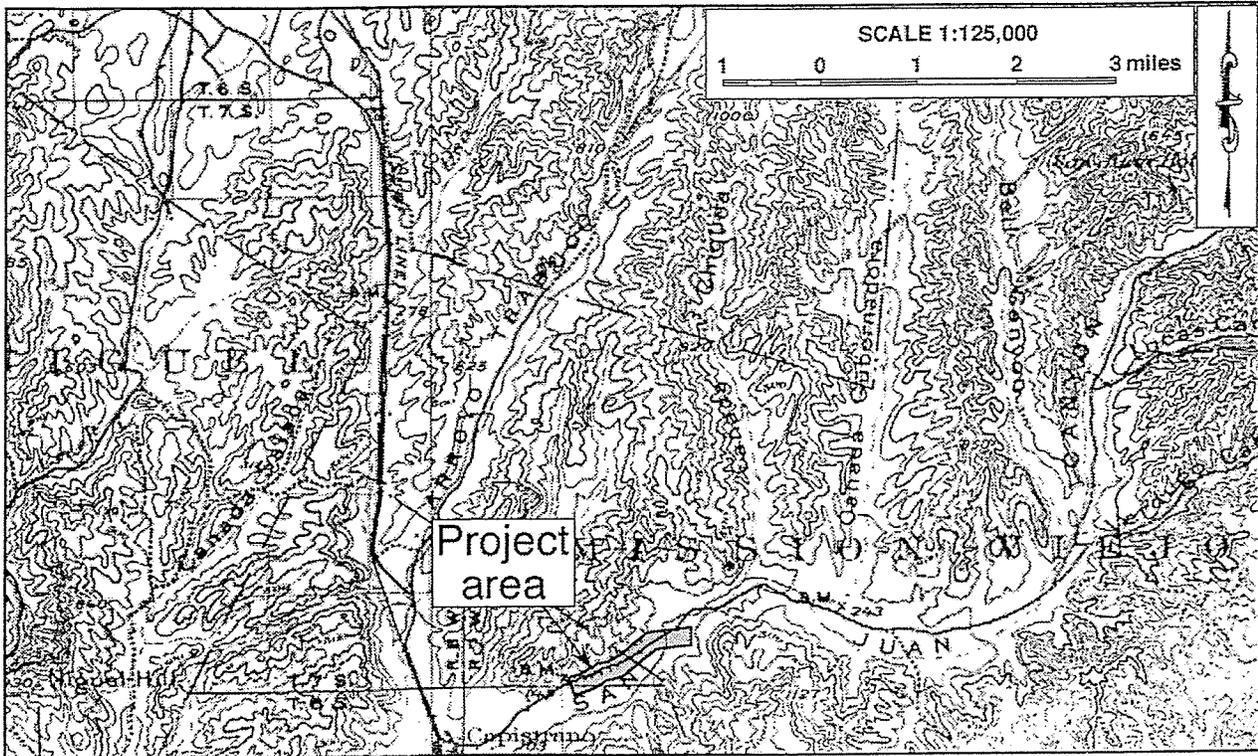
Figure 1. The project area in 1894-1899. (Source: USGS 1902)

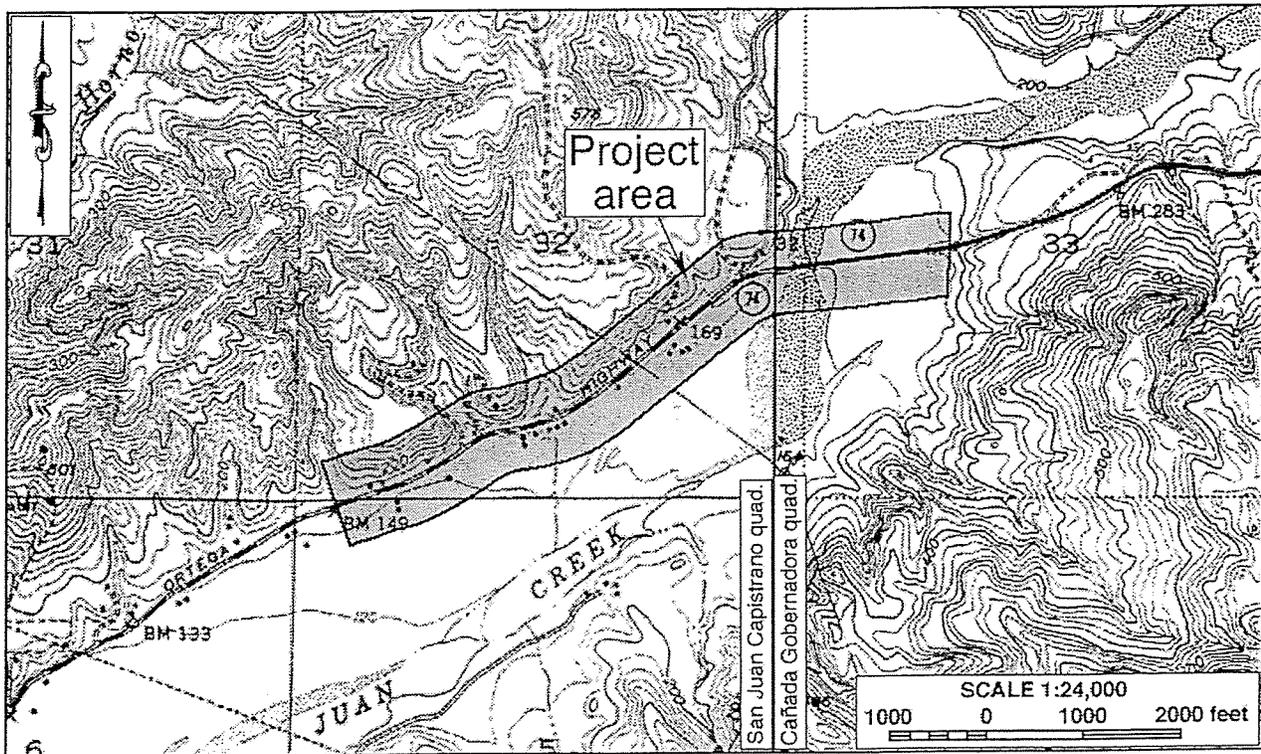
Figure 2. The project area in 1946-1948. (Source: USGS 1949a; 1949b)

The 1968 and 1975/1978 editions of USGS maps indicate that the same development pattern observed in the project area during the 1940s persisted into the 1960s and 1970s, although a residential development had appeared just to the southwest by the 1970s
