**HIGHWAY 267
FILTER FABRIC SAND TRAP
PILOT STUDY**

2004-2005 INTERIM REPORT

FEBRUARY 2006

CALIFORNIA DEPARTMENT OF TRANSPORTATION
DIVISION OF ENVIRONMENTAL ANALYSIS
1120 N STREET, SACRAMENTO, CALIFORNIA

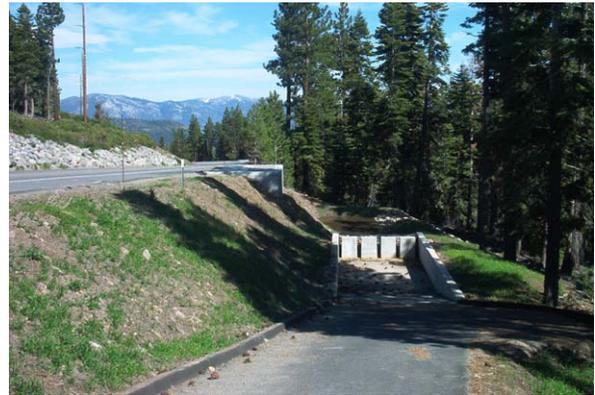
Photo 1: View of Sand Trap #2 and lower infiltration basin along Highway 267.

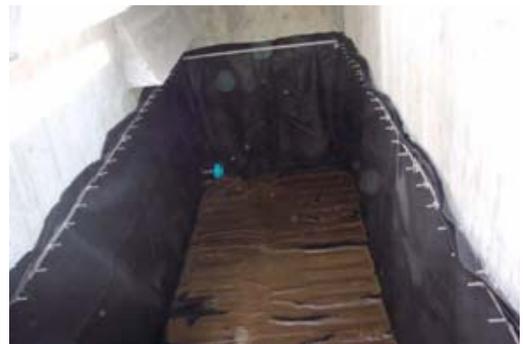
Photo 2: Filter chamber in Sand Trap #1.

Upon entering the sand trap, runoff flows into a sedimentation chamber where it is detained for a short period to allow the coarse-grained sediments to settle out. The sedimentation chamber has a sand storage capacity of 23 cubic meters (m^3) (800 cubic feet [ft^3]). When this capacity is reached, the flow will spill over a weir (height of 1.8 meters [m] [6.0 feet (ft)]) and into the filter chamber. In most conditions, the sedimentation chamber storage volume will not be exceeded and a louvered pipe in the sedimentation chamber conveys water to the filter chamber. This louvered pipe allows the sedimentation chamber to drain completely after influent flow has stopped. The filter chamber has a volume of 19 m^3 (670 ft^3) and is lined with a triple layer of non-woven geotextile. Upon entering the filter chamber, the runoff passes through the fabric and is collected in an underdrain piping system beneath the filter fabric. The effluent is then discharged to the surface. In addition, there is an emergency overflow weir (height of 1.7 m [5.6 ft]) located within the filter chamber to prevent backup if the filter fabric becomes completely clogged. Runoff flowing over this weir will bypass the filter fabric and will discharge to the surface. See Figure 2-1 for details.

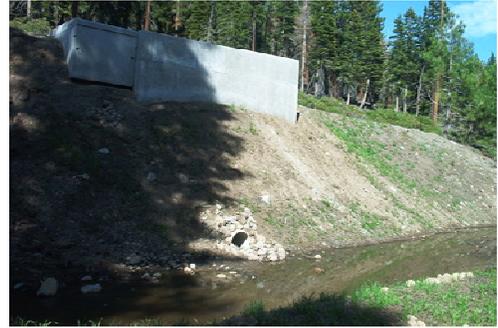
Photo 3: Outlet drainage from Sand Trap #1 to lower infiltration basin.

The sloughing soil has partially blocked the effluent discharge into the infiltration basins, causing a slight backwater condition. This backwater condition is well downstream of any treatment processes and will not affect the treatment performance of either sand trap.

Caltrans landscaping crews repaired some of the sloughs in the area but the slopes immediately below both sand traps were not addressed. The material was mostly mulch and loose soil that was installed for revegetation. The structural fill stabilizing the sand traps and the roadway did not appear to be a part of the sloughed material.

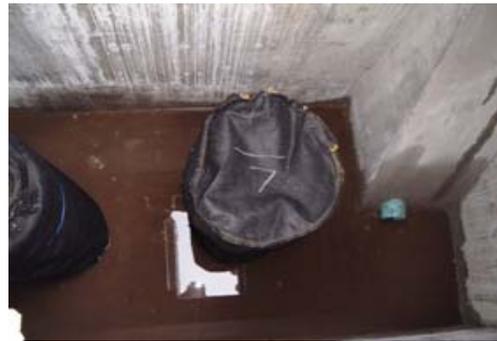
Photo 4: Filter chamber in Sand Trap #2.

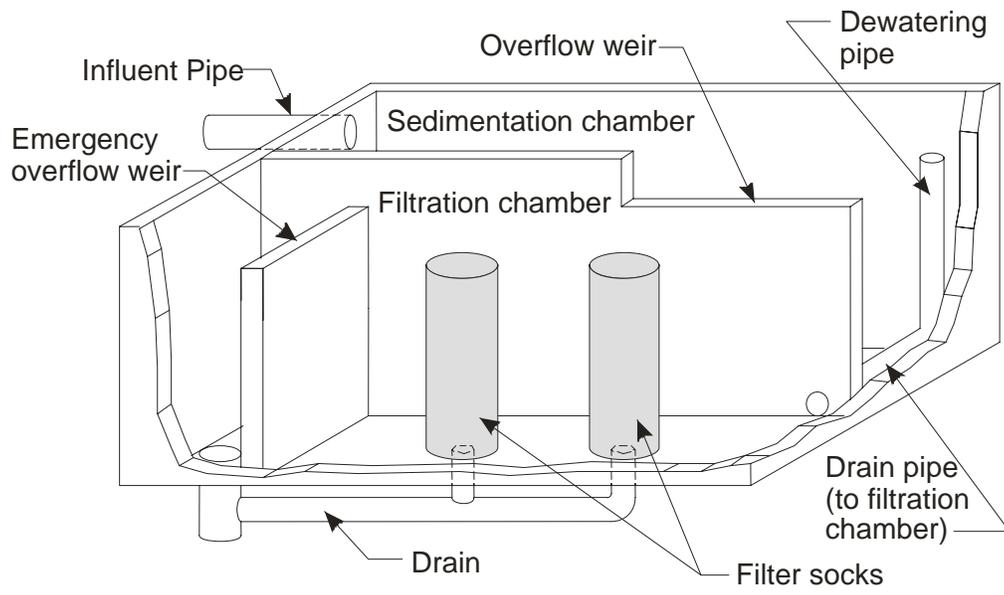
Figure 2-2. Sand Trap #2

Upon entering the sand trap, runoff flows into a sedimentation chamber where it is detained for a short period to allow the coarse grained sediments to settle out. The sedimentation chamber has a sand storage capacity of 12 m³ (400 ft³). When this capacity is reached, the flow will spill over a weir (height of 1.8 m [6.0 ft]) and into the filter chamber. In most conditions, the sedimentation chamber storage volume will not be exceeded and a louvered

pipe in the sedimentation chamber conveys the runoff to the filter chamber. This louvered pipe allows the sedimentation chamber to drain completely after influent flow has stopped. The filter chamber has a volume of 8 m³ (280 ft³) equipped with two perforated riser pipes covered with a triple layer of non-woven geotextile. Upon entering the filter chamber, the runoff passes through the fabric and is collected in an underdrain piping system beneath the filter fabric. The effluent is then discharged to the surface. In addition, there is an overflow weir (height of 1.6 m [5.2 ft]) located within the filter chamber to prevent backup if the filter fabric becomes completely clogged. Runoff flowing over this weir will bypass the filter fabric and will discharge to the surface. See Figure 2-2 for details.

Permanent standing water of approximately 2.5 cm (1 in) has been observed in both sedimentation chambers. The cause of this is likely due to the construction of the piping system between the sedimentation and filter chambers in the sand traps, when slotted pipes were installed in lieu of the specified louvered pipes. Slotted pipes may be more susceptible to clogging from the sand. Also, the lowest slot in the pipe is approximately 2.5 cm (1 in) above the sand trap floors. Standing water also is observed in both sand traps in the effluent pipe under the filter due to negative slopes.

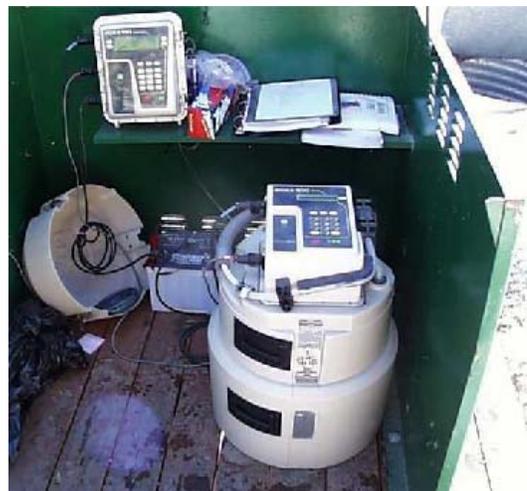
Photo 5: Standard flow monitoring equipment consists of an autosampler (front), flow meter (top rear), and a battery (bottom rear) housed in an enclosure.

Flow rates for the influent and effluent were calculated by use of the Manning Equation. This method involves measuring the depth of flow with a bubbler tube mounted on the inside of the pipe, and using the pipe diameter, slope, and roughness to

estimate the flow rate. This method was selected because site constraints did not allow for installation of a flume or other primary flow measurement devices. The Manning's roughness coefficient of 0.011 was determined from literature values for the smooth-walled plastic pipe. Flow rates were calibrated by measuring flows manually and adjusting the depth measurement on the flow meter to match the measured rate. Figure 3-1 illustrates typical flow measurement configurations.

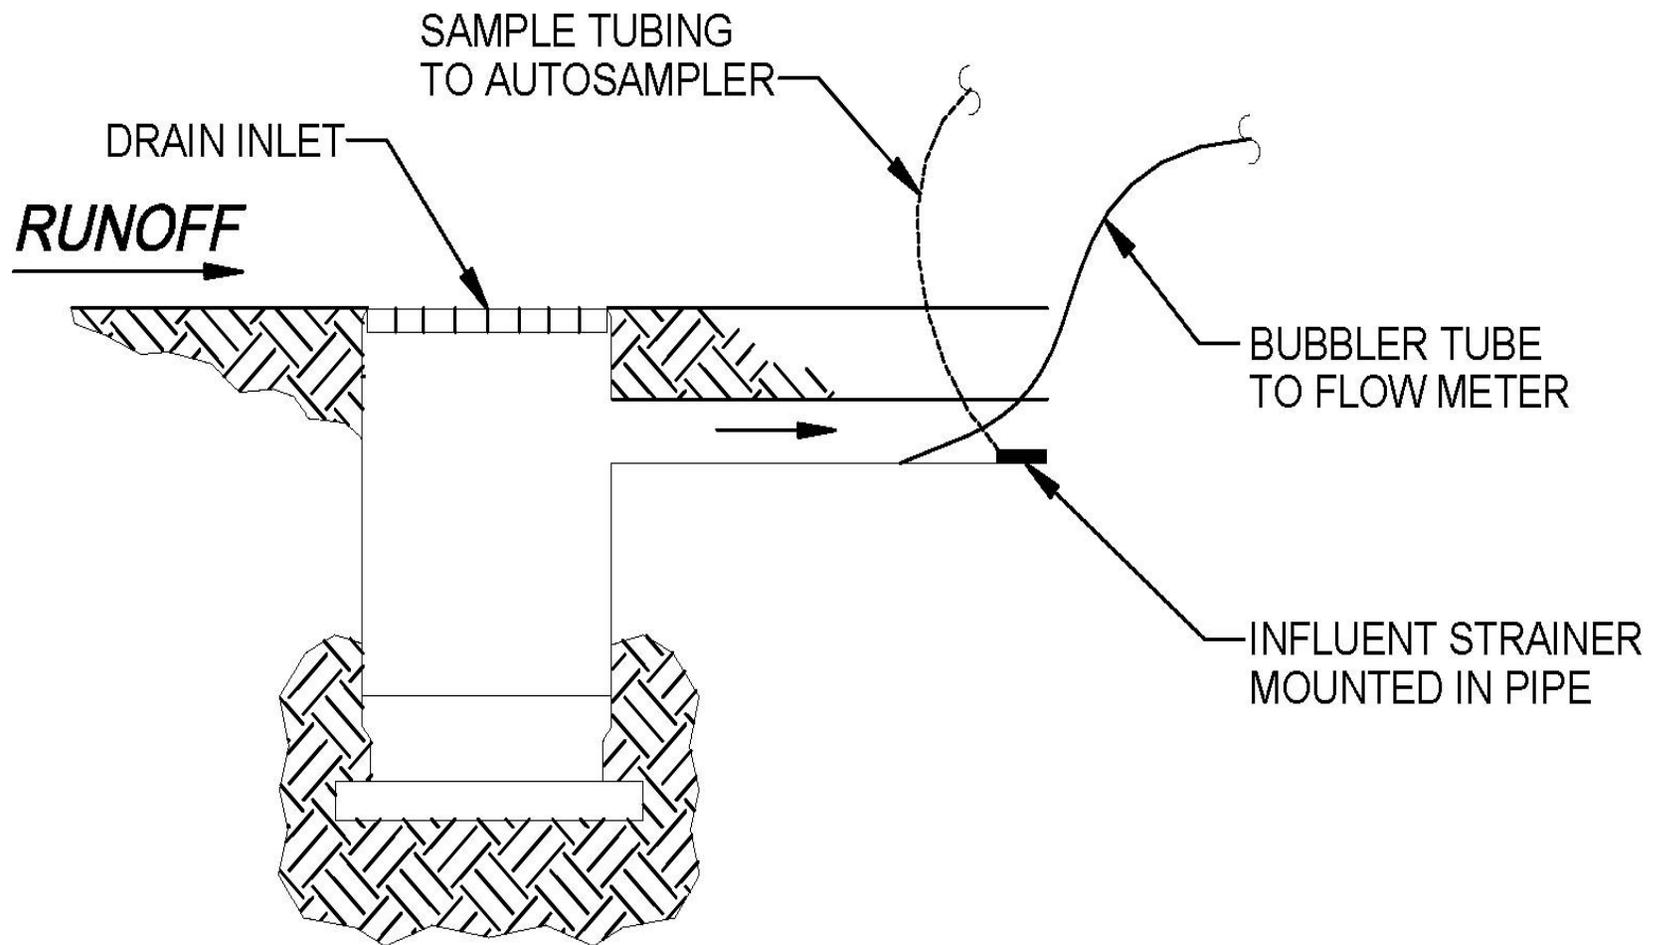
FIGURE 3-1
 RUNOFF SAMPLING EQUIPMENT CONFIGURATION, DRAIN INLET TO SEDIMENTATION CHAMBER
 Highway 267 Filter Fabric Sand Trap Pilot Study
 Tahoe Basin, El Dorado County, California

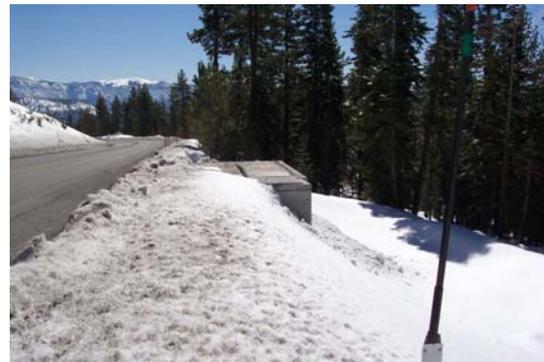
Photo 6: Snow accumulation at Sand Trap #2.

Snowmelt Events. Snowmelt events occur when temperatures rise above freezing and the accumulated snow melts in sufficient quantities to produce runoff. Snowmelt runoff monitoring differs fundamentally from rainfall/runoff and rain/snow monitoring in that sampling was initiated in response to runoff flow in the absence of precipitation. Once substantial snowfall occurred, field crews tracked weather conditions for the possibility of significant snowmelt. When the desired conditions occurred (warming temperatures after a period of snow accumulation or when salt was applied to melt snow accumulated on roads), field crews

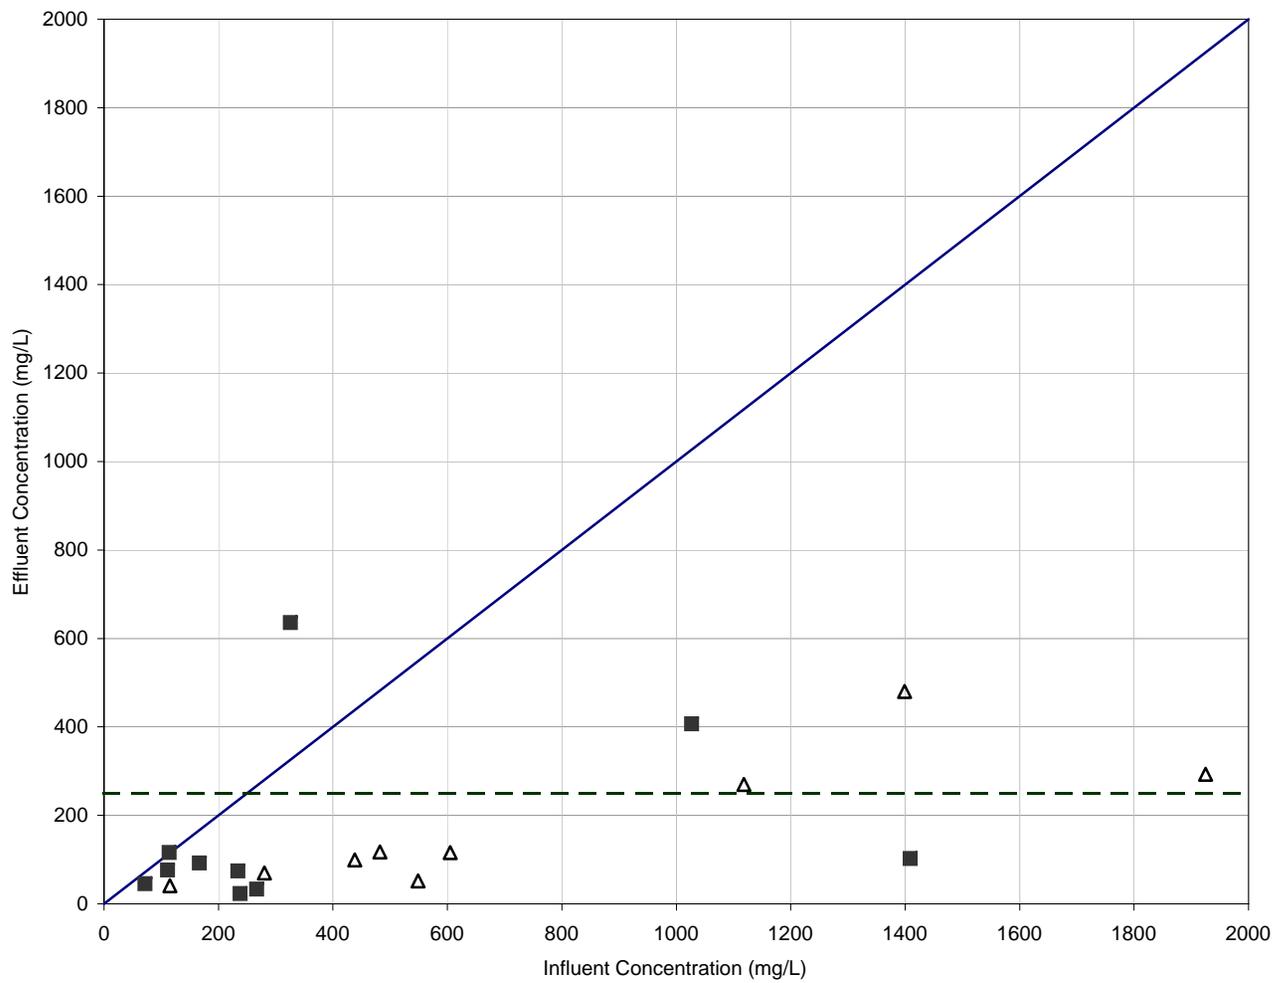
Sand Trap #1 Effluent
 Sand Trap #2 Effluent
 No Treatment
 TRPA Surface Water Discharge Limit

Note: No treatment line is the hypothetical line of effluent = influent. TRPA = Tahoe Regional Planning Agency.

FIGURE 5-1
 TREATMENT OF TOTAL SUSPENDED SOLIDS
 Highway 267 Filter Fabric Sand Trap Pilot Study
 Tahoe Basin, El Dorado County, California

Sand trap performance for reducing the TSS and turbidity was assessed by comparing mean EMCs in samples collected at influent and effluent monitoring stations. These data can be found in Table 5-1, which contains computed means and other summary statistics for the individual monitoring stations.

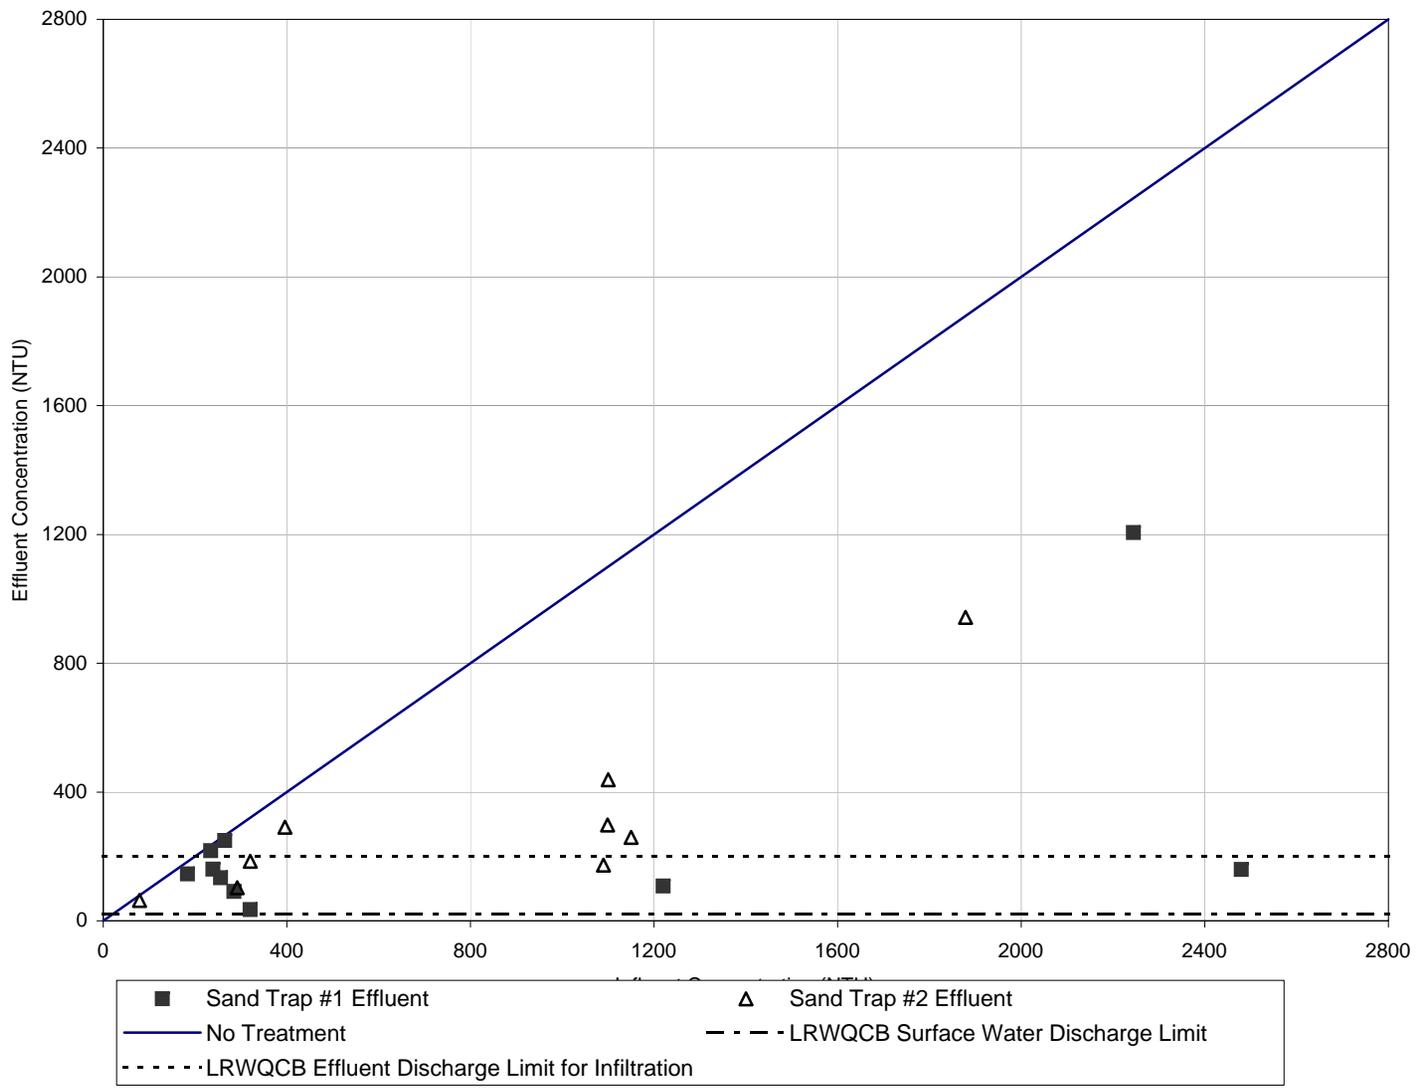
Note: No treatment line is the hypothetical line of effluent = influent. LRWQCB = Lahontan Regional Water Quality Control Board

FIGURE 5-2
 TURBIDITY
 Highway 267 Filter Fabric Sand Trap Pilot Study
 Tahoe Basin, El Dorado County, California

Turbidity. For those storm events which produced paired influent and effluent data, the mean values and percent removal are shown in Table 5-2. The LRWQCB effluent limit for surface water discharge is 20 nephelometric turbidity units (NTU) and the effluent discharge limit for infiltration is 200 NTU. Figure 5-2 indicates the sand traps are not effective at decreasing the runoff turbidity below the surface water discharge limit of 20 NTU. In addition, the sand traps

do not consistently decrease the runoff turbidity below the infiltration discharge limit of 200 NTU.

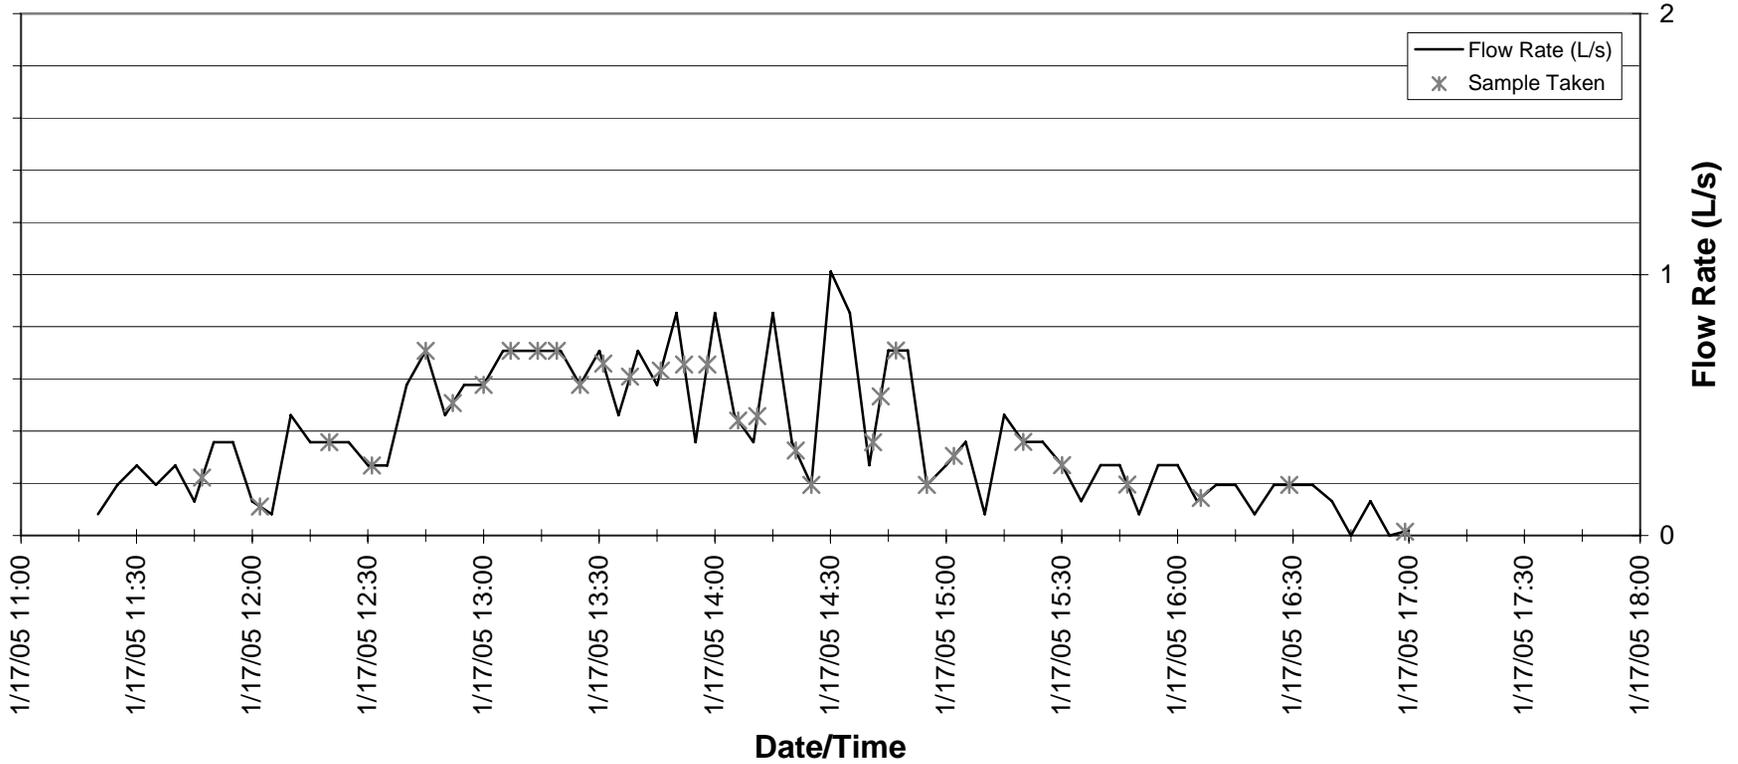
Site: Sand Trap #1 Influent - HWY 267 (3-301)
 Event: 2004-01

Start Date/Time: 01/17/05 11:20
 Stop Date/Time: 01/17/05 17:00
 Total Flow Volume (L): 7743
 Peak Flow (L/s): 1.01

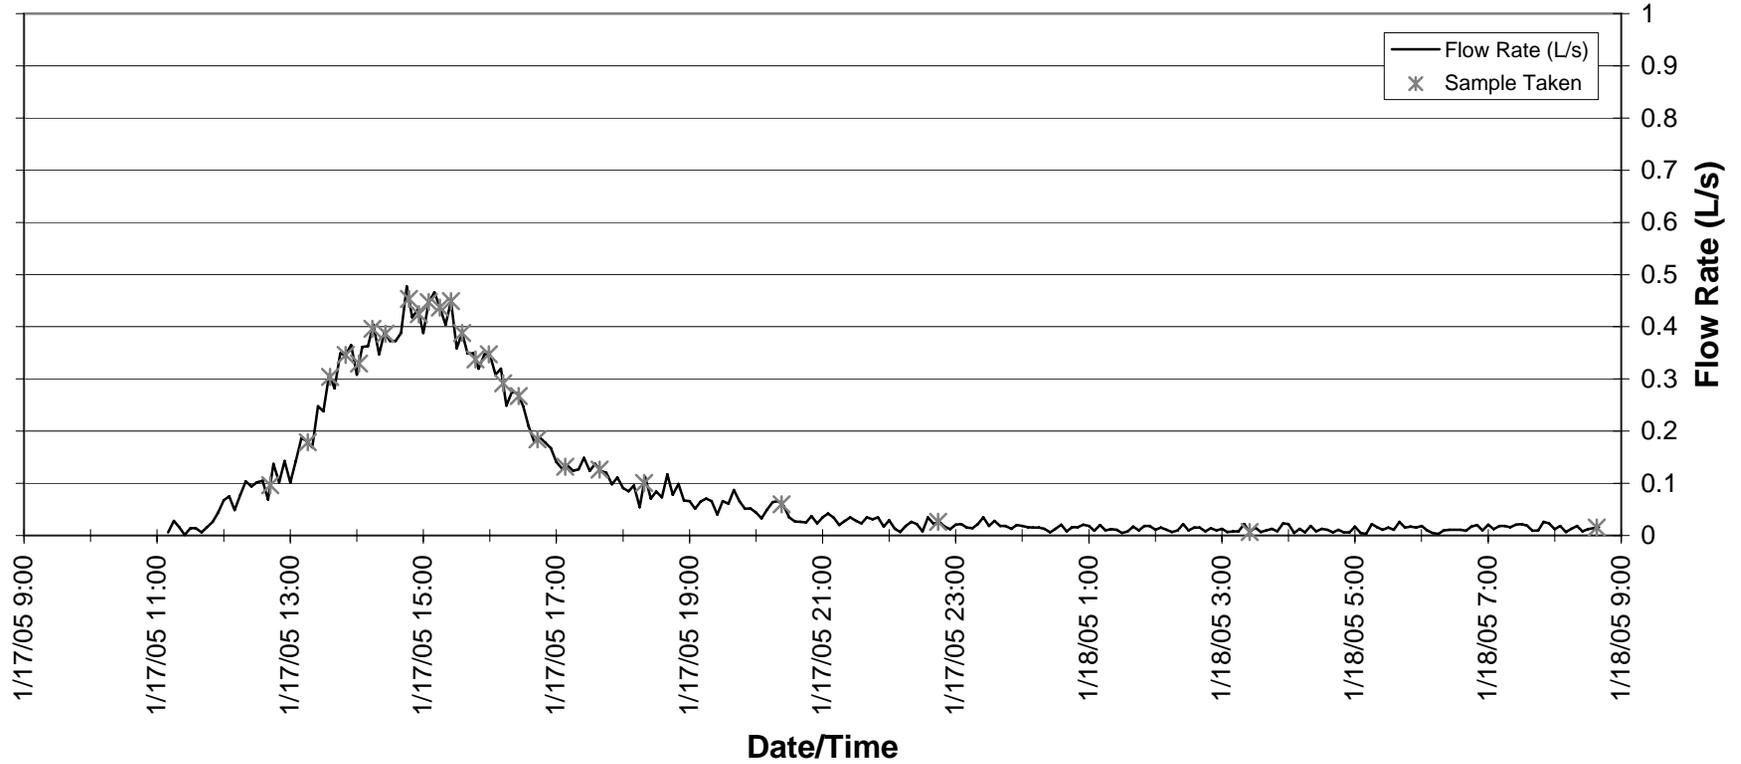
Site: Sand Trap #1 Effluent - HWY 267 (3-302)
 Event: 2004-01

Start Date/Time: 01/17/05 11:10
 Stop Date/Time: 01/18/05 08:40
 Total Flow Volume (L): 6745
 Peak Flow (L/s): 0.48
