For Contract No. 11-414704

Geotechnical Design Report, Dated September 22, 2015

File: 11-SR-67- 9.3/11.2
EA 11-41470
ID 1112000191

Subject: **Geotechnical Design Report for the Removal and Replacement of the Guardrail Barrier on State Route 67.**

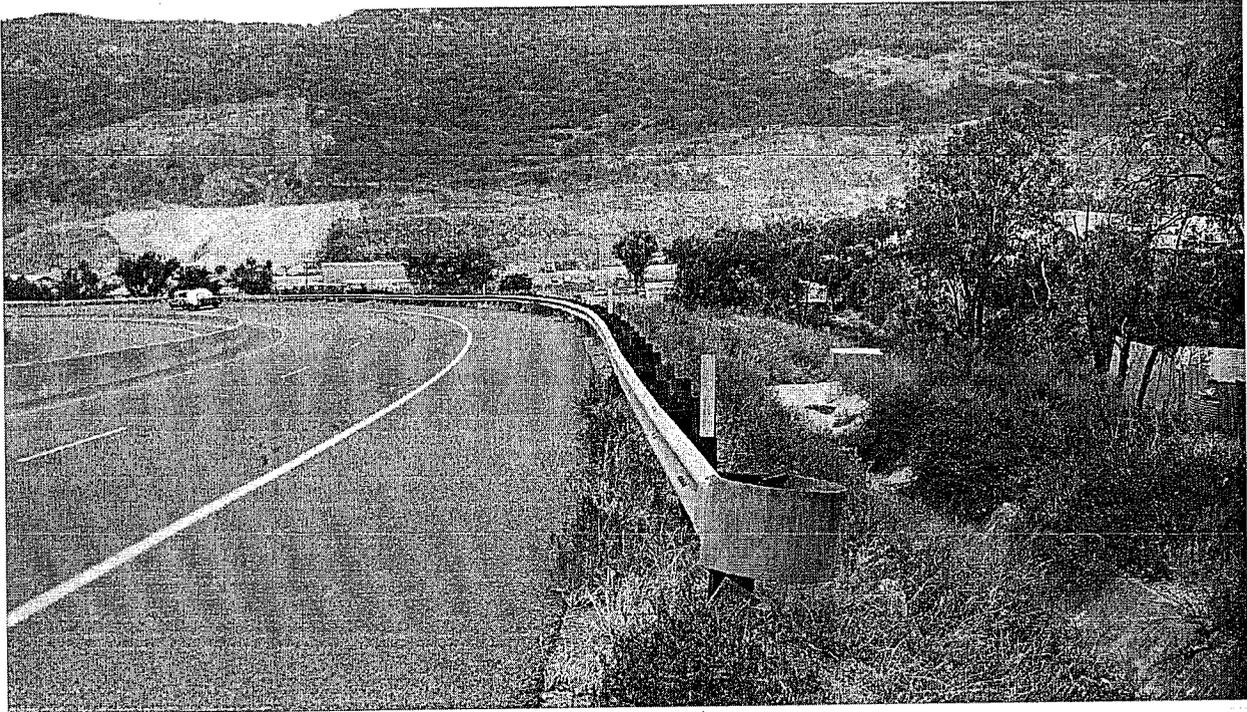
Location-1

From about Station 512+40 to 523+30, the existing guardrail is located west of western shoulder of SR-67. To the west of this guardrail, a descending west facing slope with an average inclination of 4:1 (horizontal to vertical) exists. No seepage or spring water was observed on the face of the slope. No evidence of distress was observed on the face of this slope. In addition, no adverse erosional features were observed on the slope face as well.

Along this section the highway was constructed as a slope cut. Therefore, the location of the existing guardrail is underlain by native soils consisting of gravels with few cobbles within the sandy matrix. No groundwater was encountered during subsurface investigation.

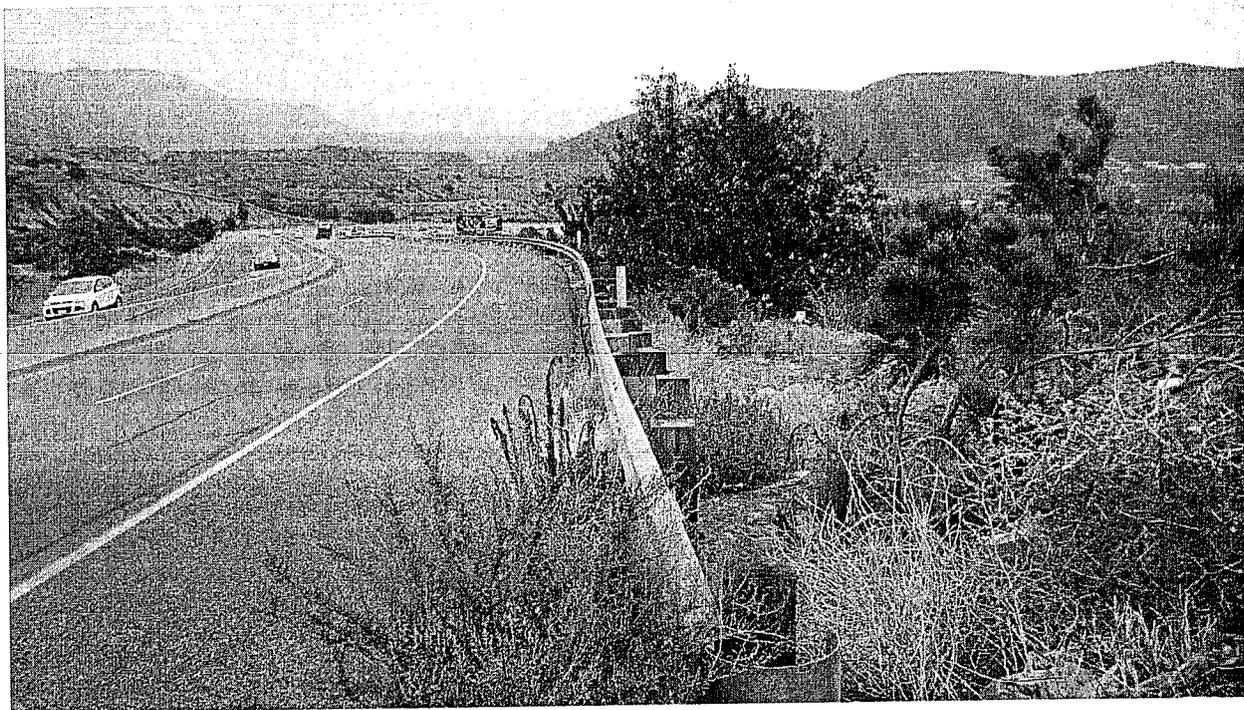
Location-2

From about Station 529+90 to 540+12, the existing guardrail is located west of western shoulder of SR-67. To the west of this guardrail, a descending west facing slope with the inclination of 1.5:1 exists. No seepage or spring water was observed on the face of the slope. No evidence of distress was observed on the face of this slope. In addition, no adverse erosional features were observed on the slope face as well. Along this section the highway was constructed as a road embankment built of fill materials. Therefore, the location of the existing guardrail is underlain by gravels, sands, and few cobbles. No ground water was encountered during the subsurface investigation.

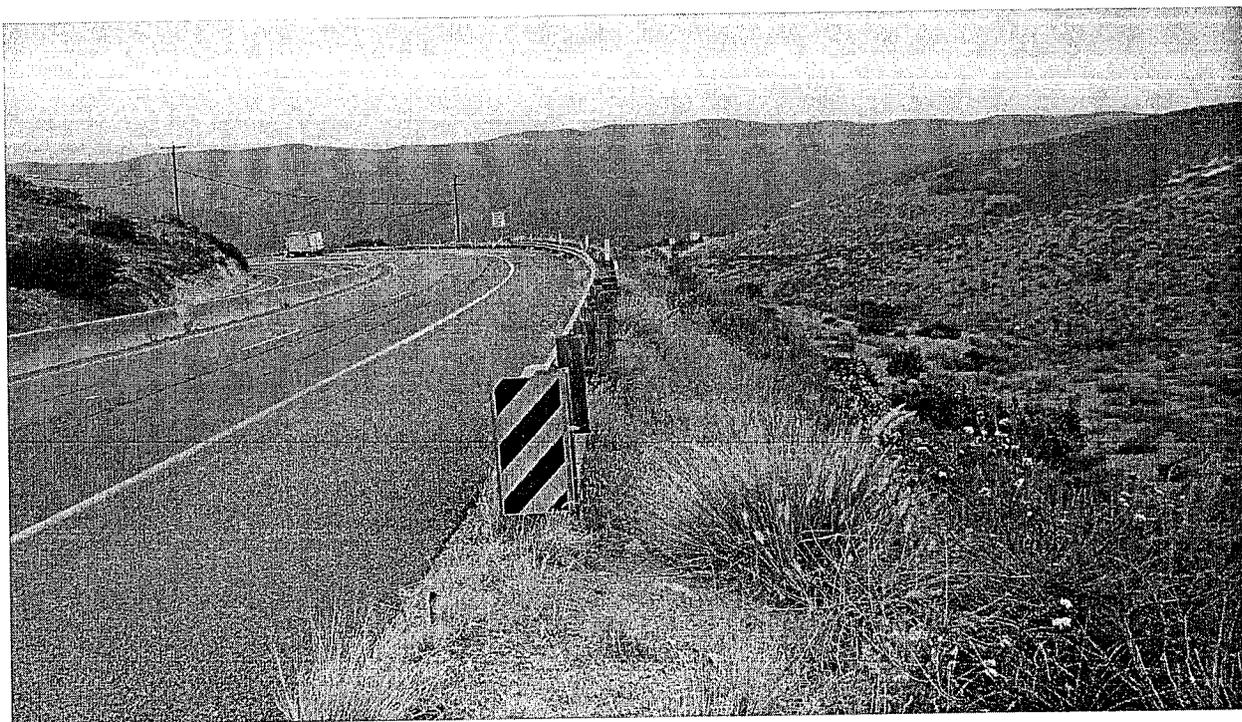
Location-3

From about Station 559+22 to 572+29, the existing guardrail is located west of western shoulder of SR-67. To the west of this guardrail, a descending west facing slope with the inclination of 1.5:1 exists. No seepage or spring water was observed on the face of the slope. No evidence of distress was observed on the face of this slope. In addition, no adverse erosional features were observed on the slope face as well. Along this section the highway was constructed as a road embankment built of fill materials. Therefore, the location of the existing guardrail is underlain by sands, gravels, and a few cobbles. No ground water was encountered during the subsurface investigation.

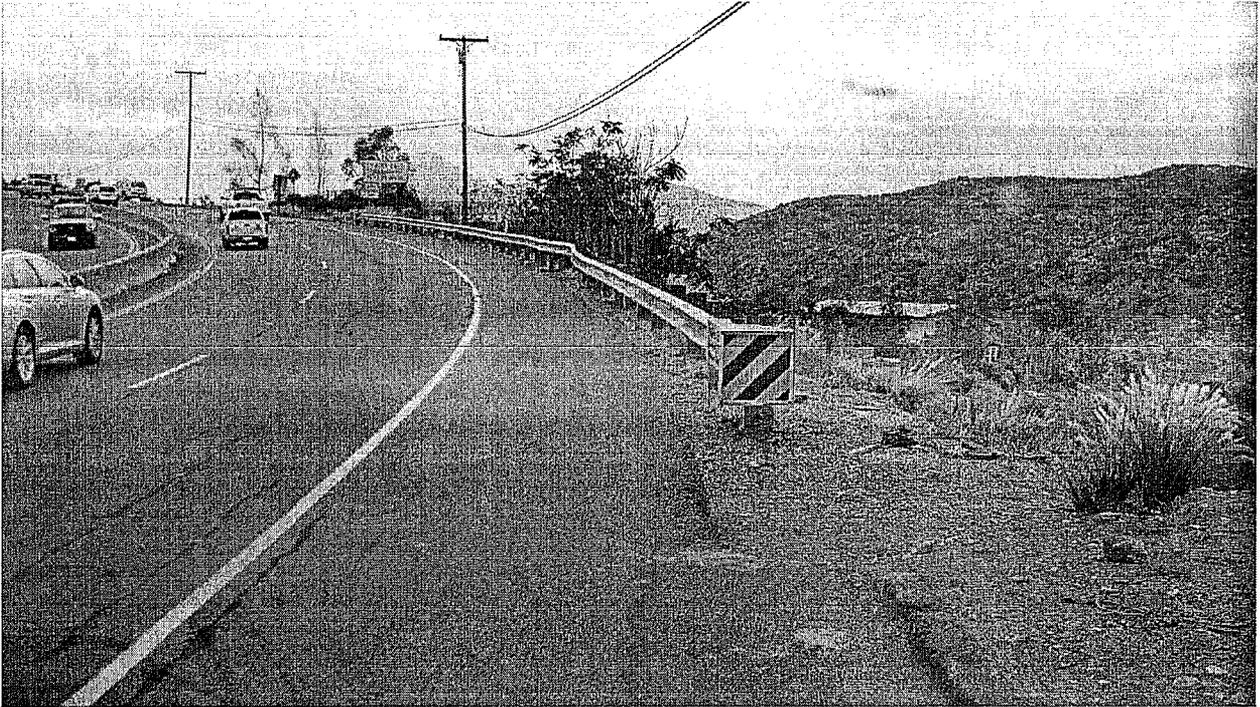
Location-4

From about Station 581+10 to 578+90, the existing guardrail is located east of eastern shoulder of SR-67. To the east of this guardrail, a descending east facing slope with the inclination of 1.5:1 exists. No seepage or spring water was observed on the face of the slope. No evidence of distress was observed on the face of this slope. In addition, no adverse erosional features were observed on the slope face as well. Along this section the highway was constructed as a slope cut. Therefore, the location of the existing guardrail is underlain by a relatively shallow fill layer that in turn is underlain by sedimentary formation.

Both the fill layer and the underlying sedimentary deposit consist of sands and gravels. No ground water was encountered during the subsurface investigation.

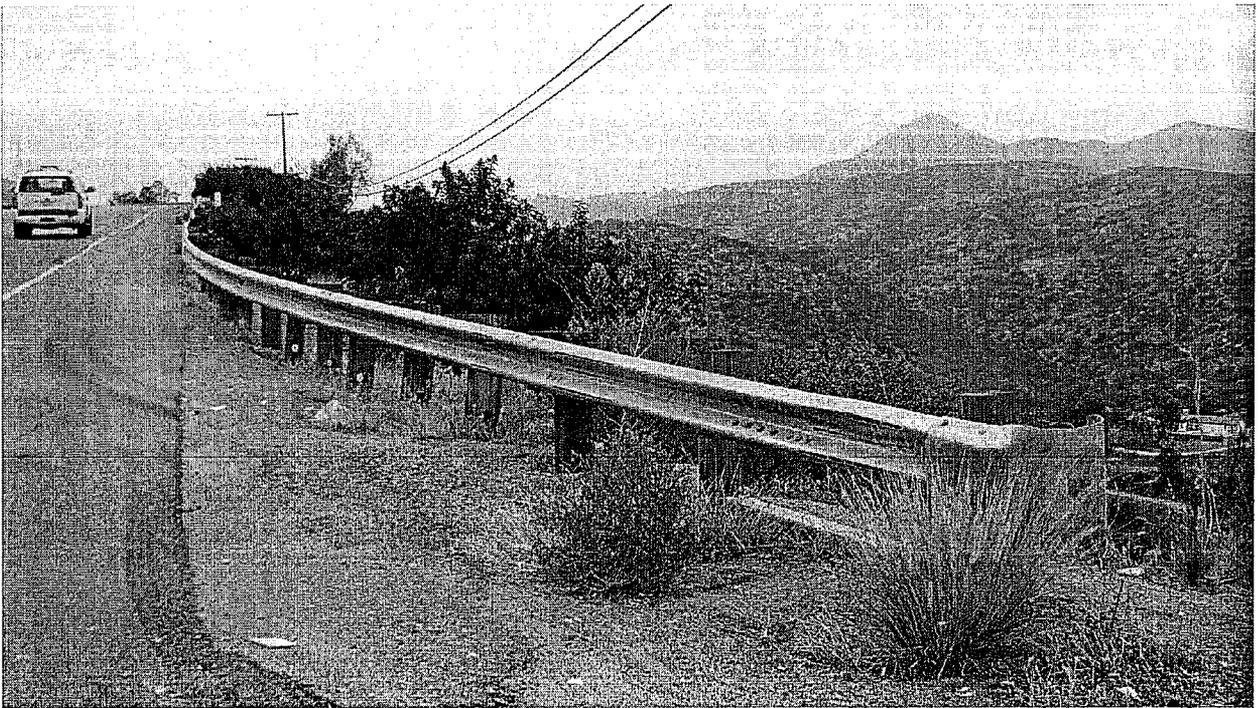
Location-5

From about Station 583+77 to 586+65, the existing guardrail is located east of the edge of the eastern shoulder of the northbound lane of SR-67. To the east of this guardrail, a descending east facing slope with the inclination of about 1.5:1 exists. No seepage or spring water was observed on the face of the slope. No evidence of distress was observed on the face of this slope. In addition, no adverse erosional features were observed on the slope face as well.

Along this section the highway was constructed as a slope cut. Therefore, the location of the existing guardrail is underlain by a relatively shallow fill layer that in turn is underlain by sedimentary formation. Both the fill layer and sedimentary formation consist of gravels, sands, and few cobbles. No ground water was encountered during the subsurface investigation.

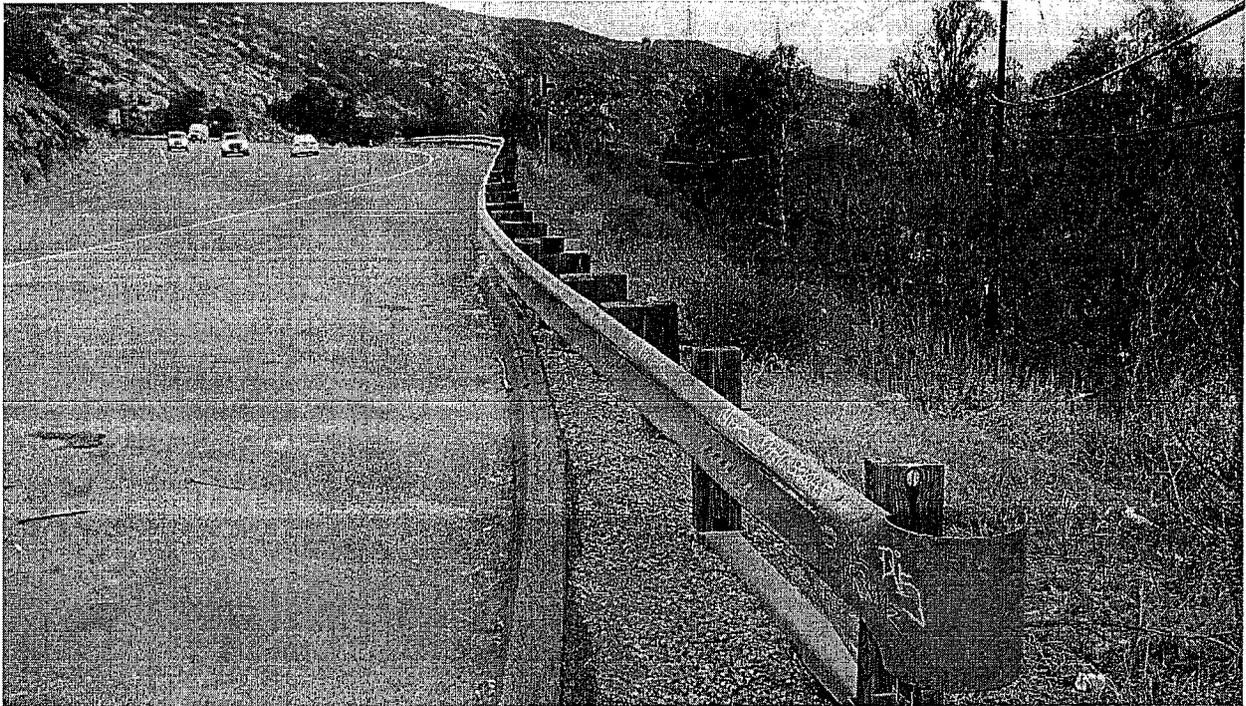
Location-6

From about Station 589+34 to 592+84, the existing guardrail is located east of eastern shoulder of SR-67. To the east of this guardrail, a descending east facing slope with the inclination of 1.5:1 exists. No seepage or spring water was observed on the face of the slope. No evidence of distress was observed on the face of this slope. In addition, no adverse erosional features were observed on the slope face as well. Along this section the highway was constructed as a road embankment built of fill materials. Therefore, the location of the existing guardrail is underlain by sands, gravels, and a few cobbles. No ground water was encountered during the subsurface investigation.

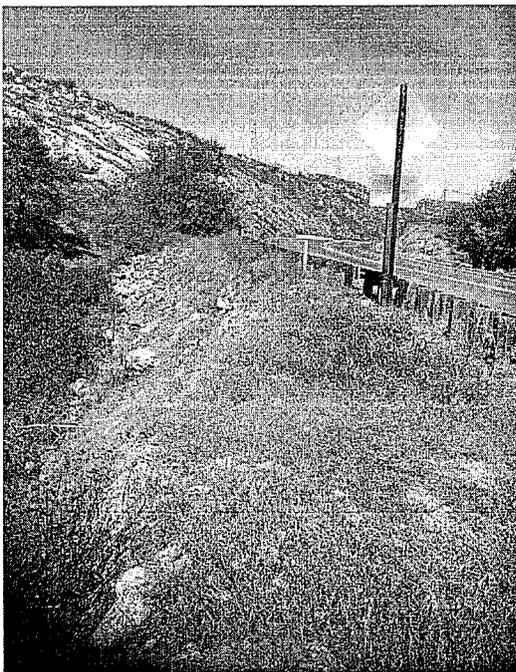
Location-7

From about Station 596+32 to 598+22, the existing guardrail is located west of western of SR-67. To the west of this guardrail, a descending west facing slope with an average inclination of 1.5:1 horizontal to vertical exists.

Along this section the highway was constructed as a road embankment built of fill materials. Therefore, the location of the existing guardrail is underlain by a relatively shallow layer of fill materials consisting of gravels, sands and cobbles. This shallow fill layer is underlain by a layer of predominantly angular metavolcanic rocks, up to 4 feet in diameter. These rocks were placed during the grading operations associated with the construction of the highway. No groundwater was encountered during subsurface investigation.

Due to the gravelly and rocky nature of the materials that underlay the project alignment, we anticipate hard drilling conditions at all locations. In addition, at Location 7 we anticipate these drilling conditions to be very hard. It is expected that gravels, cobbles, and boulder size rocks will be encountered in excavations impacting the rate of the progress of excavating or/and drilling. At Location 7 a layer of

relatively fresh metavolcanic rocks will be encountered. Their occurrence could significantly affect the rate of progress of excavating or drilling.

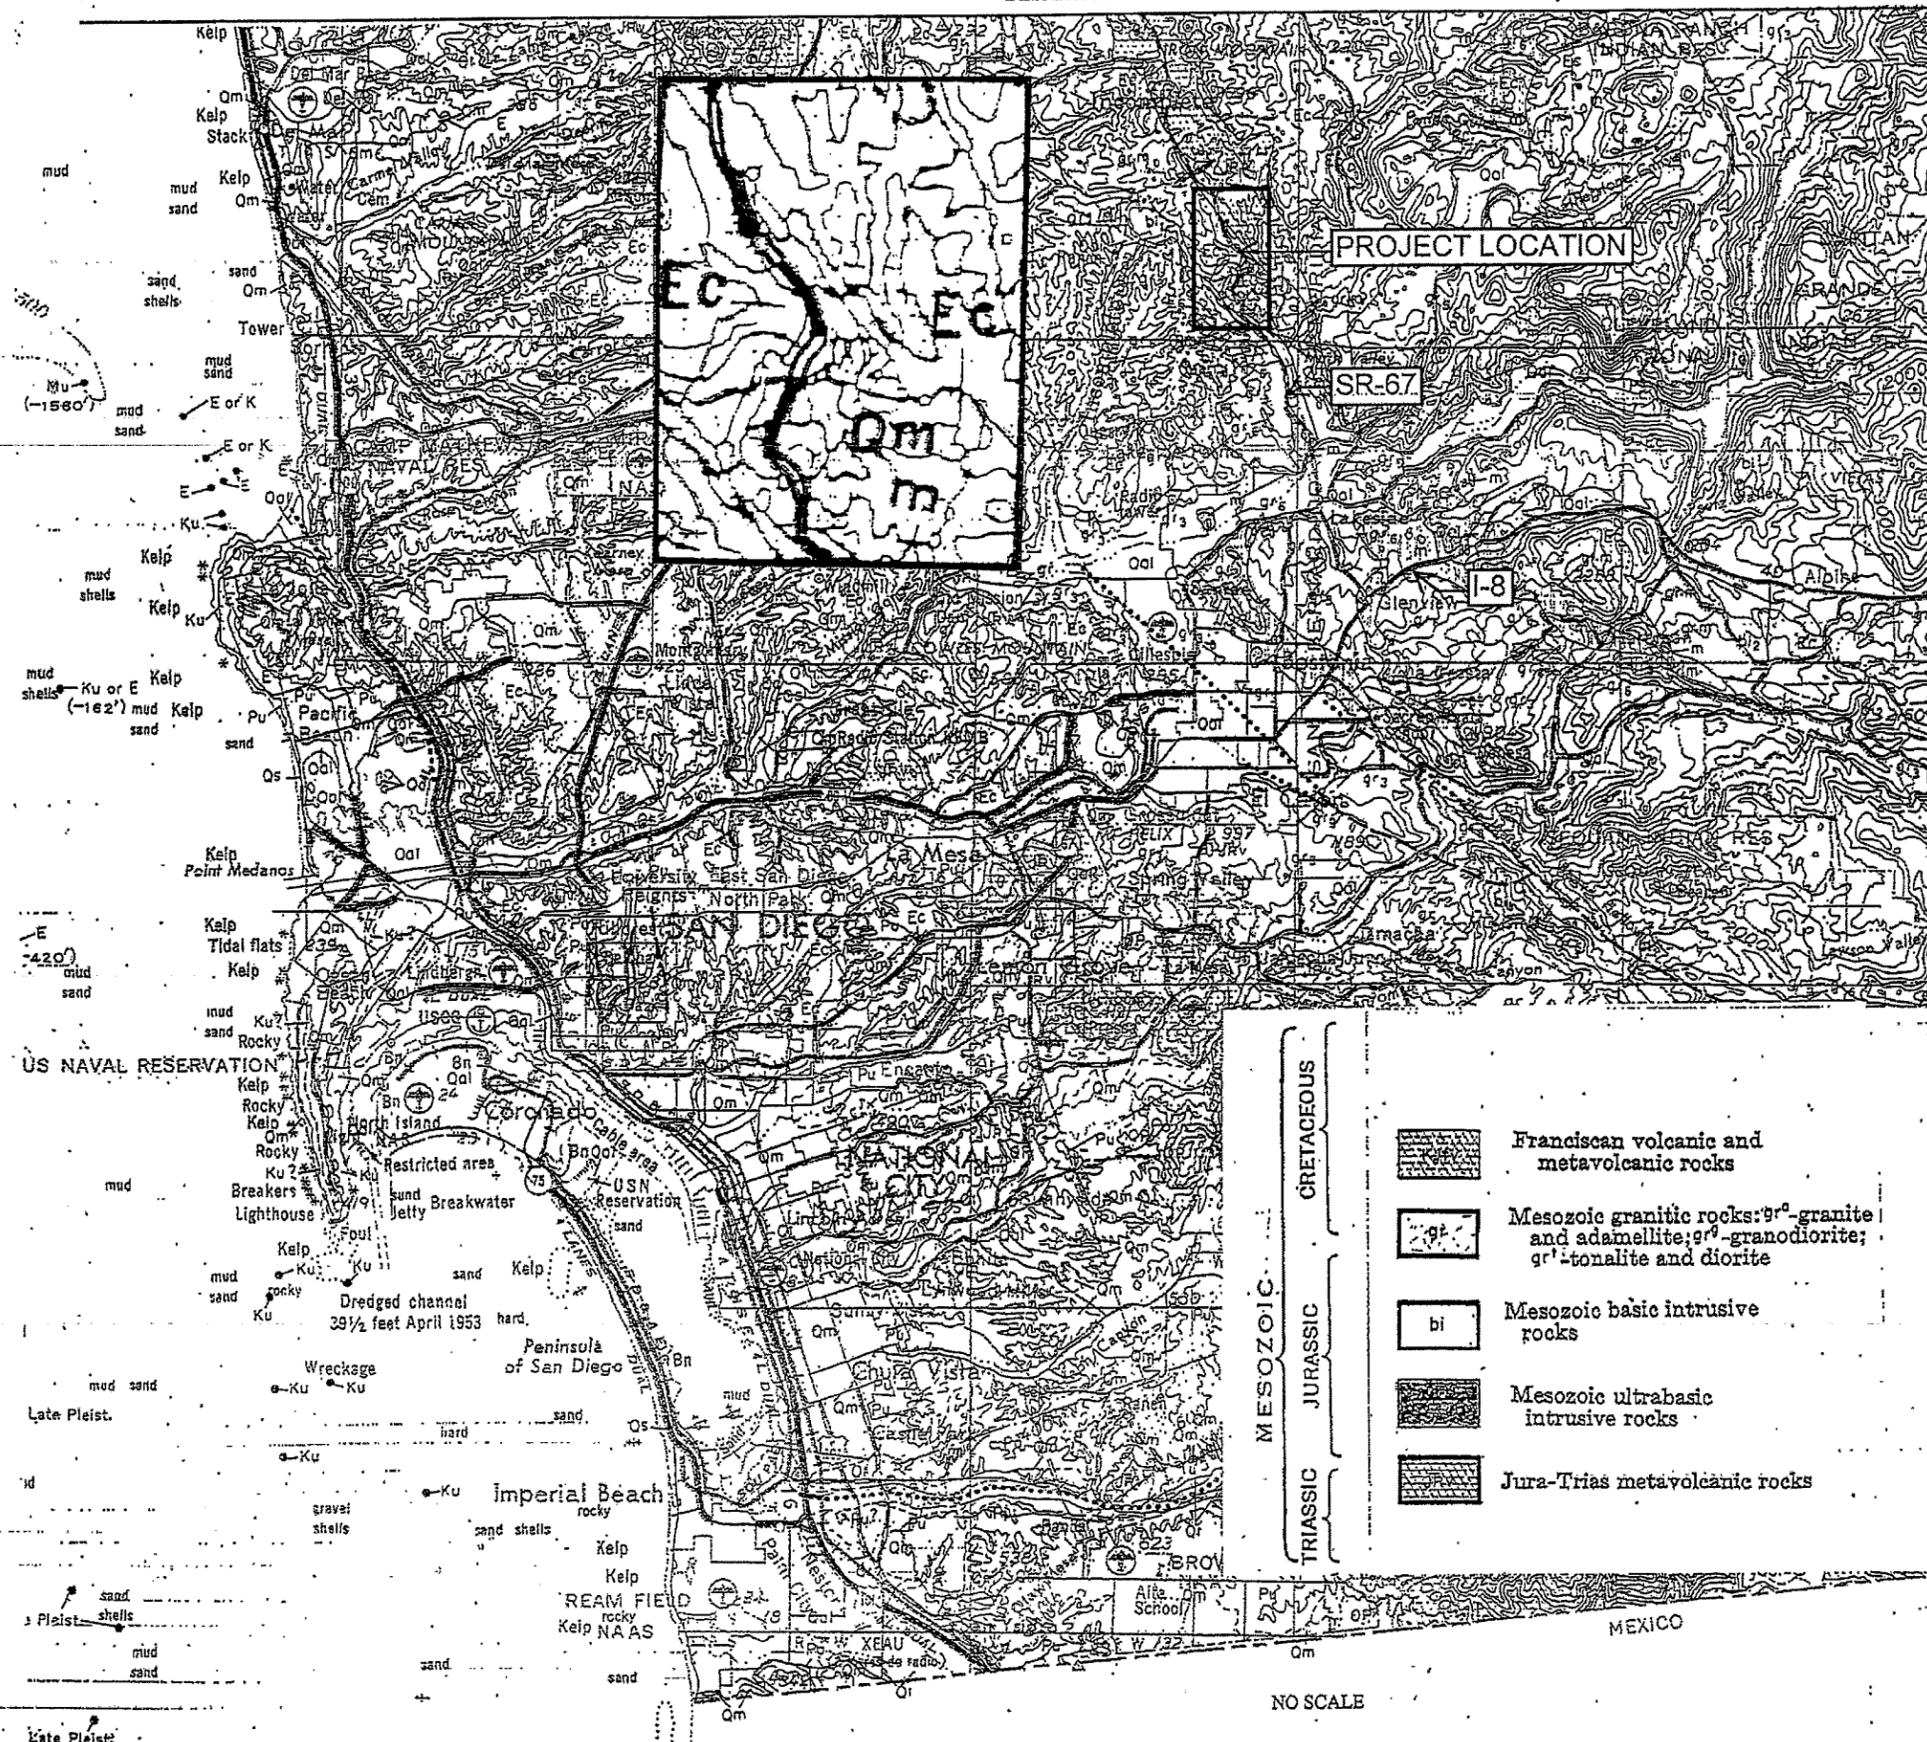
FIGURE 2
GEOLOGIC MAP
SR-67-SUBSURFACE SOIL CONDITIONS

The project alignment is underlain by three geologic units: Pleistocene age Marine and Marine Terrace Deposits (Qm), Eocene age Nonmarine Deposits (Ec), and the Jura-Trias age Metavolcanic Rocks (JTrv) (O.P. Jenkins, 1993.)

In addition, several sections of the project alignment are underlain by embankment fill derived from the nearby cuts in native soils. A Geologic Map depicting the project location is presented in Figure 2.
