For Contract No. 11-414704

Geotechnical Design Report, Dated September 22, 2015

File: 11-SR-67- 9.3/11.2
EA 11-41470
ID 1112000191

Subject: **Geotechnical Design Report for the Removal and Replacement of the Guardrail Barrier on State Route 67.**

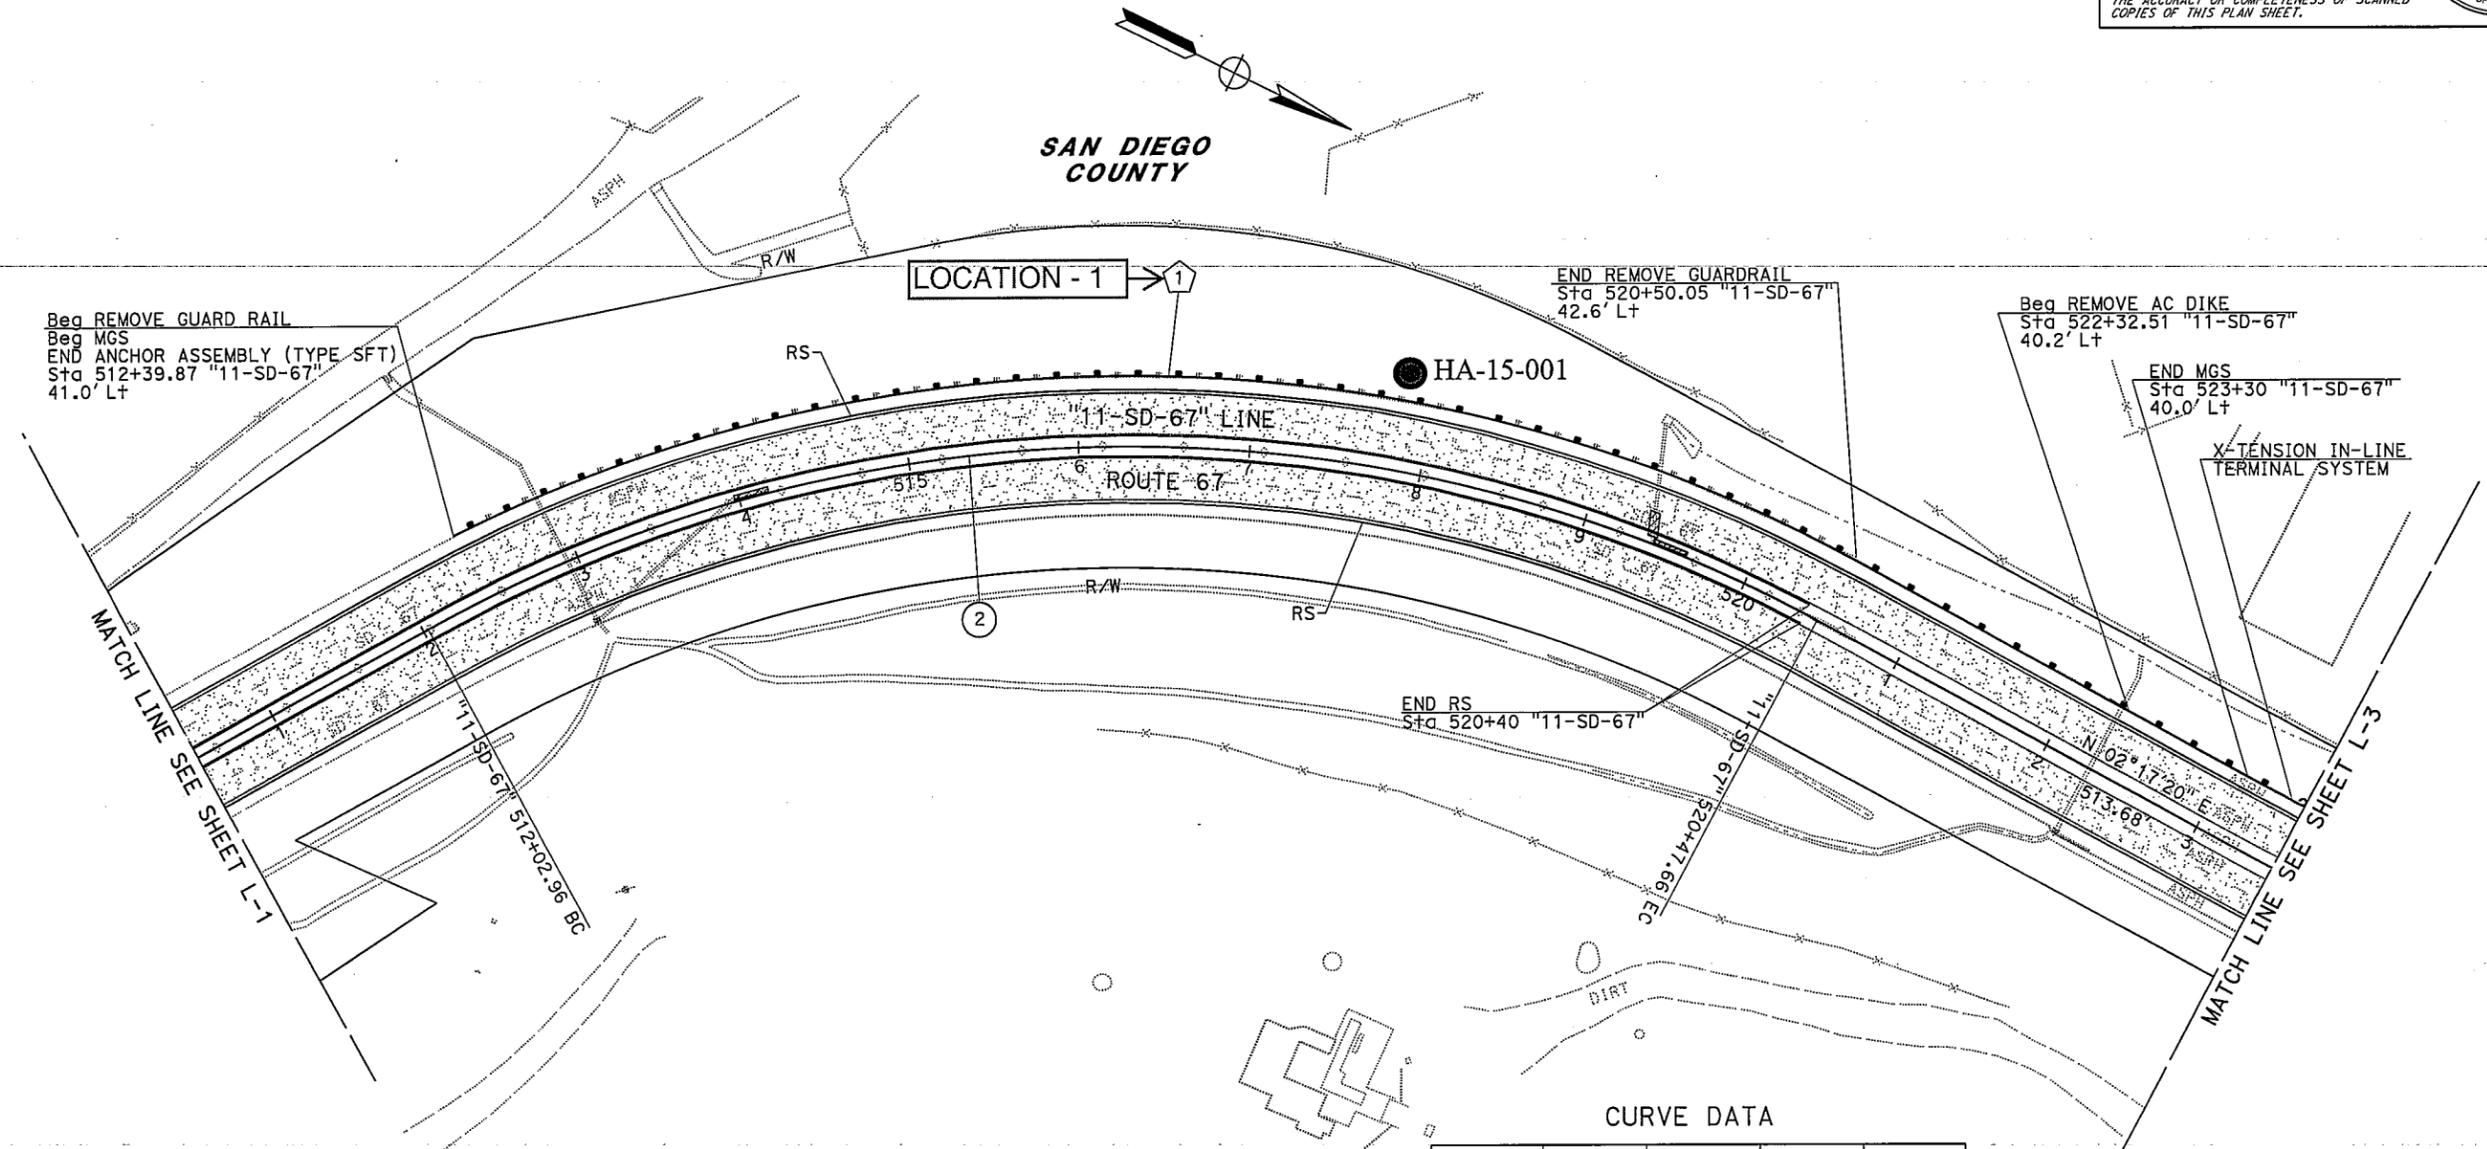
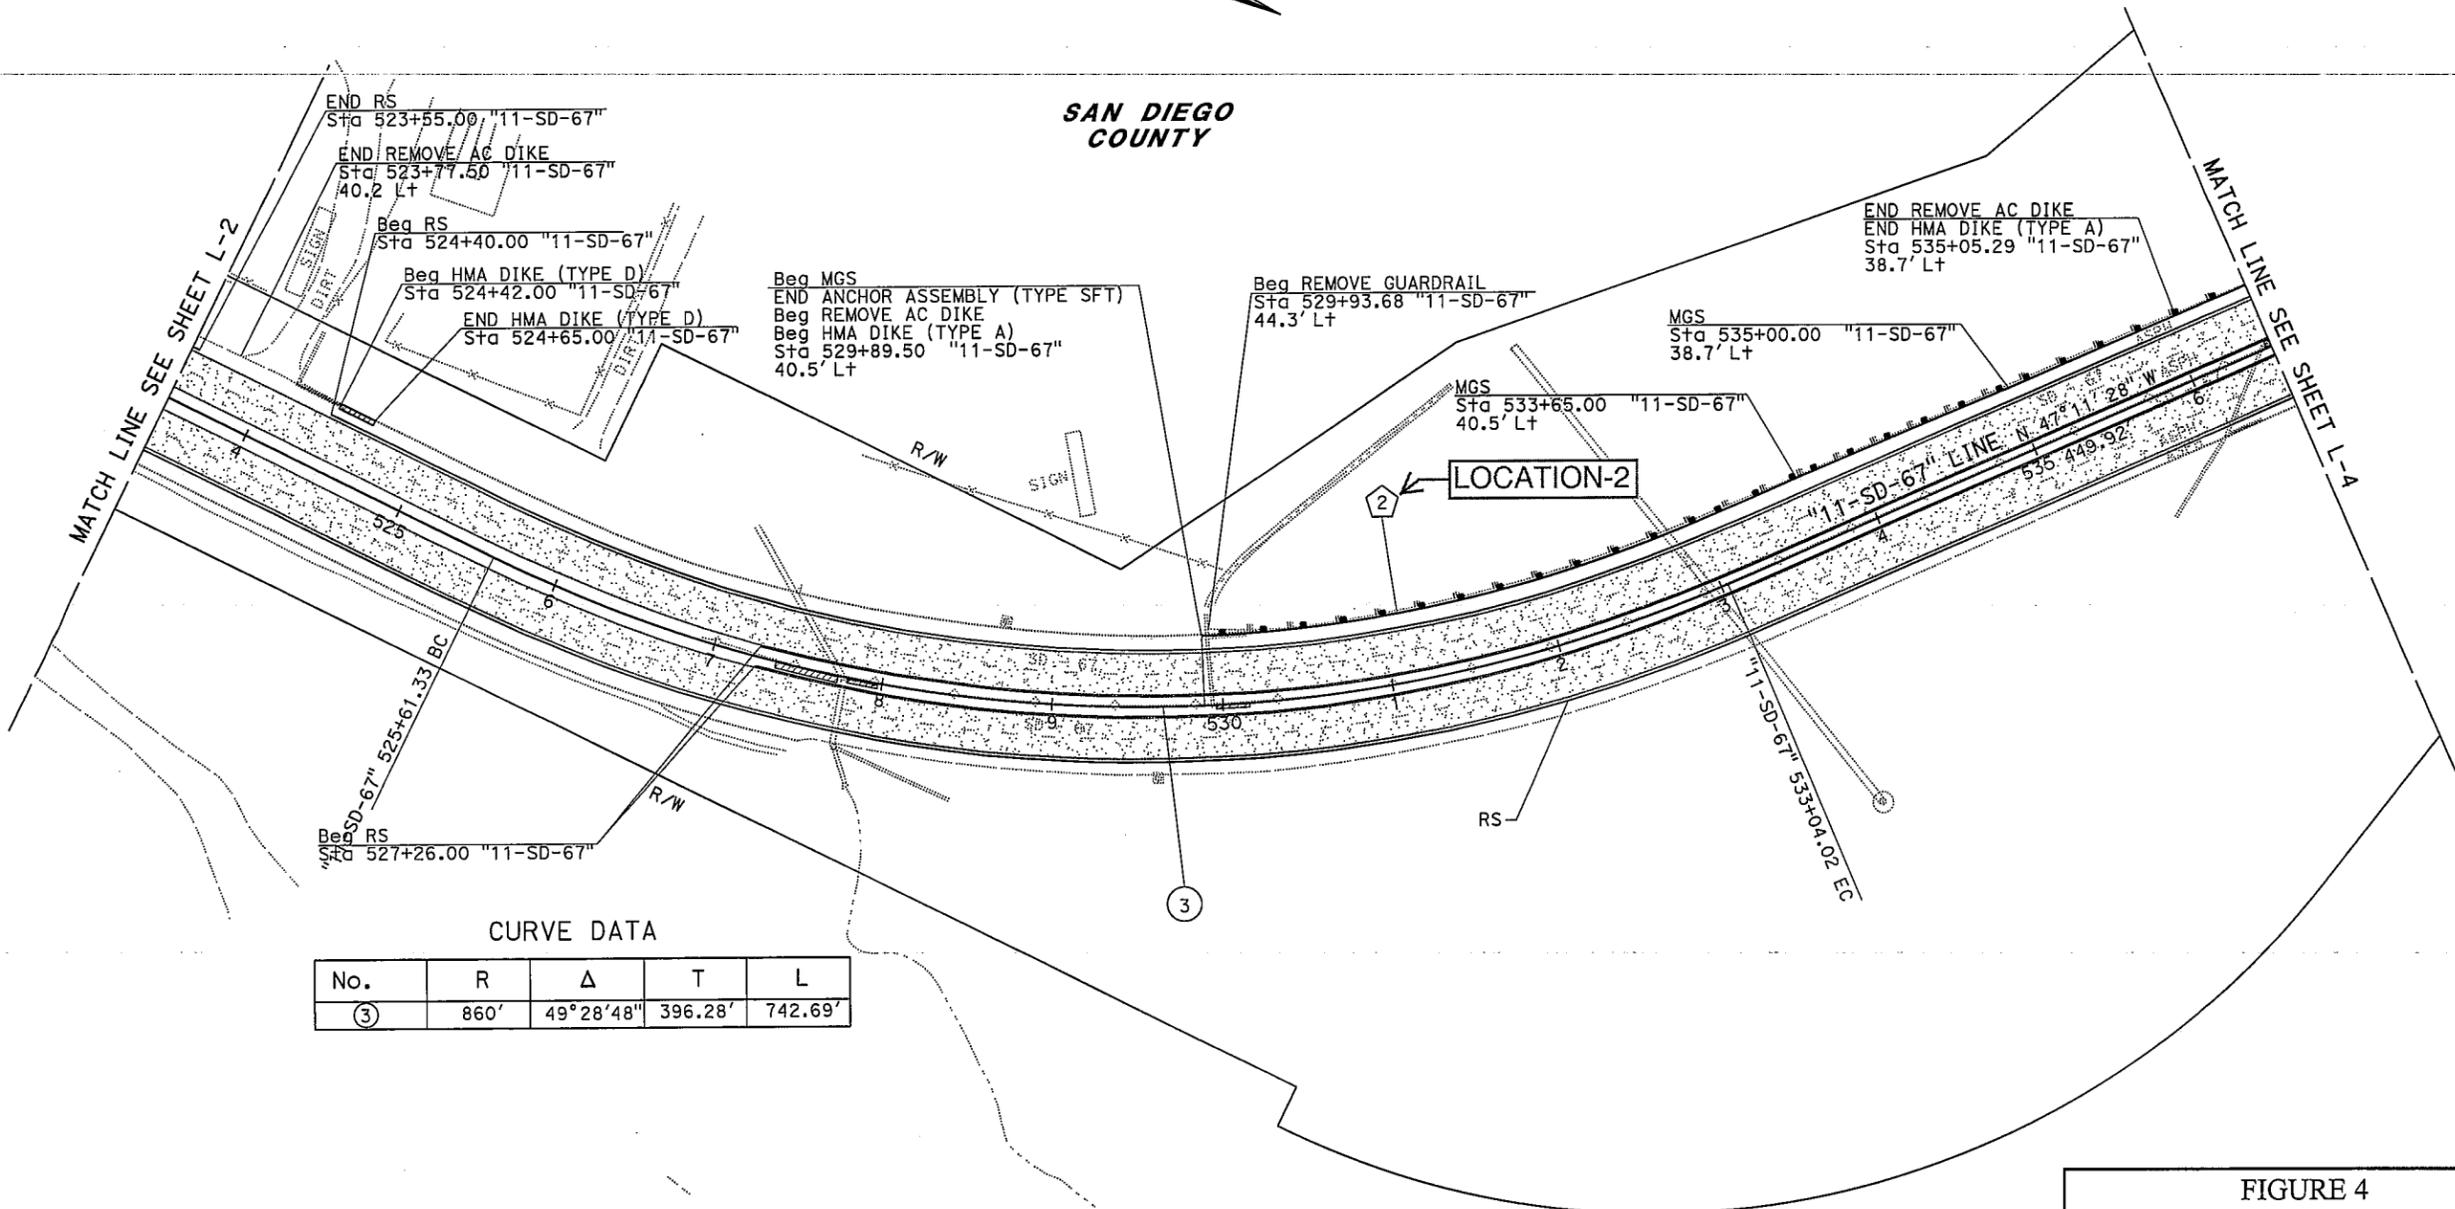
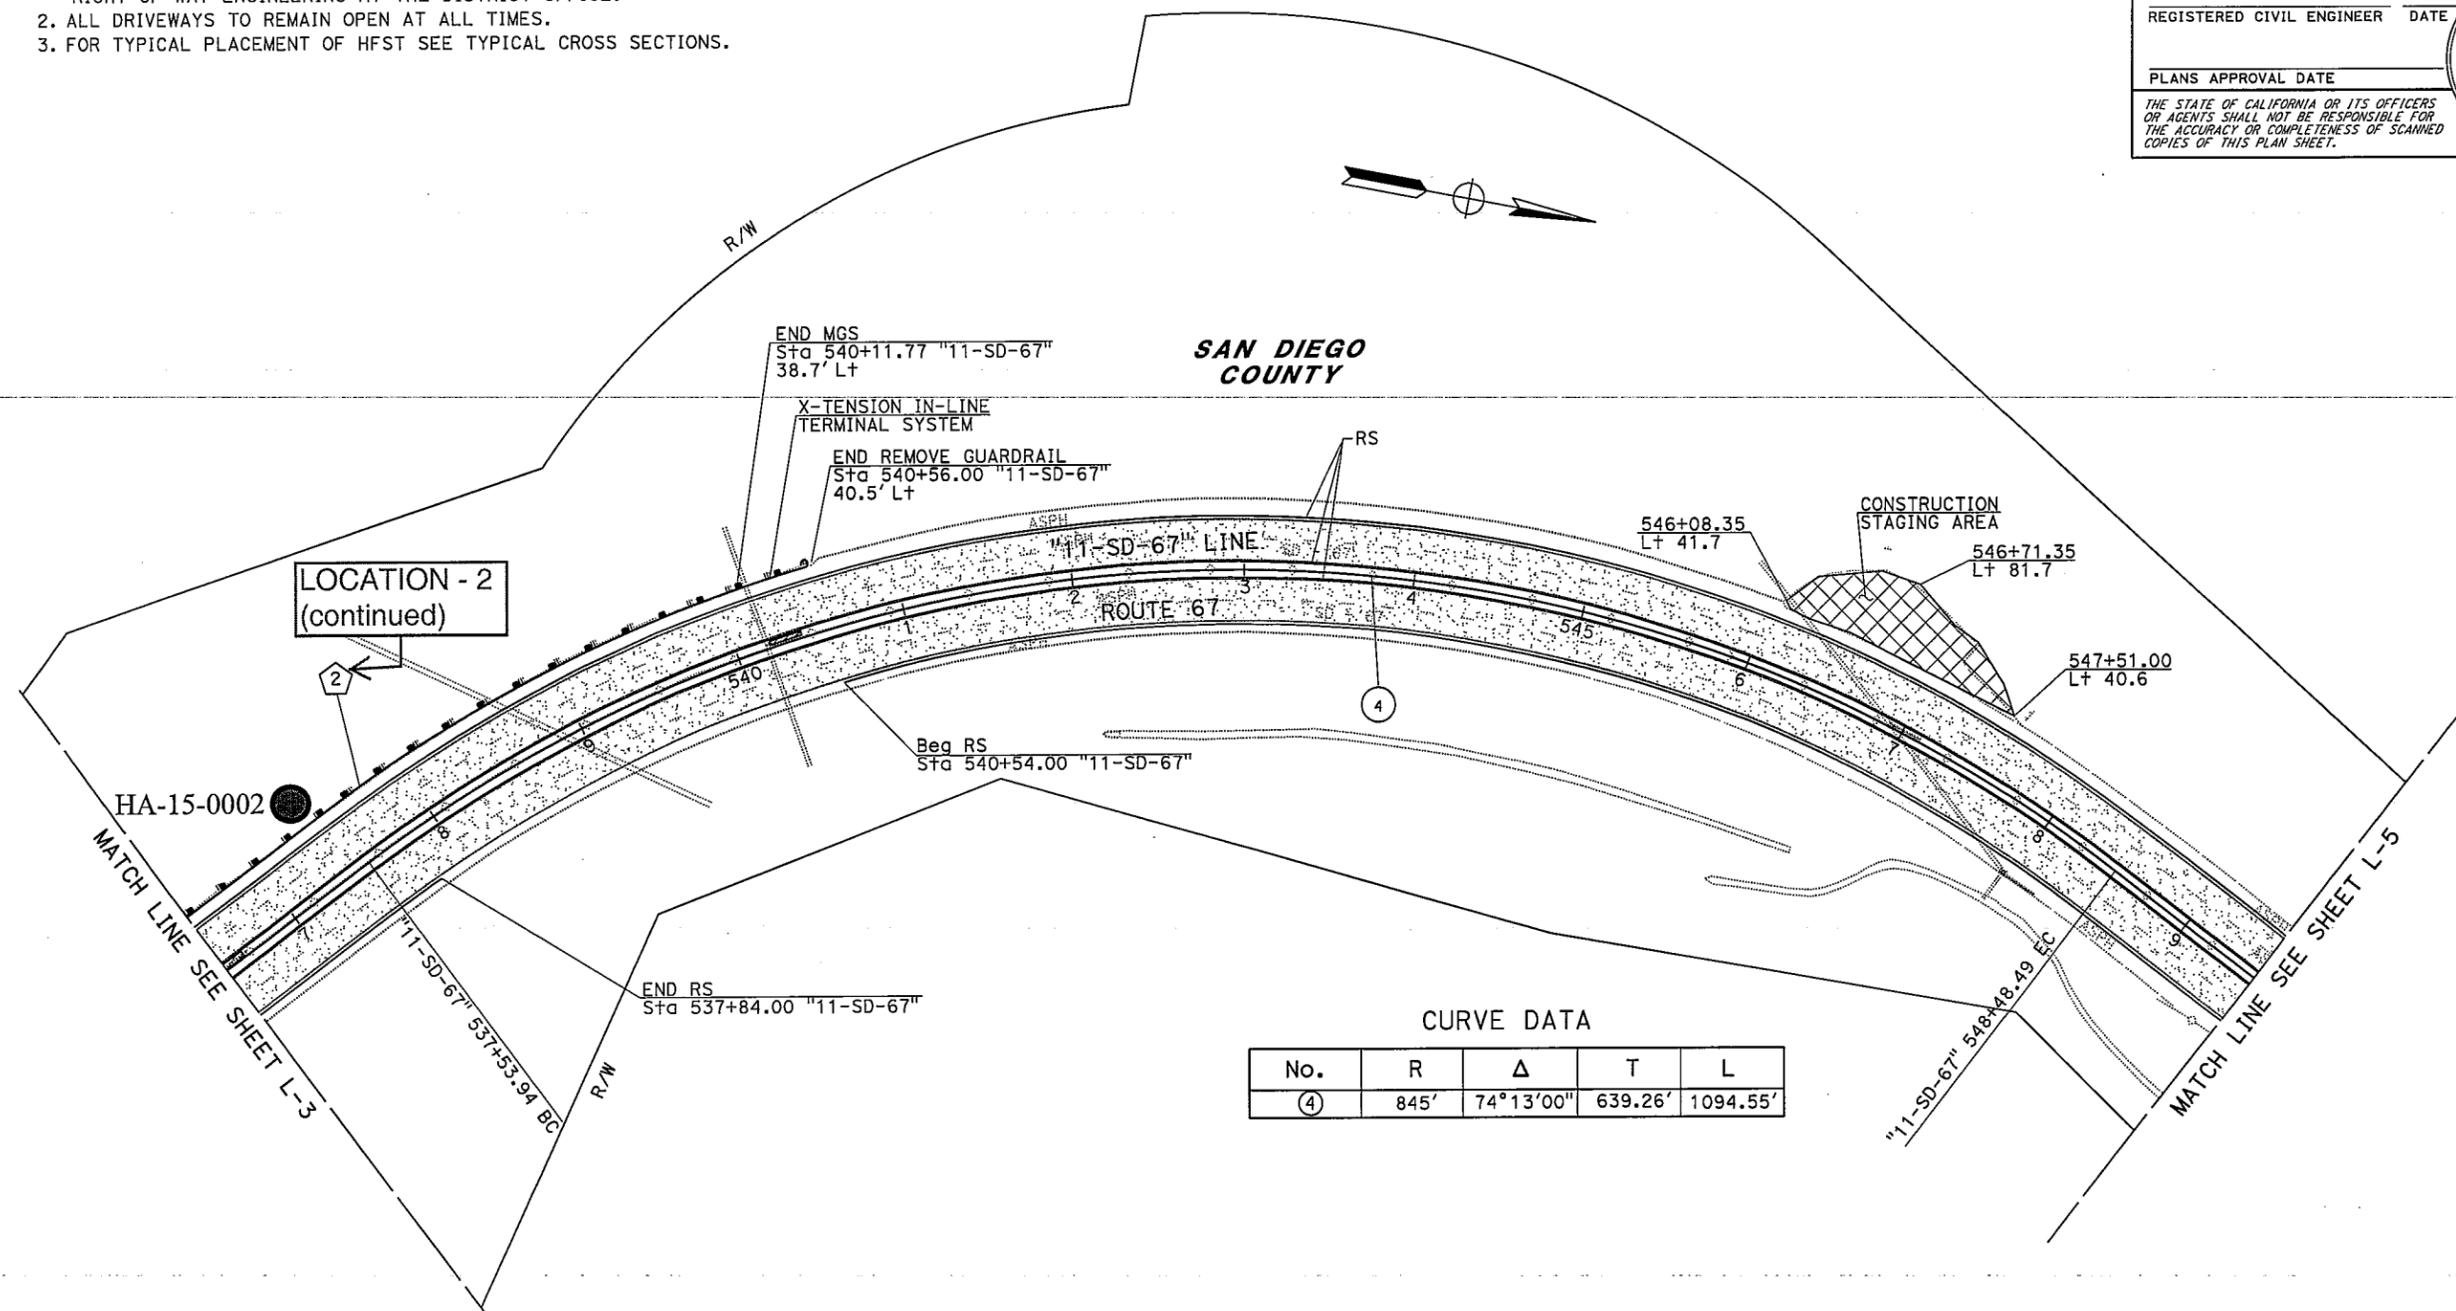
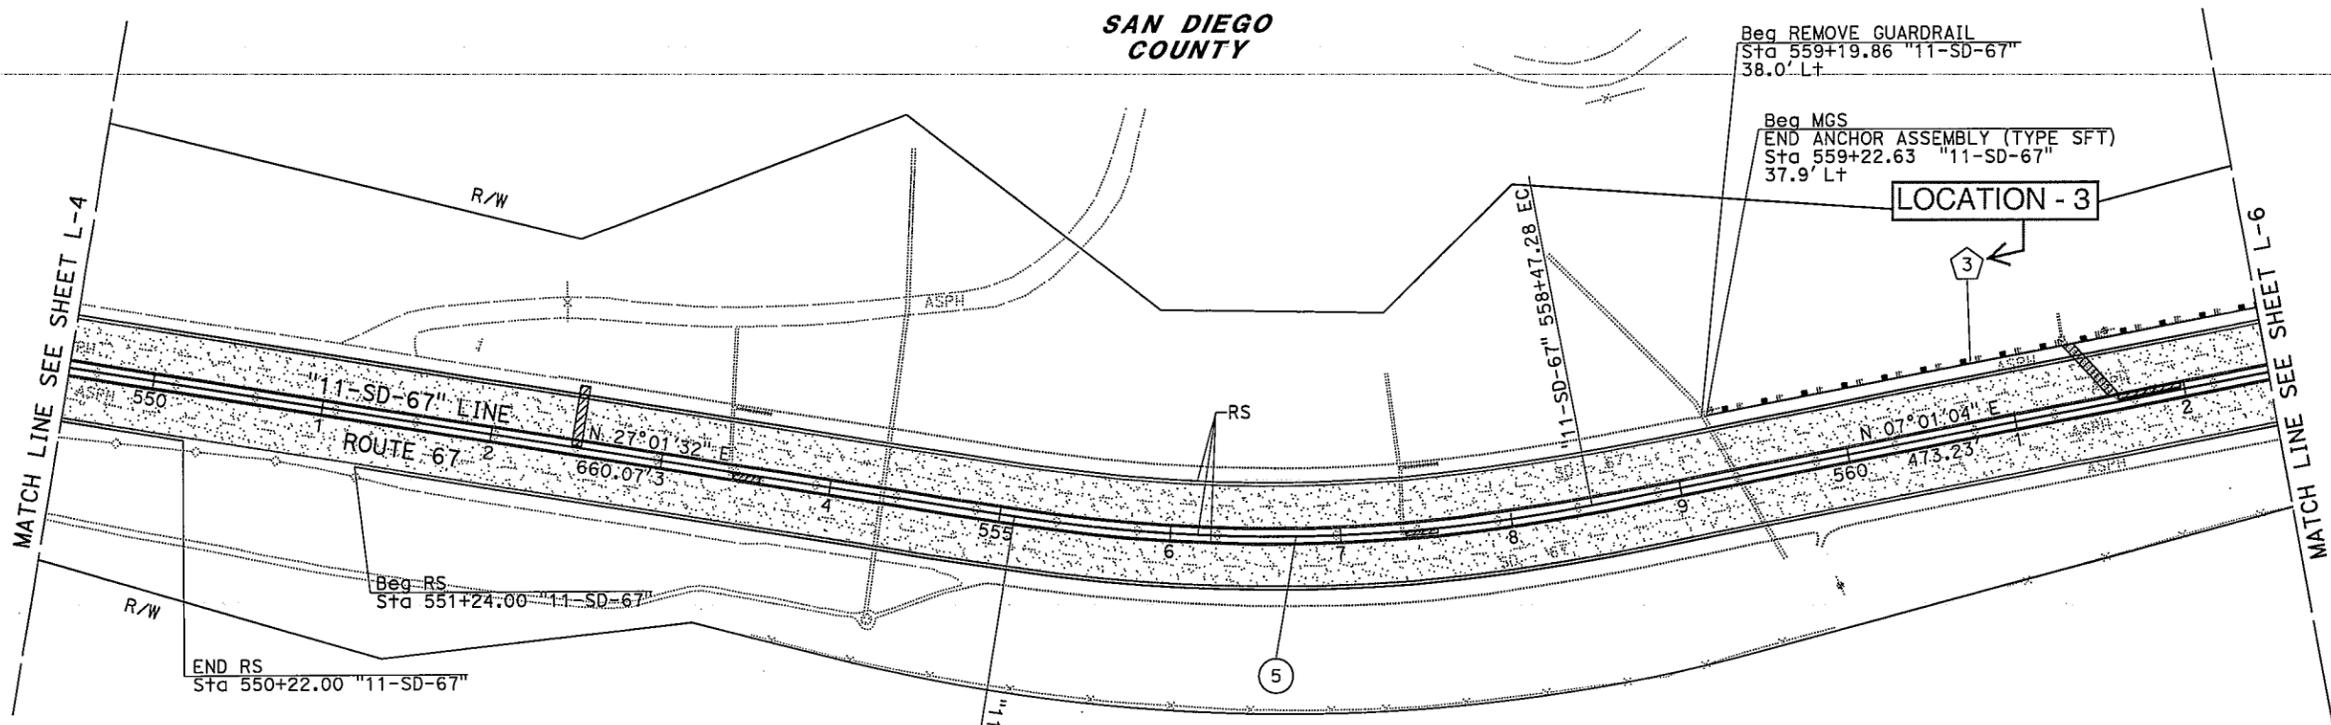
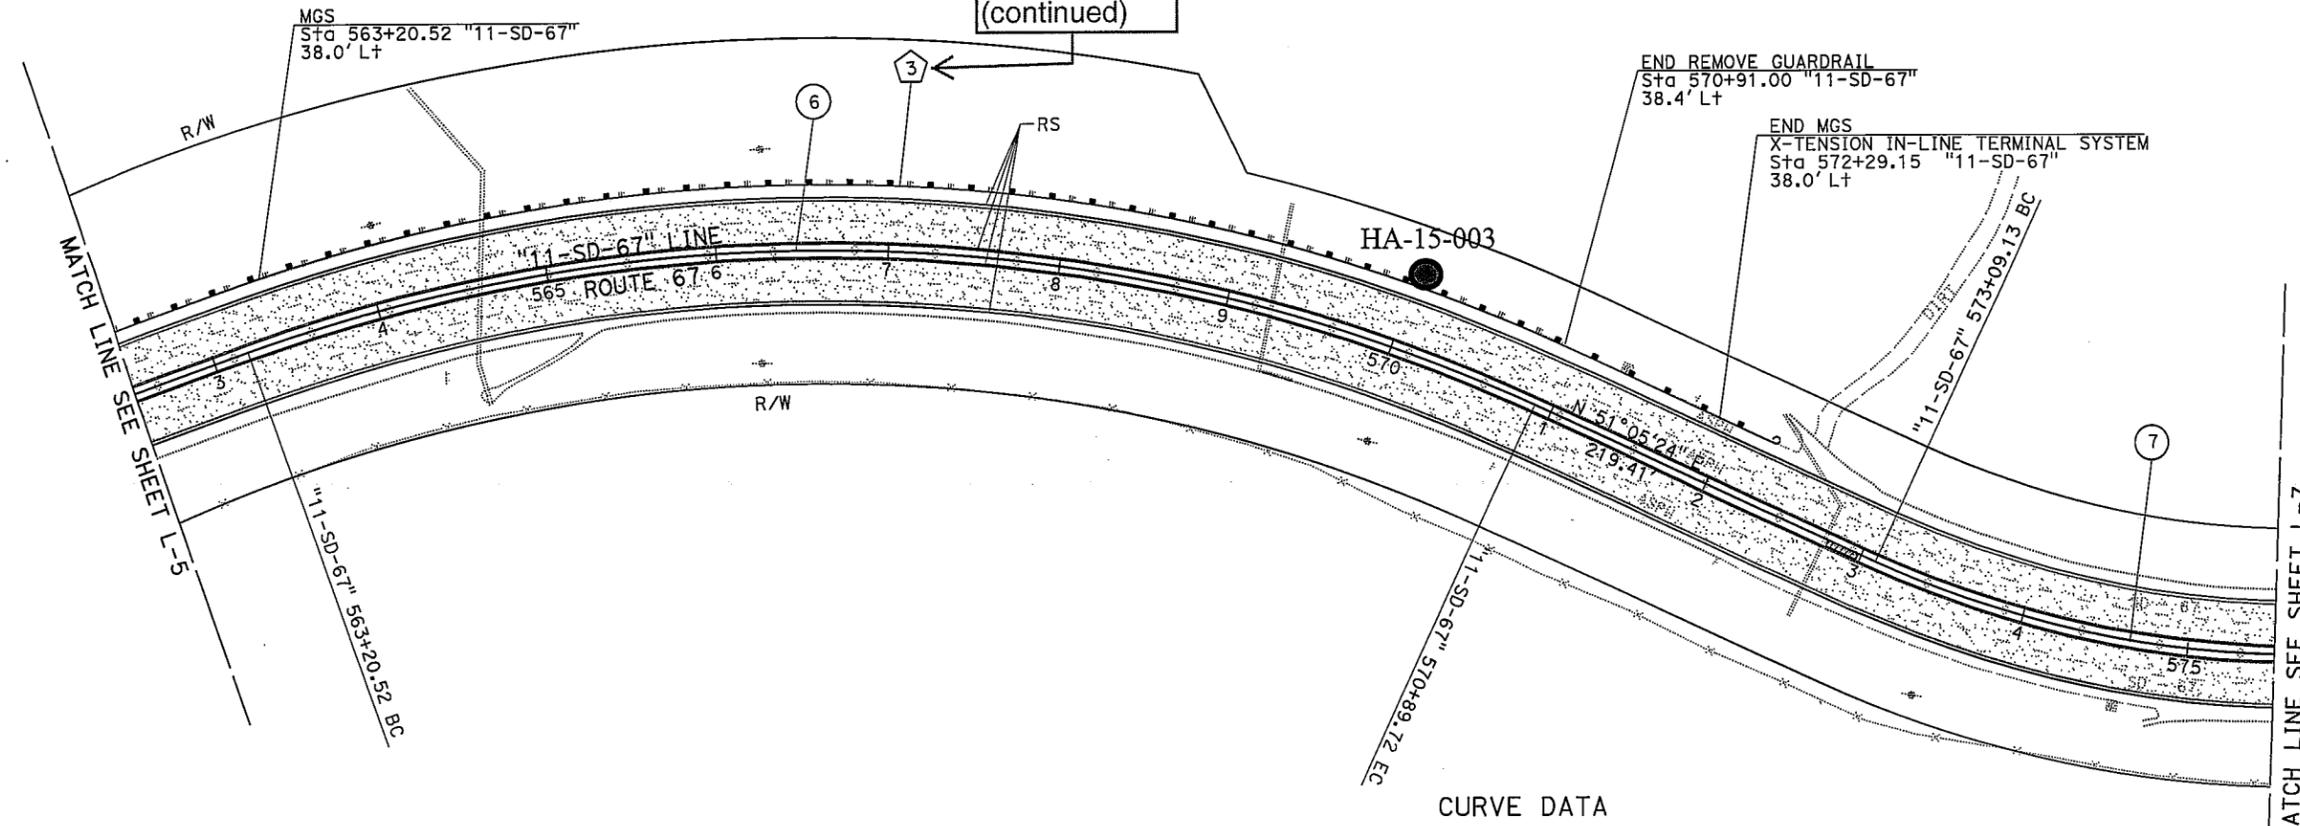
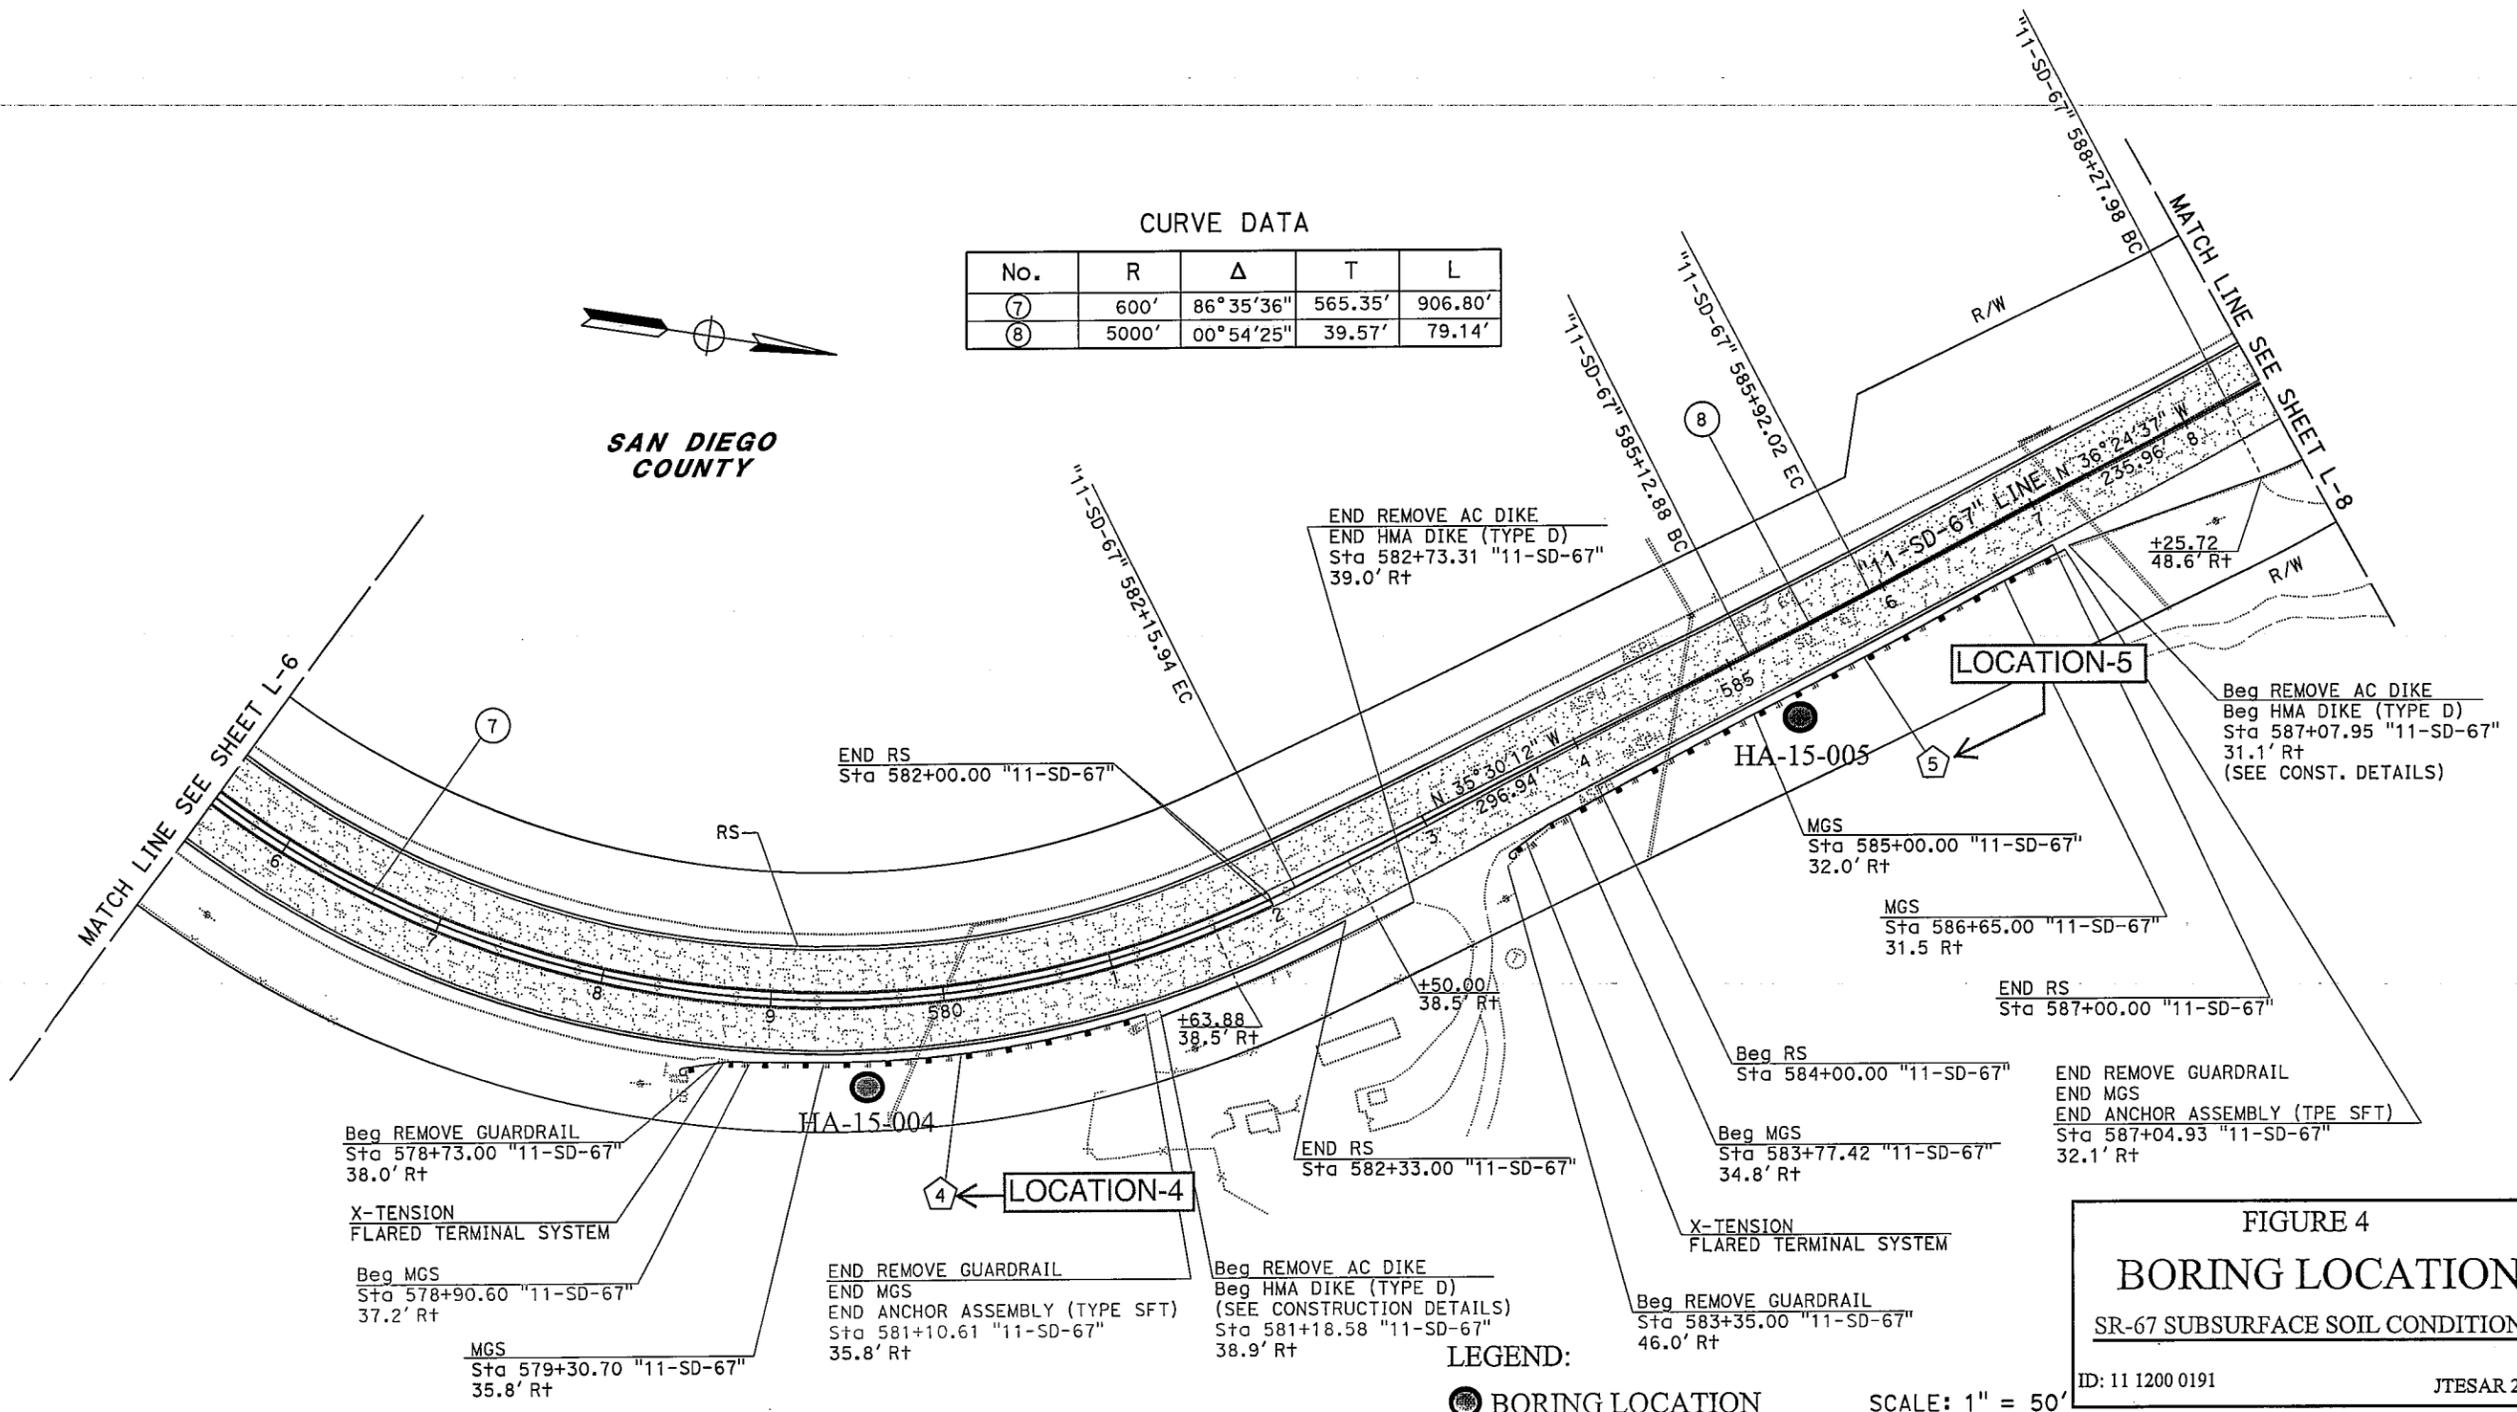
FIGURE 4
BORING LOCATIONS
 SR-67 SUBSURFACE SOIL CONDITIONS

The subsurface investigation that was conducted in August 2015 consisted of excavating seven hand augers to depths ranging from 0.5 to 4.0 feet below the ground surface. All hand augers were terminated at relatively shallow depths due to gravelly and/or rocky subsurface soil conditions. The subsurface soils encountered were logged and field index tested. No groundwater was encountered. Table 1 provides subsurface investigation data and description of the soil conditions pursuant to the Caltrans Soil and Rock Logging, Classification, and Presentation Manual of 2010. Hand auger locations are provided in Figure 4, Boring Locations Plan. They can also be found in Figure 3, Aerial Photo.
