## **Geotechnical Design Report**

AERIALY DEPOSITED LEAD INVESTIGATION RESULTS  
RED HILL AVENUE BETWEEN I-405 AND AIRPORT LOOP DRIVE  
COSTA MESA, CALIFORNIA  
CONTRACT 12A1535; EA 0N5401; TO 12-0N5401-02

FINAL MATERIALS LETTER REPORT FOR RE-CONSTRUCTION OF SOUTHERN  
EMBANKMENT OF RED HILL AVENUE OVERCROSSING BRIDGE IN CITY OF  
COSTA MESA, CALIFORNIA.

**File:** 12-ORA-405-PM 8.4  
12-0N540  
Red Hill Avenue MSE Wall

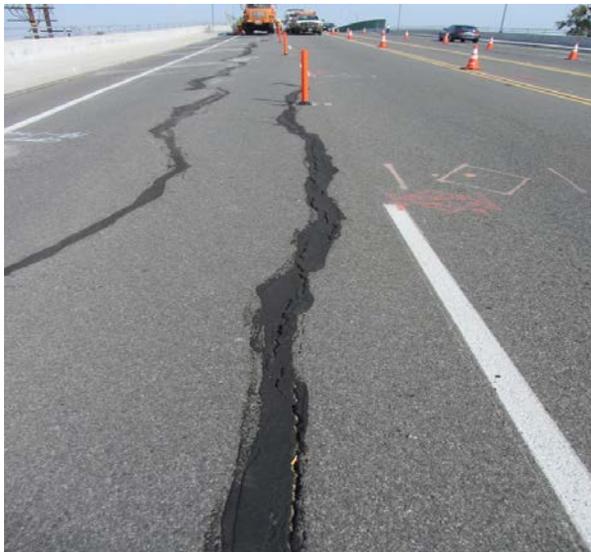
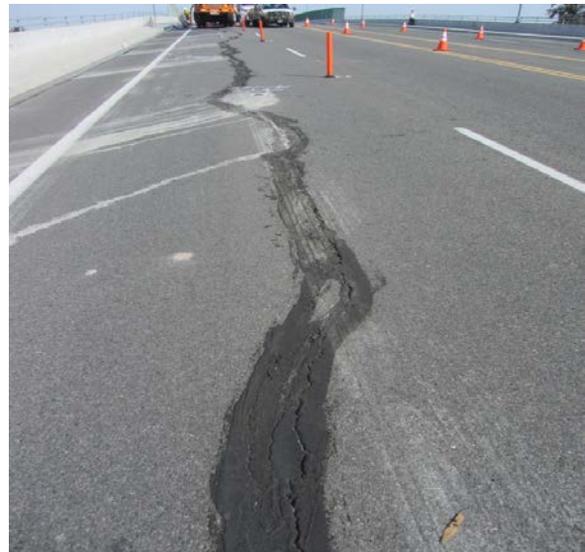
**Figure 2: Pavement Cracks**

In May 2013, new cracks on the pavement were observed in the areas behind MSE wall reinforcements and along the entire length of the MSE walls (Wall Nos. 28 and 29). The cracks begin at about 100 feet south of the beginning of the MSE wall in the City of Costa Mesa (Figure 2), and the location and pattern of the cracks are similar to that observed in 2006. At abutment 1,

In October 2013, our office recommended the closure of Lane No. 2 of sound bound Red Hill Avenue, sealing of the pavement cracks and grouting of the gaps between the embankment and the wall No. 29.

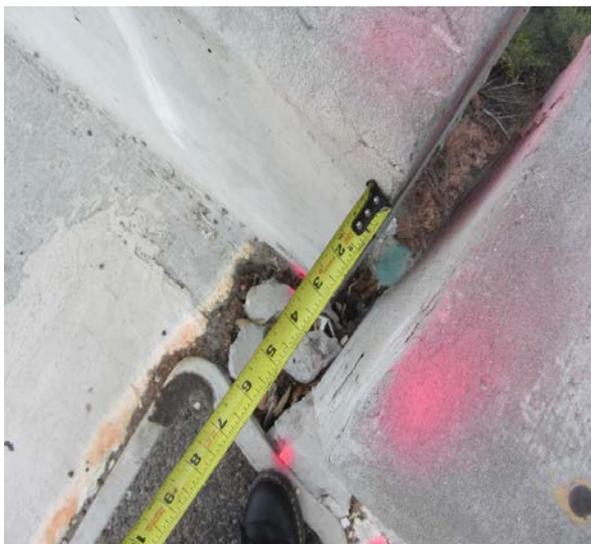
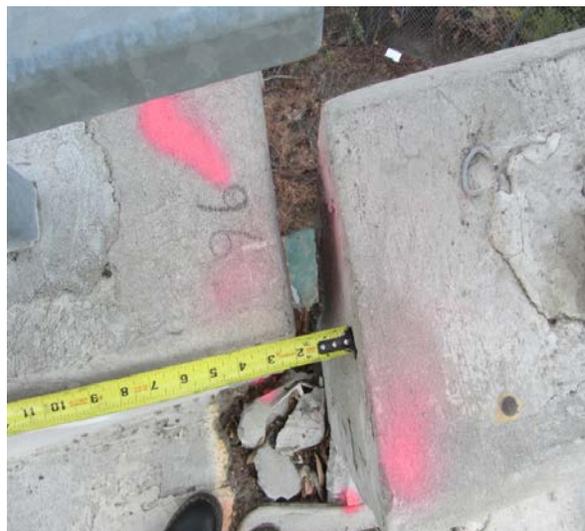
**Figure 3: Separation at Abutment 1 (Wall No. 29)**

the top of MSE wall (Wall No. 29) registered cumulative (since completion of the wall) horizontal movement of about 6 inches (Figure 3). Badly mis-aligned MSE wall panels at this location tilted in every other direction.

The tilting and mis-alignment of the MSE wall panels at Abutment 1, and the gap between embankment backfill and the MSE wall reported in “Geotechnical Forensic Study Report” dated May 2008, were not addressed in the 2009 repair.

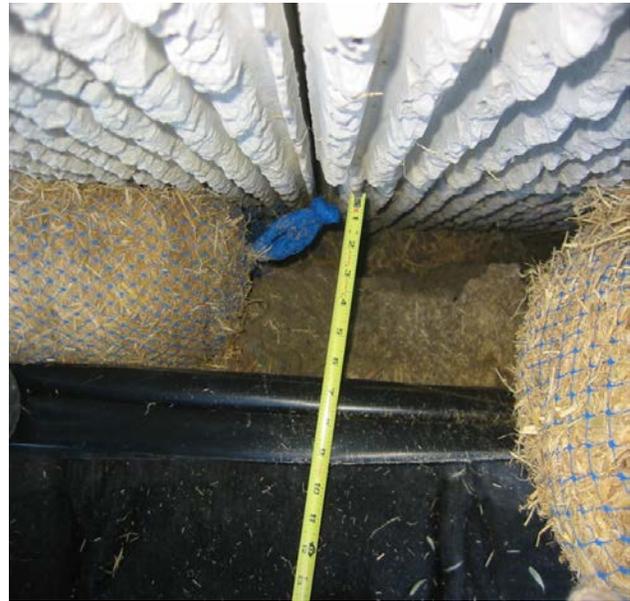
**Figure 5: Gap between embankment backfill and MSE wall at the toe of the MSE wall (Wall No. 29): (Figure from “Geotechnical Forensic Study Report” dated May 2008)**

At the toe of the wall No. 29 a gap of 3 inch wide and 2 to 3 feet deep between embankment backfill and the face of the wall (Figure 5) was also observed.

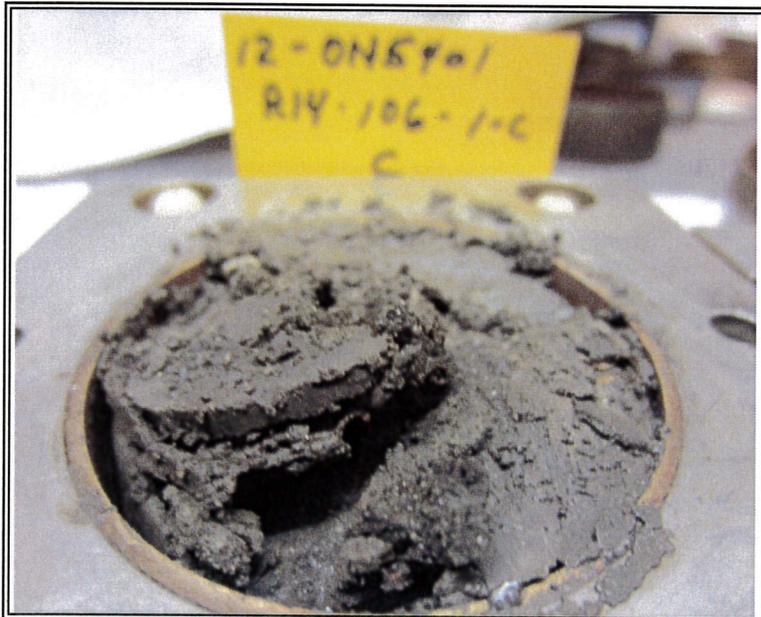
One-Dimensional Consolidation by ASTM D 2435 - Method B

Project: Redhill Slope Repair  
 Boring No.: R-14-104  
 Sample No.: 1-A  
 Test No.: 14-014-G1

Soil Description: Moist; Black; Clay with gravel, silt  
 Remarks: Swell @ 0.3 tsf
