Visual Inspection & Capacity Assessment of Earthquake Damaged Reinforced Concrete Bridge Elements

Final Report

Report No. CA08-0284

November 2008

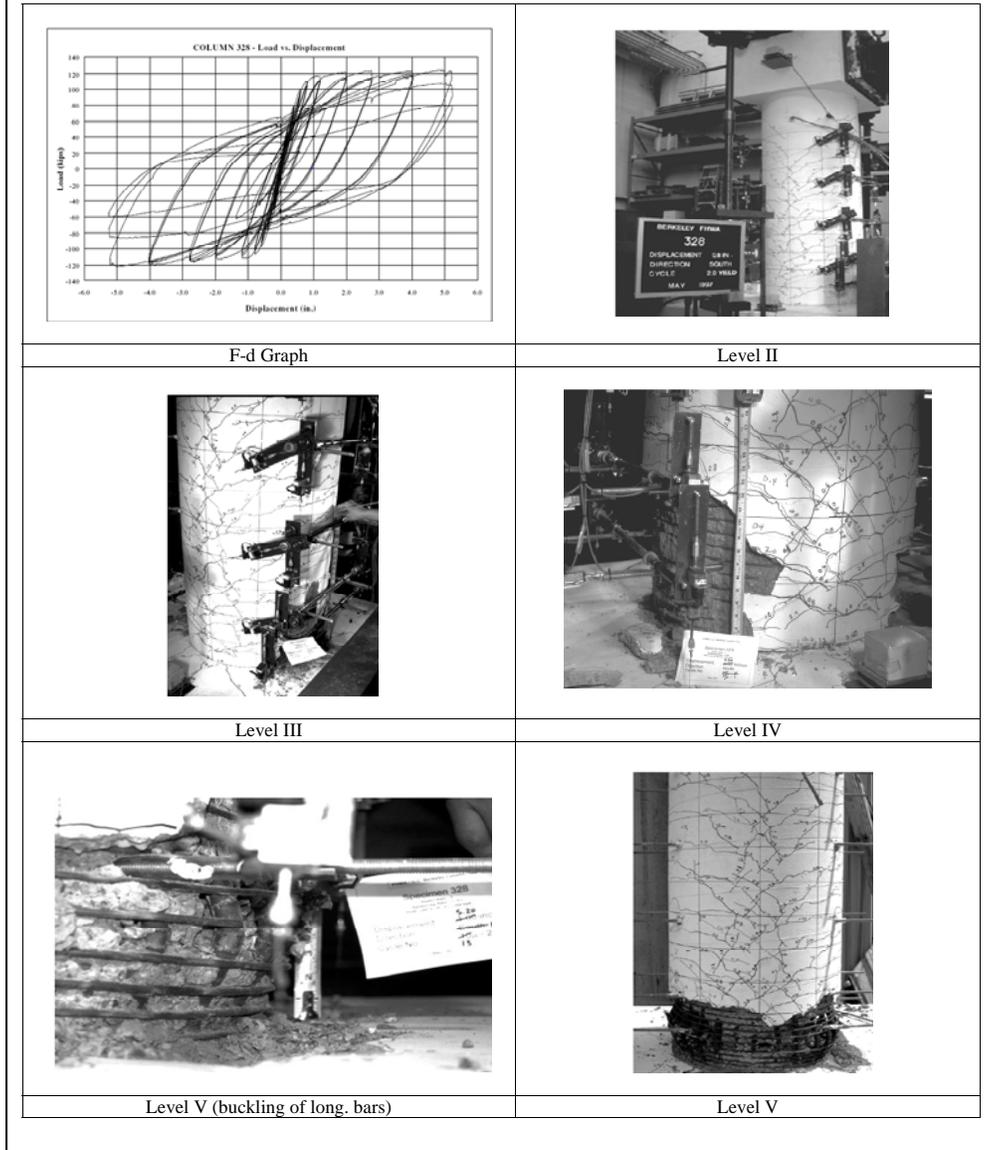
Figure 1 - Excerpt from "Visual Catalog of RC Bridge Damage"

The “Visual Catalog of RC Bridge Damage” documents damage from laboratory experiments and from historic earthquakes and classifies the performance of an array of bridge components, sub-assemblages, and systems in a consistent format. The Visual Catalog organizes photos of over one hundred test units from forty research reports dating back to 1990. The damage to each test unit has been classified into five different damage levels. The Visual Catalog also includes a force-displacement diagram of the test to document the performance of each test unit. A sample page from the Visual Catalog is shown in Figure 1. The Visual Catalog also organizes and classifies photos from fourteen historic earthquakes dating back to the 1971 San Fernando event.

The intention is that this document will be used by inspection and maintenance engineers as a reference to confirm the type and level of damage observed after an earthquake. It will also be used as a teaching tool to train engineers in identifying the failure type and level of damage to bridge components.

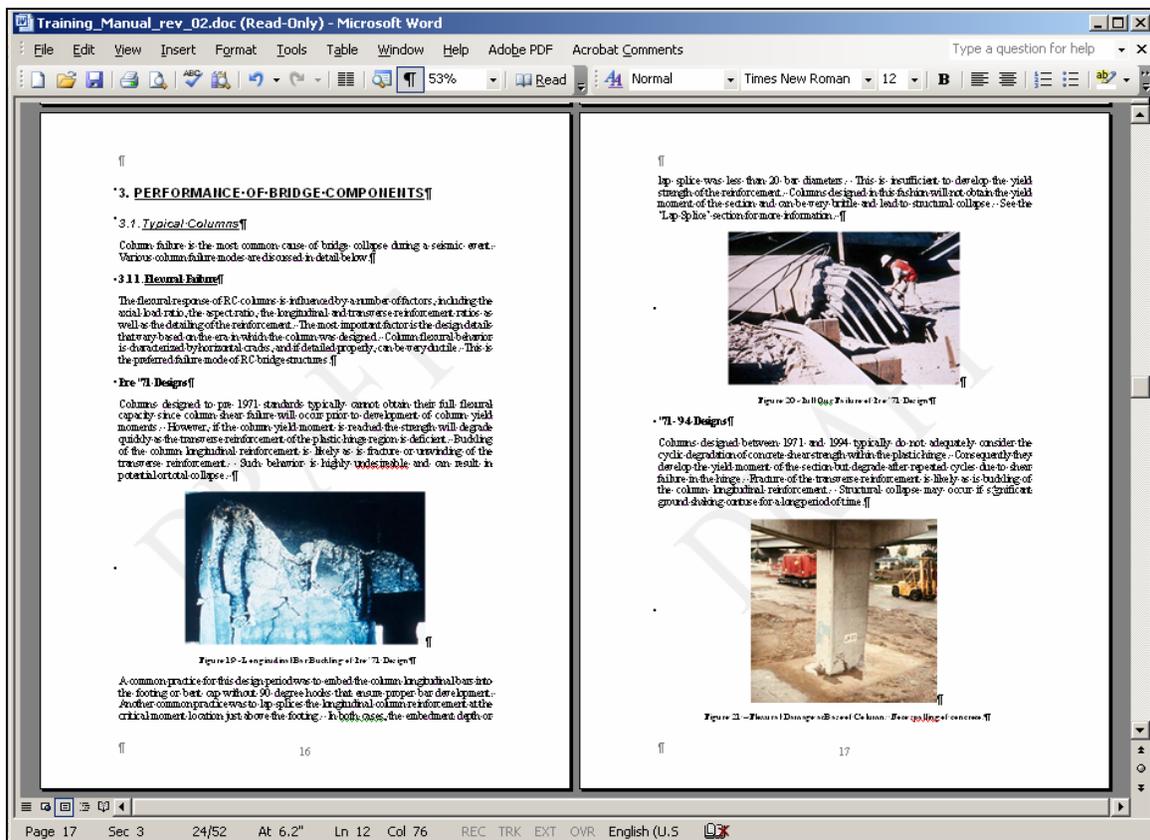
Figure 2 - Excerpt from "Capacity Assessment Training Manual"

The "Capacity Assessment Training Manual" will be a primary teaching tool for inspection and maintenance engineers. This document discusses seismic design concepts such as inelastic response, plastic hinge mechanisms, and capacity design principles. It explains the vulnerabilities of bridge from different design provision eras and reviews the past performance of RC bridge components and the seismic vulnerabilities of different construction methods. The training manual also discussed post earthquake bridge evaluation and ends with lessons learned about damage evaluation and capacity assessment. An excerpt from this manual is shown in Figure 2.

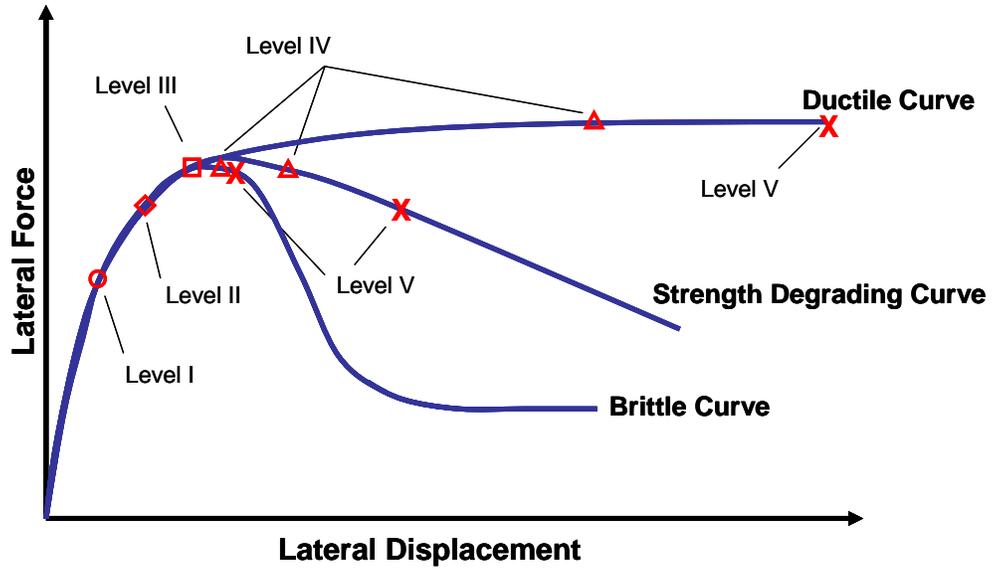
Figure 4 - Performance Curves

This phase is probably the most complicated and time intensive portion of the protocol as it requires access to all construction drawing of the bridge. Each column needs to be associated with a performance curve that best summarizes the expected seismic response. There are three performance curves to choose from: Ductile, Strength Degrading, and Brittle (see Figure 4). The engineer can determine the anticipated performance curve by following the decision making flowchart shown in Figure 5. This phase is most efficiently performed before hand in the office. The use of summary tables identifying the design detail and the performance curve for every column is recommended.

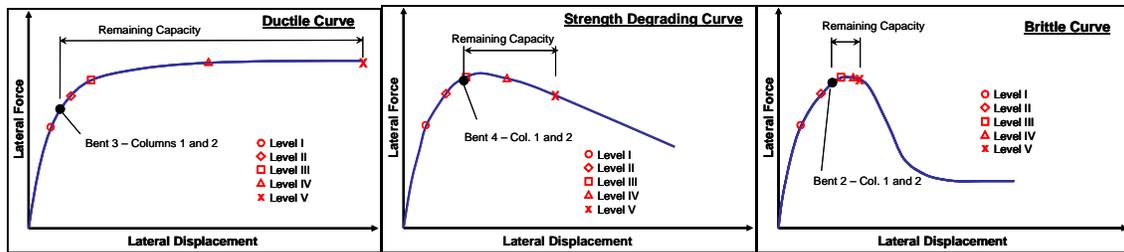
Figure 6 - Visualization of Remaining Capacity of Bridge Columns

In this phase, it is recommended that engineers plot the level of damage of each column on their respective performance curve. This will assist the engineer in visualizing the remaining capacity of the structure (see Figure 6). It is important to note that bridges are complex structures and decisions about the bridge should include issues beyond column damage, such as damage to the superstructure, the abutments and expansion joints.

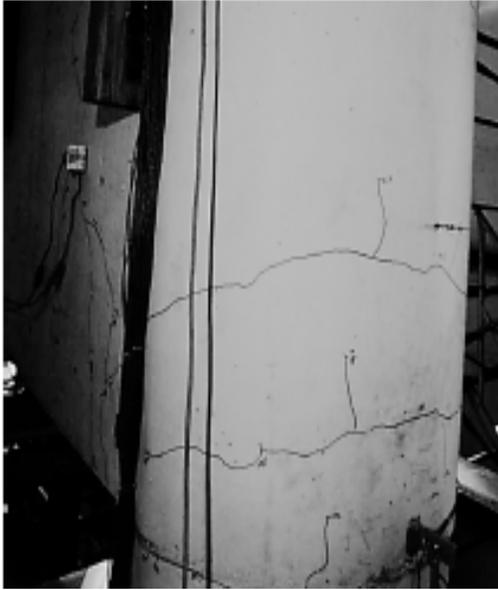
Level II flexural cracks at joint

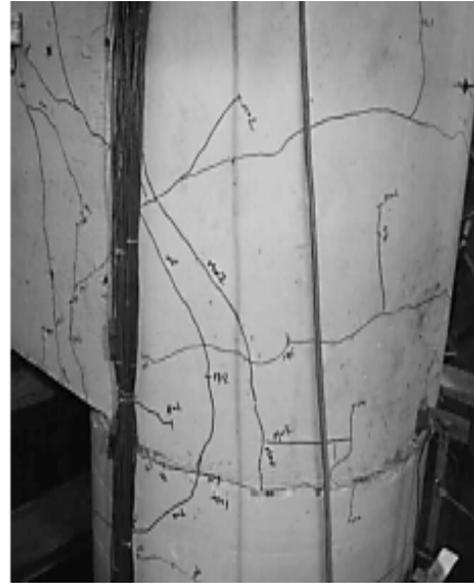
Level III joint shear cracks (from pull out)

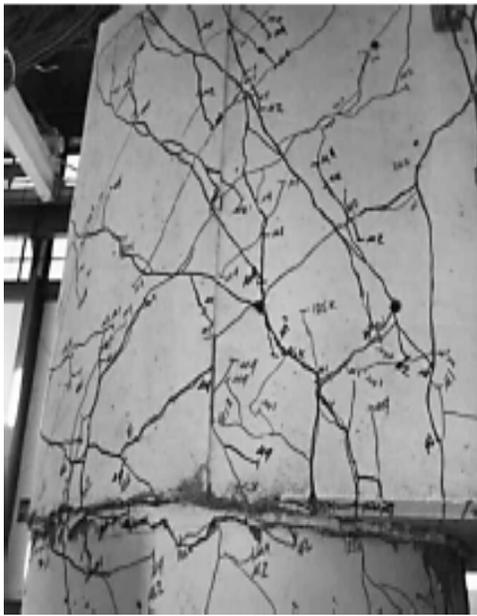
Level IV splitting cracks of cap beam

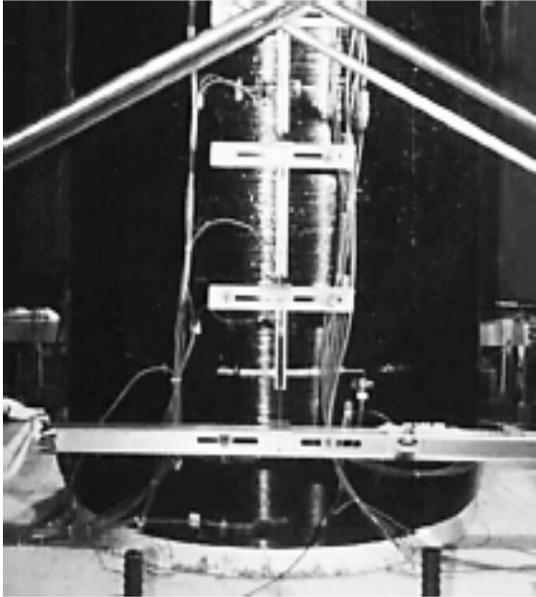
Level II first cracks at interface

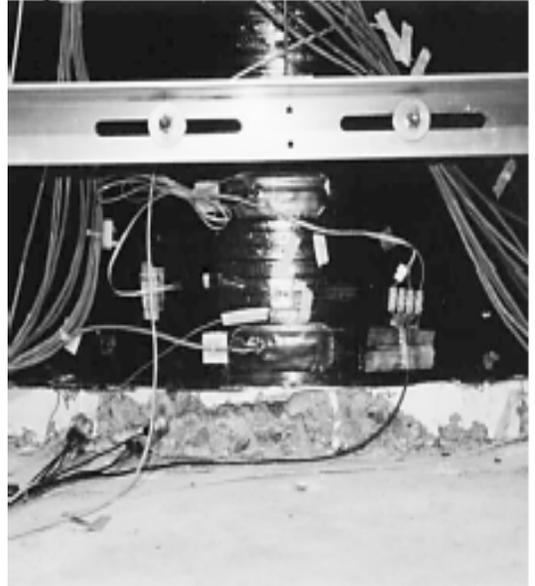
Level III cracks in jacket filaments and gap

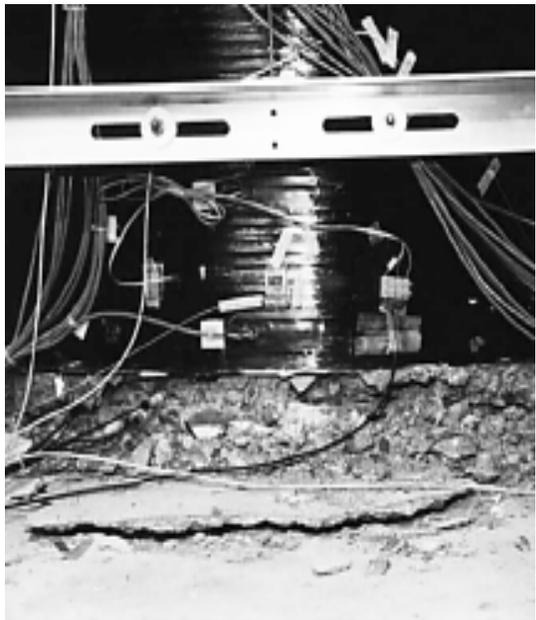
Level IV extensive spalling at plastic hinge

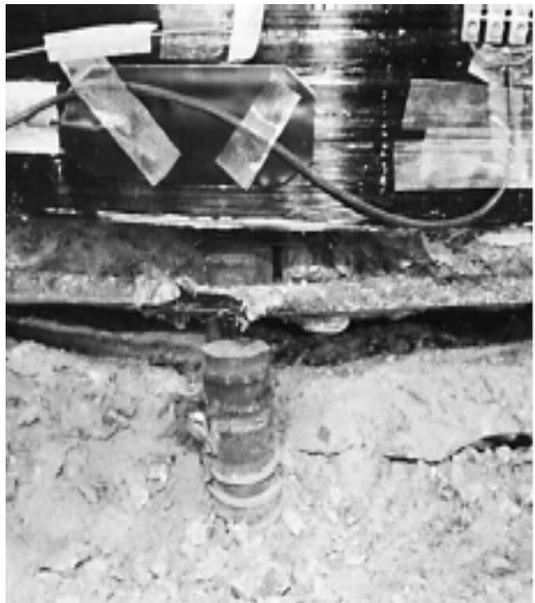
Level V jacket cracks, bar rupture

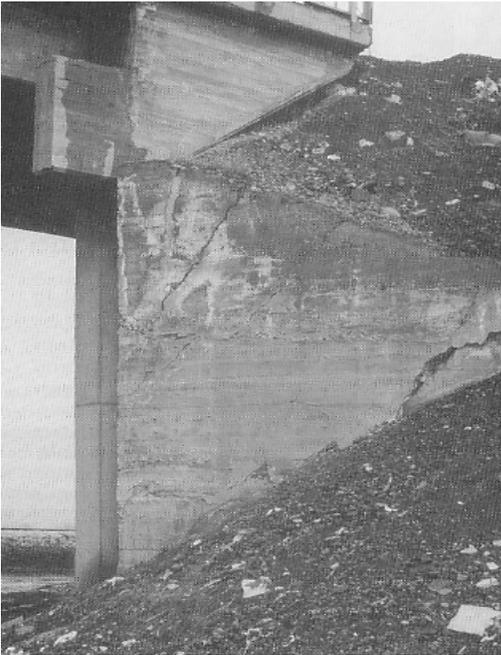
Cracking of abutment wall – Level IV

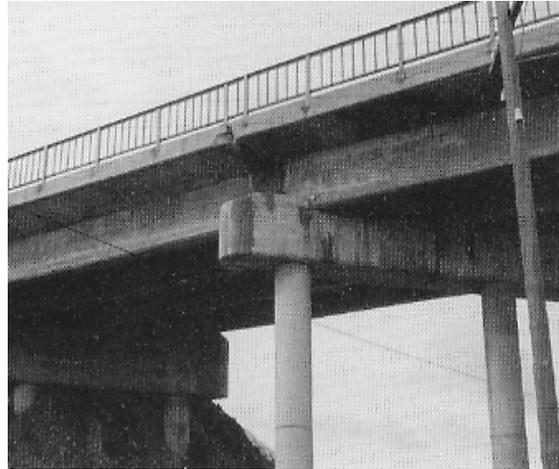
Pounding above piers – Level V

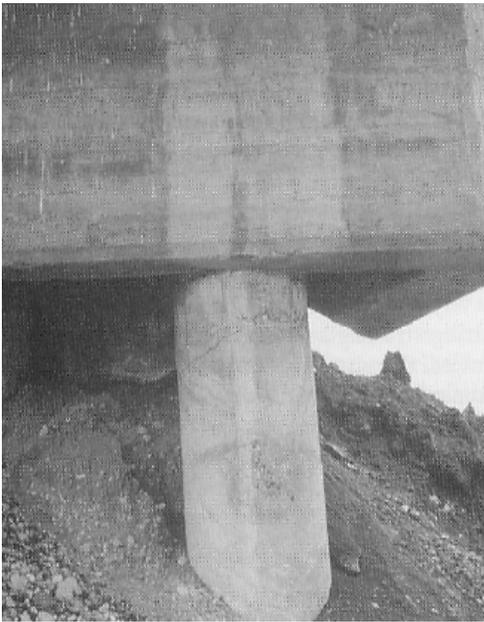
Shear crack on column – Level IV

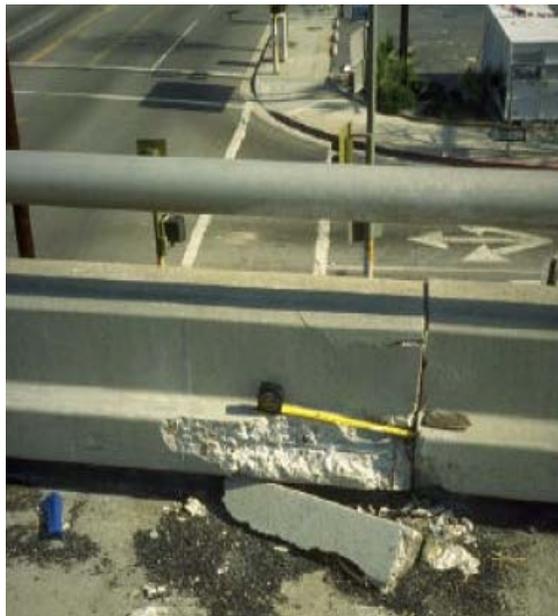
Barrier cracking – Level IV

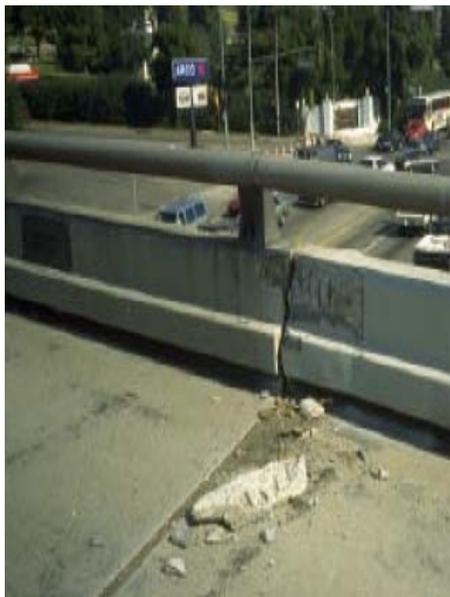
Deck damage- Level IV

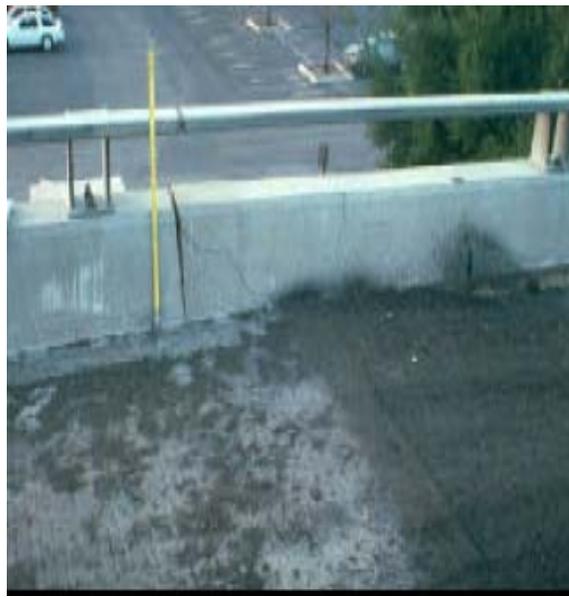
Curb separation – Level IV

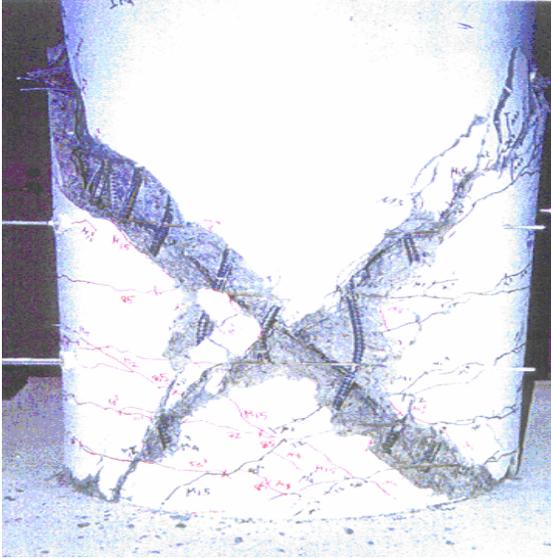
diagonal crack (plastic hinge region-base)

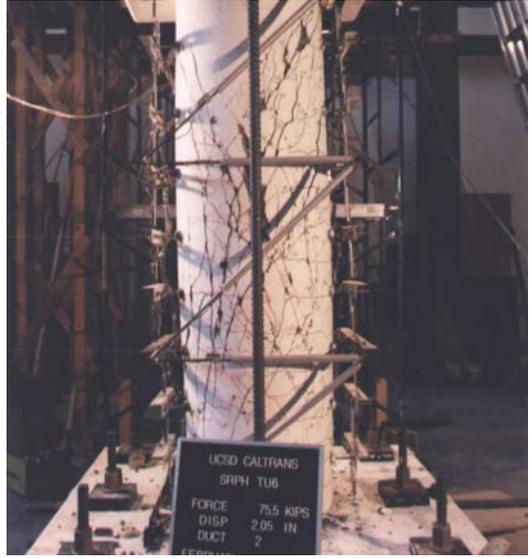
Diagonal crack- midheight

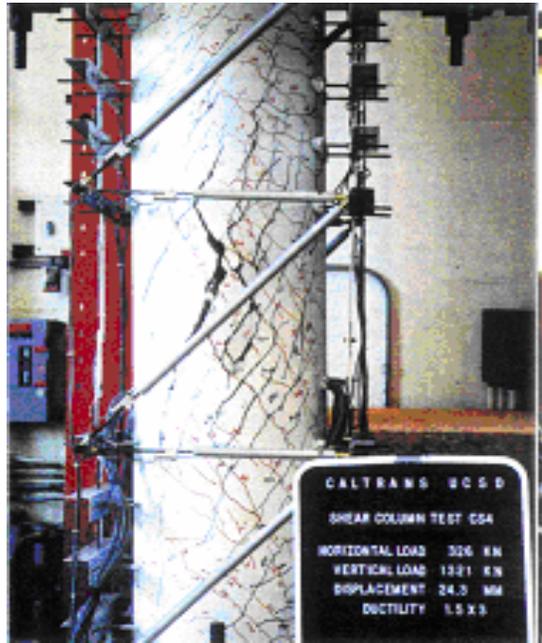
Diagonal crack - midheight

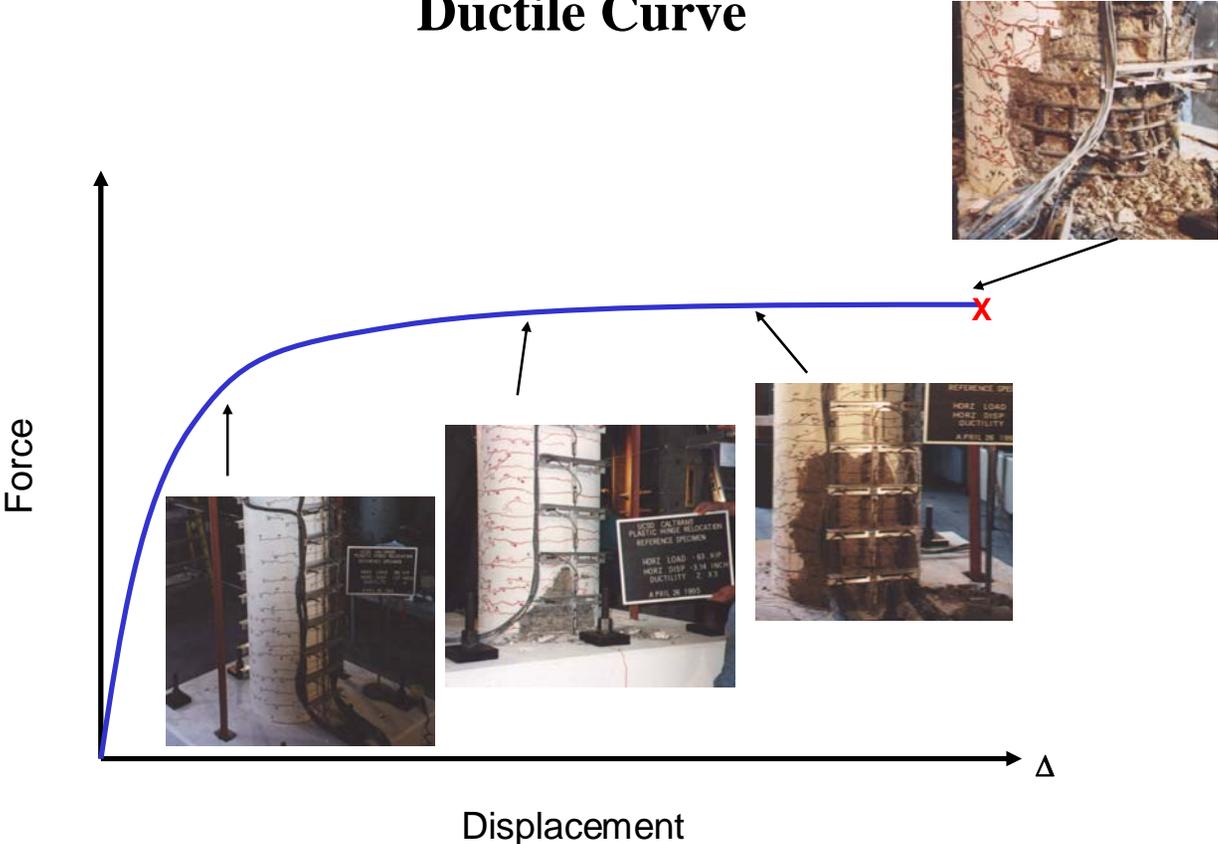
Ductile Curve

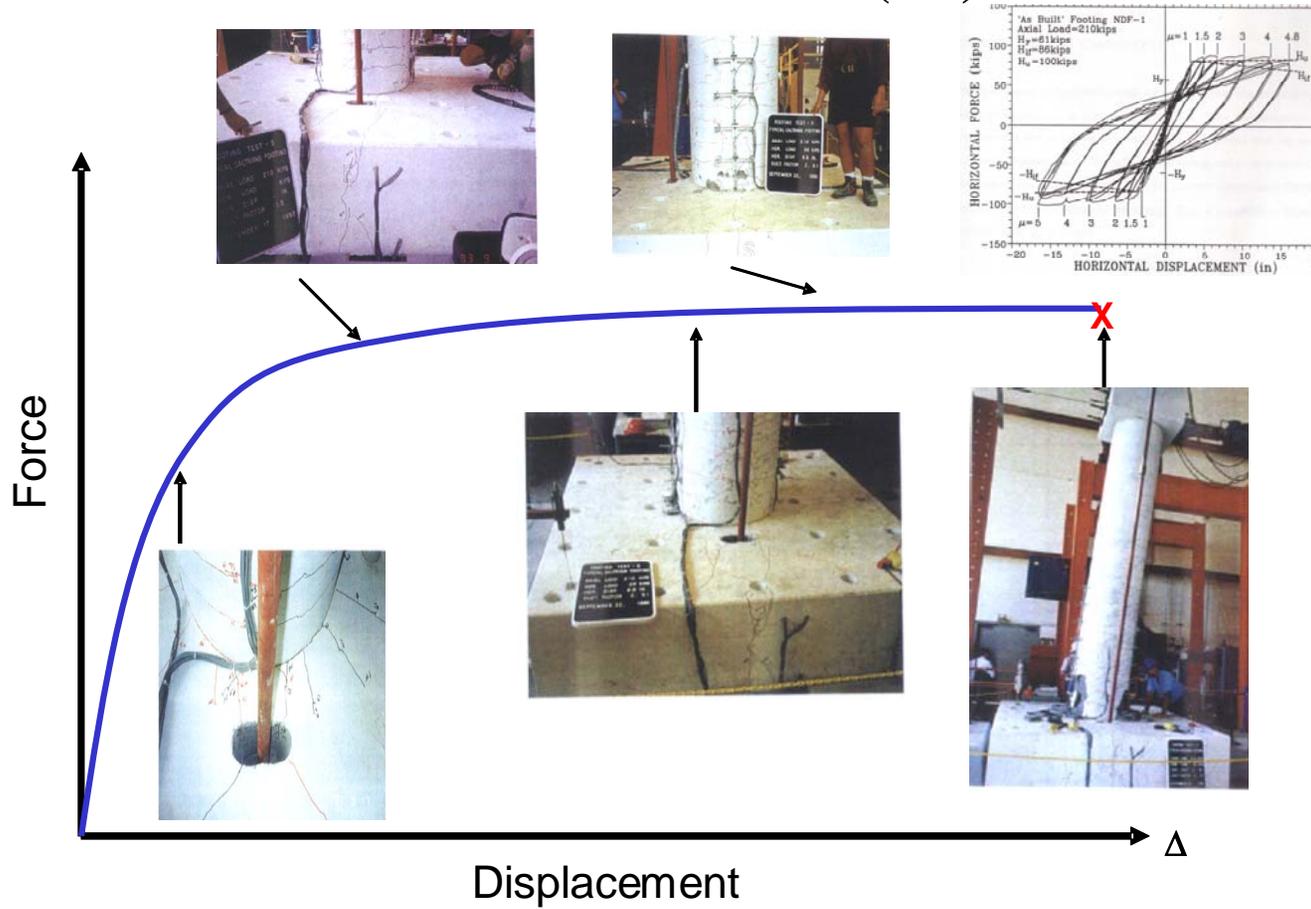
Ductile Curve (F4)

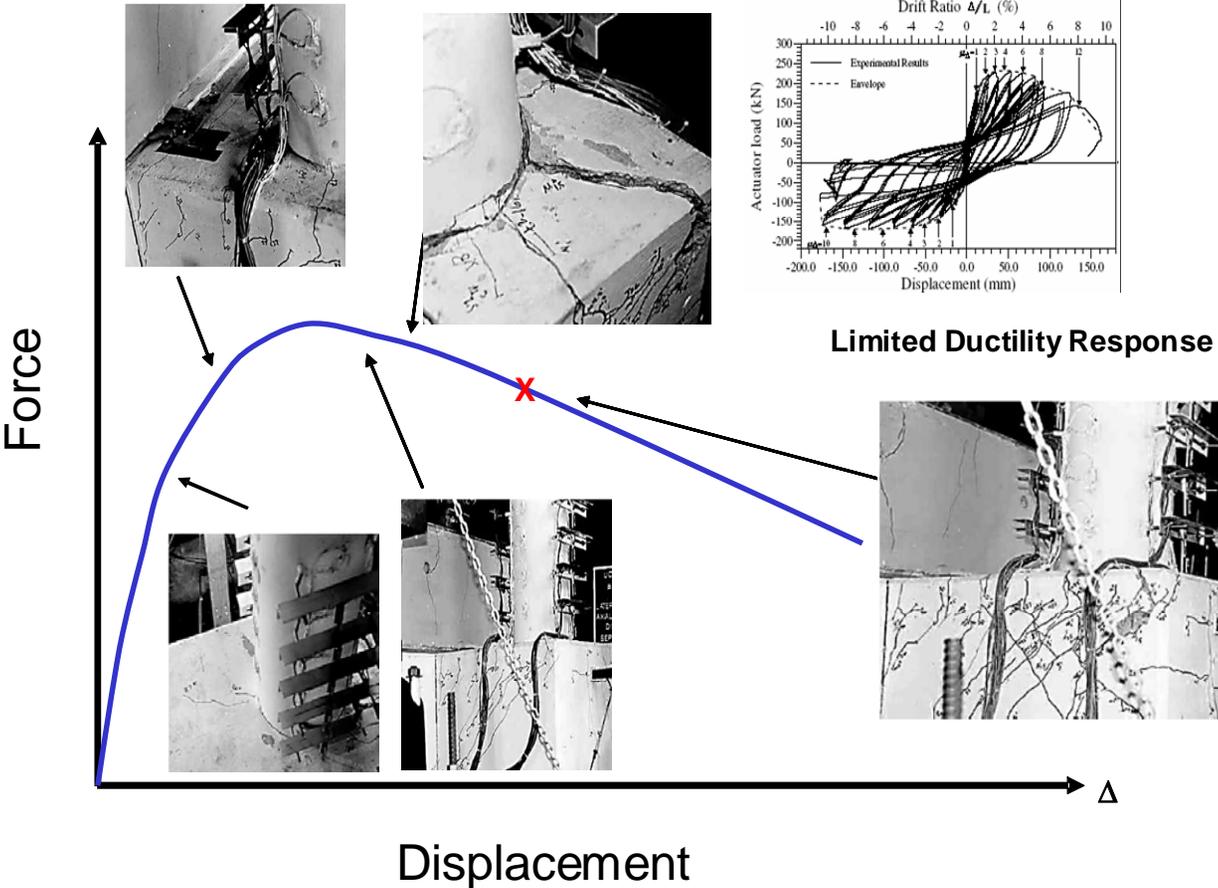
Degrading Curve (F3)
