ASBESTOS AND LEAD-CONTAINING SURFACES SURVEY

LIMITED ASBESTOS SURVEY REPORT

**ASBESTOS AND LEAD-CONTAINING
SURFACES SURVEY
KEARNY MESA MAINTENANCE STATION
LABORATORY BUILDING REMODEL
7177 OPPORTUNITY ROAD
SAN DIEGO, CALIFORNIA
TASK ORDER NO. 20, EA NO. 11-287700
CONTRACT NO. 11A1023**

January 18, 2008
Project No. 105388020

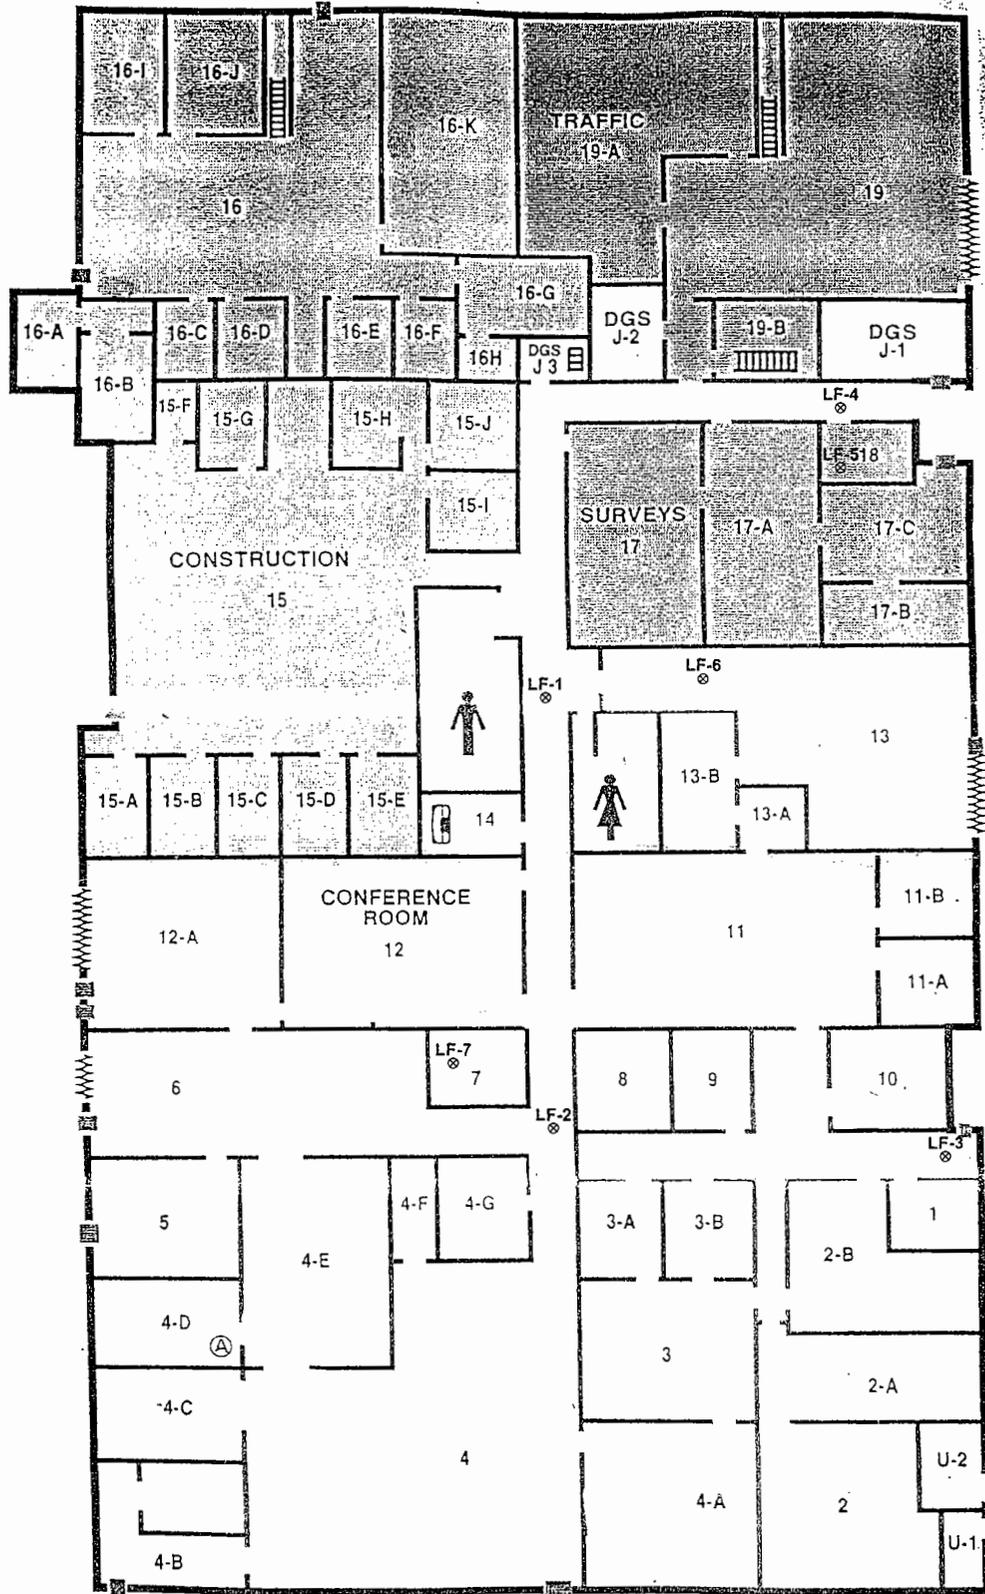
Ninyo & Moore		XRF SAMPLE LOCATION MAP	FIGURE
PROJECT NO.	DATE	7177 OPPORTUNITY ROAD SAN DIEGO, CALIFORNIA	3
105388020	1/08

To test potential LCSs for future contractor safety and waste characterization, a portable NITON XL 309 XRF spectrum analyzer was utilized. The testing was conducted in general accordance with accepted environmental science and engineering practices for renovation and/or demolition projects. The testing methodology utilized is presented in Appendix B. A total of 76 XRF readings (including calibrations) were collected. Surfaces that were tested for the presence of lead are presented in the attached Table 2. The XRF testing orientation (A, B, C, and D wall orientations) utilized during the testing are provided on the attached sample location map (Figure 3). The locations of surfaces found to be lead-containing are

indicated on Figure 3. Surfaces found to contain lead concentrations in excess of 1.0 milligrams per square centimeter (mg/cm^2), which is the regulatory standard for lead in surface coatings, are summarized in Table 4, including the locations of the surfaces.
