STATE OF CALIFORNIA  
DEPARTMENT OF TRANSPORTATION  
DIVISION OF RESEARCH AND INNOVATION  
OFFICE OF MATERIALS AND INFRASTRUCTURE

**DEVELOPMENT OF STAKING CONFIGURATIONS  
FOR K-RAIL**

1. REPORT NO. FHWA/CA/MI-2006/21	2. GOVERNMENT ACCESSION NO.	3. RECIPIENT'S CATALOG NO.	
4. TITLE AND SUBTITLE <b>DEVELOPMENT OF STAKING CONFIGURATIONS FOR K-RAIL</b>		5. REPORT DATE December 2008

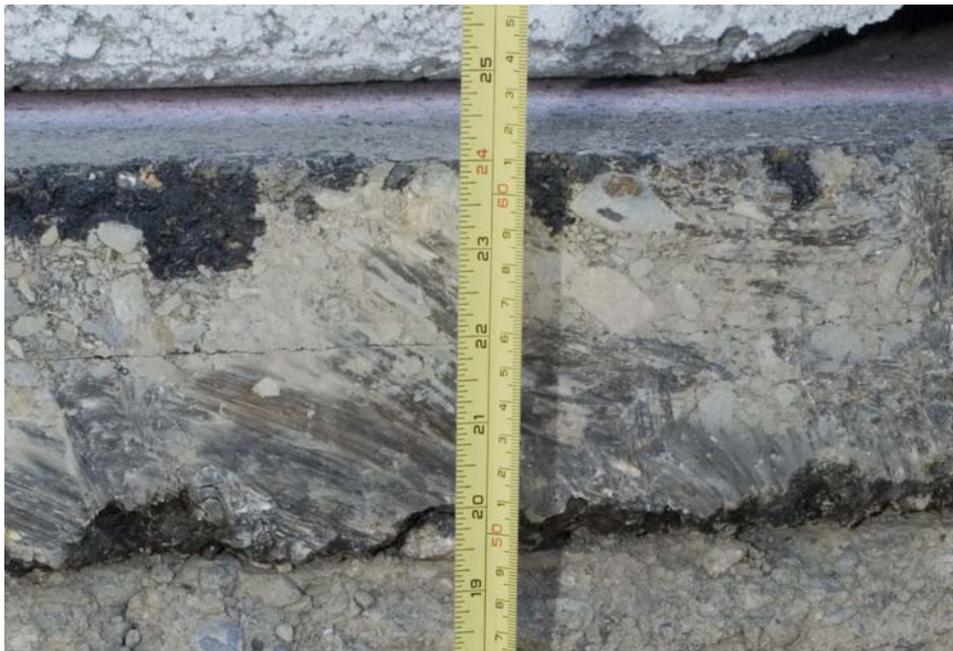
Figure 2-1. Asphalt Concrete Thickness

All of the crash tests were conducted at the Caltrans Dynamic Test Facility in West Sacramento, California. The test area is a large, flat, asphalt concrete surface containing 2 overlays (Figure 2-1). Each overlay measured approximately 51 mm (2 in) thick. There were no obstructions near or within the testing area.

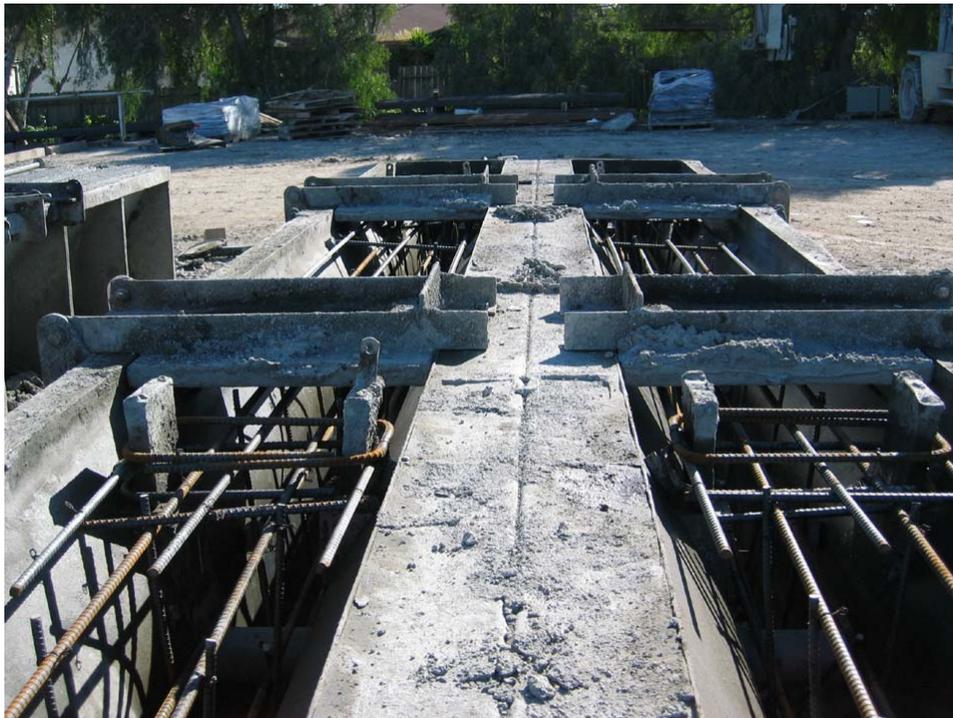
Figure 2-2. K-rail Rebar Placement

The K-rail was purchased new at Concrete Products in Tracy, CA. The K-rail was manufactured to Caltrans' Standard Plans and Specifications. Members of the Roadside Safety and Research Group visited the plant to inspect the K-rail. They evaluated the construction process, collected concrete samples for testing, measured the concrete temperature, performed a slump test, and checked the rebar placement (Figure 2-2).

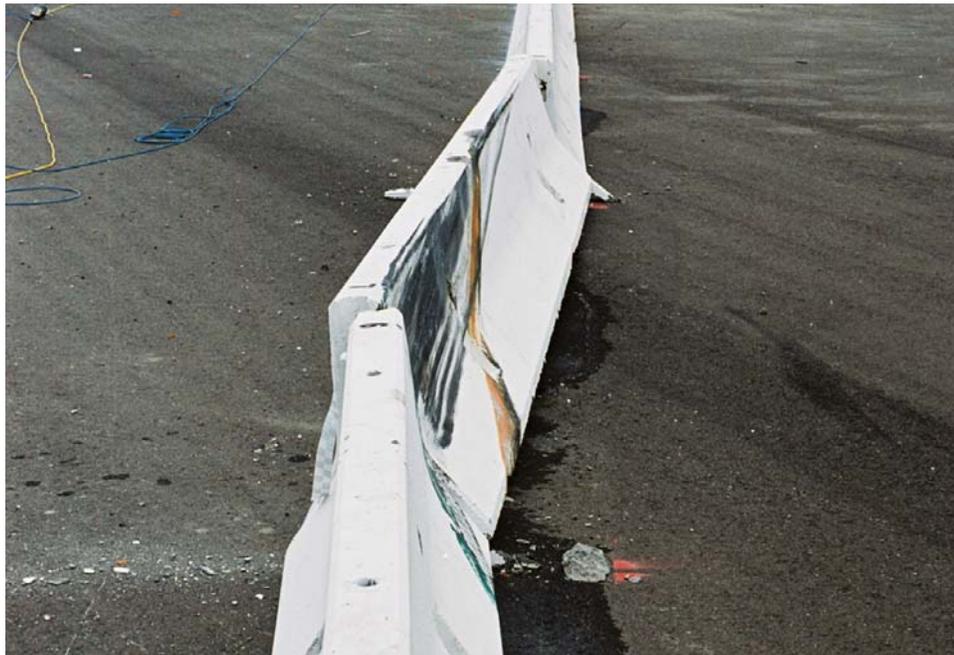
Figure 2-11. Test 671 - Downstream View of Barrier Post-Impact

The pin and loop connection between sections 5 & 6, 6 & 7 (nearest to the impact point) and 7 & 8 bent and caused spalling at the joint. Sections 6 through 12 had scuffmarks. Sections 10 and 11 had minor scuffing on the top, which occurred when the vehicle rode on top of the barrier. The upstream stake in Section 6 & both stakes in Section 7 were bent. The staked, upstream slot in Section 6 had spalling. The maximum lateral static displacement was 370 mm (14.6 in), and the maximum lateral dynamic displacement was 389 mm (15.3 in) at the toe. Static measurements were taken with a tape measure and dynamic measurements were obtained via film analysis. After impact, segments 6 and 7 maintained a backward lean due to obstructions under the K-rail.

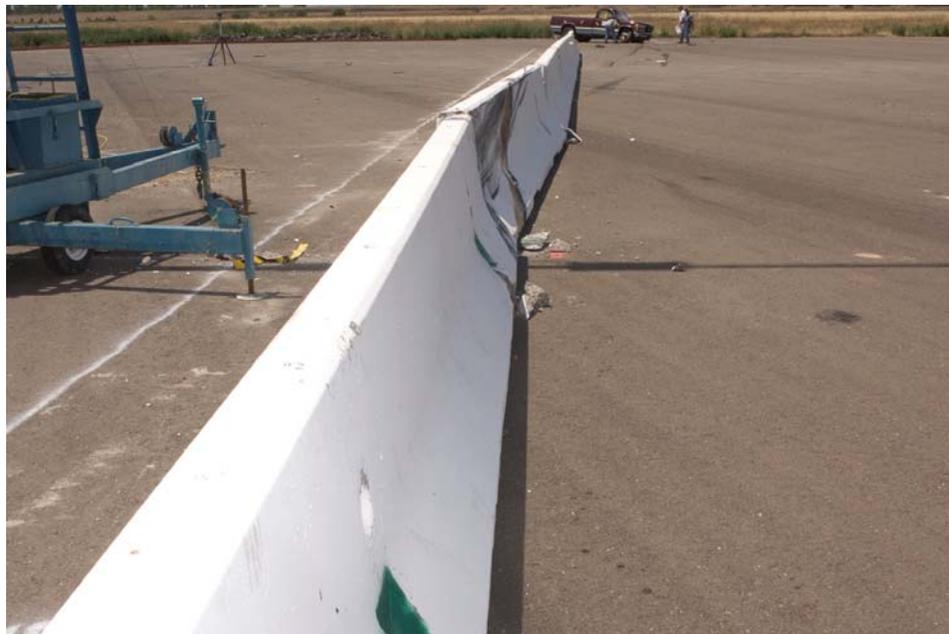
Figure 2-24. Test 672 - Downstream View of Barrier Post-Impact

The pin and loop connection between sections 5 & 6, 6 & 7 (nearest to the impact point) and 7 & 8 bent and caused spalling at the joint. Some stakes in Section 6 were bent and the slots they were in had spalling. Sections 6 and 7 had scuffmarks from the impact. Sections 10 through 12 had minor scuffing on the top, which occurred when the vehicle rode on top of the barrier. Section 7 underwent the most movement with a maximum lateral static displacement of 205 mm (8.1 in) and maximum lateral dynamic displacement of 256 mm (10 in) at the toe. Static measurements were taken with a tape measure and dynamic measurements were obtained via film analysis.

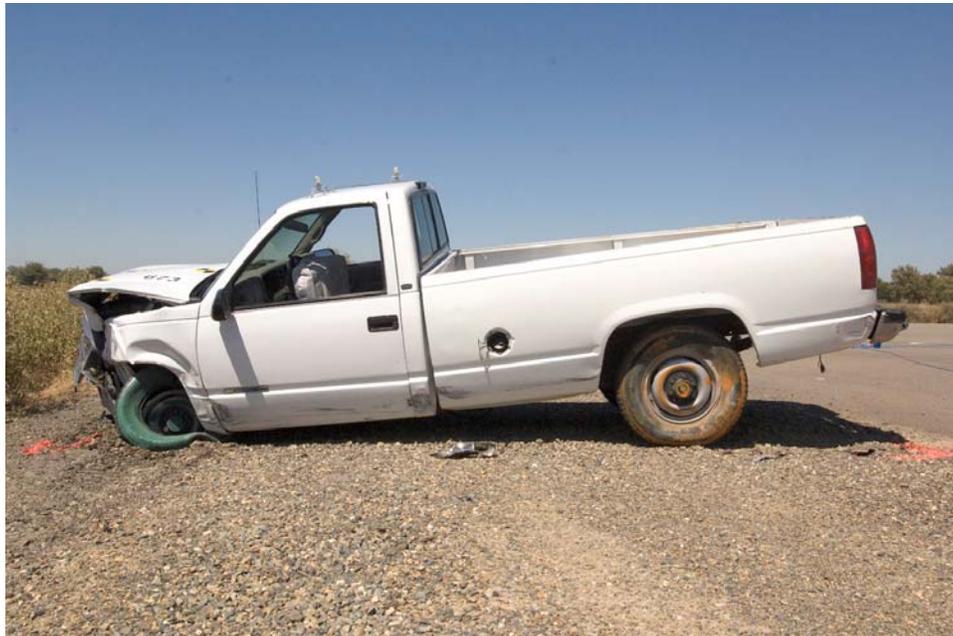
Figure 2-40. Test 673 - Side View of Vehicle Post-Impact

The initial impact damaged the left front corner of the vehicle. The left front quarter panel and bumper were crushed. A secondary impact occurred when the vehicle impacted a barrier protecting a camera. The impact was located at the left front corner again and further damaged the area. The hood was crushed inwards and the left front tire and rim were damaged. The maximum floorboard intruded<sup>d</sup> into the occupant compartment by 3 cm (1.2 in). The floorboard deformation area was approximately 3275 cm<sup>2</sup> (3.5 ft<sup>2</sup>) and was located at the left front corner.

For Test 673, the vehicle impacted a K-rail section that had greater lateral and uplift resistance from the stakes than previous tests (due to the number of stakes and the caps); thus, Test 673's vehicle was damaged more than previous tests.

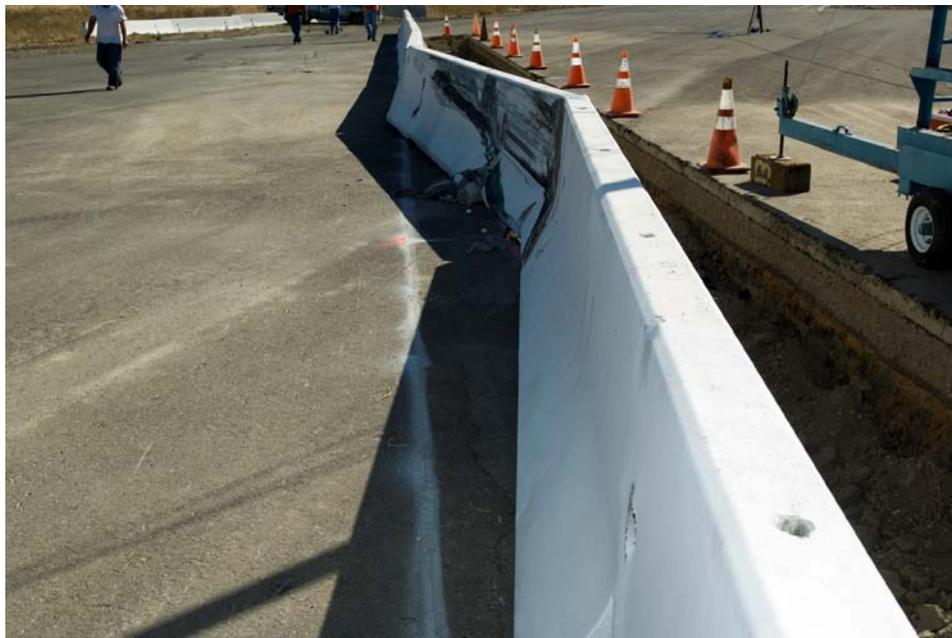
Figure 2-50. Test 674 - Downstream View of Barrier Post-Impact

The pin and loop connection between sections 7 & 8 (nearest to the impact point) and 8 & 9 bent and caused spalling at the joint. Section 8 had spalling at the upstream, impact-side slot due to the stake bending. The upstream, excavation-side stake in Section 8 broke through the AC. The maximum lateral static displacement was 670 mm (26.3 in). Static measurements were taken with a tape measure. Due to the angle between the vehicle targets and the camera, the dynamic displacement could not be accurately measured.

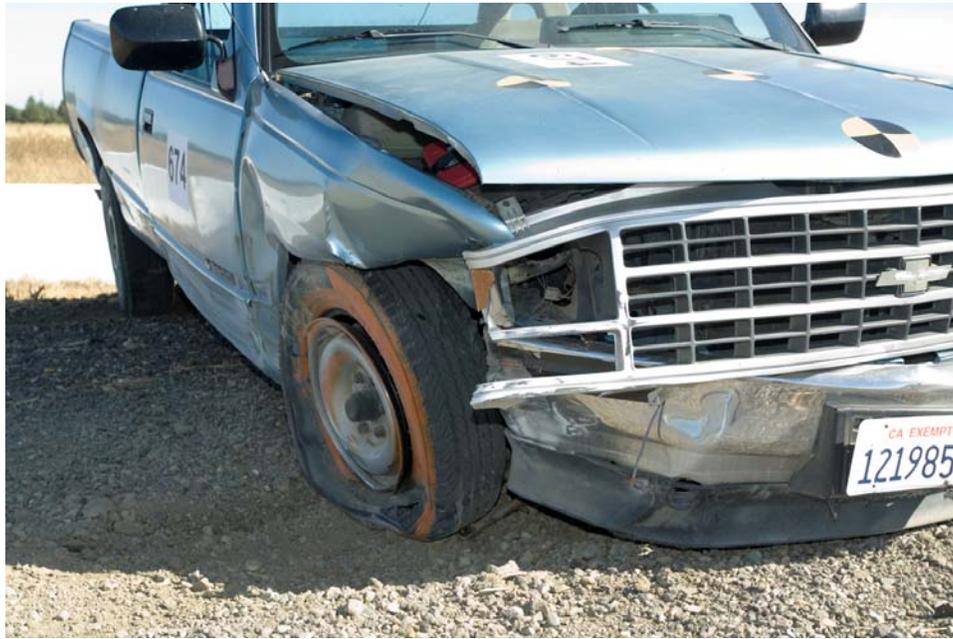
Figure 2-57. Test 674 - Front-right View of Vehicle Post-Impact

The impact damaged the right front corner of the vehicle. The right front quarter panel and bumper were crushed. Both front tires were damaged. The body on the right side had minor body damage from scraping against the barrier. The bottom of the tailgate detached from the bed and was held in place by the upper hinges.

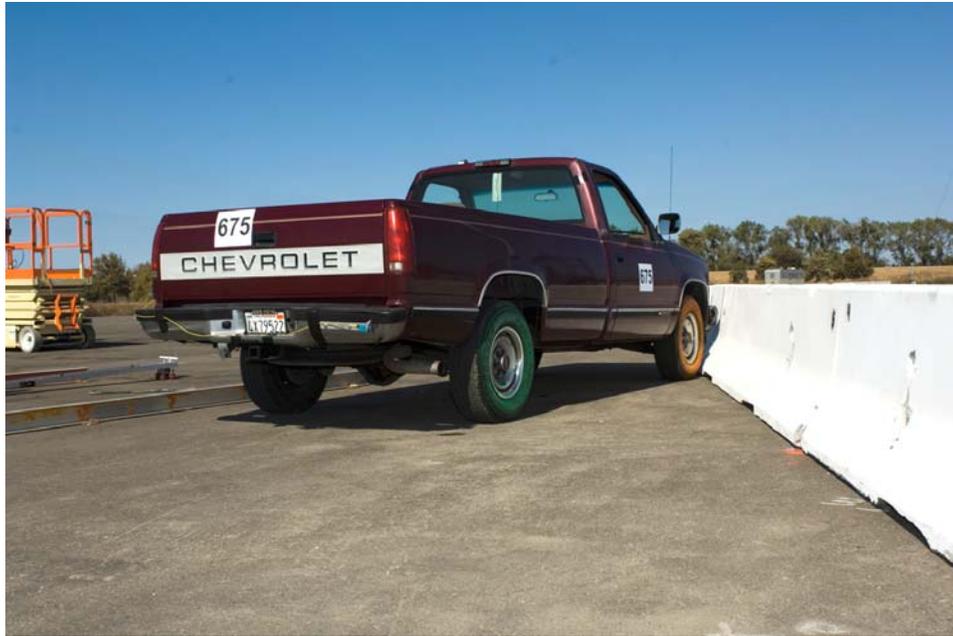
Figure 2-60. Test 675 - Vehicle at Impact Location Pre-Impact

The intended impact angle of 25° and impact location on the vehicle's right-front corner was set by the placement of the guide rail (Figure 2-60). Film analysis indicated that the actual impact angle was 26.4°, and the actual impact location was 170 mm (6.7 in) downstream from the intended CIP. The impact speed of 100.6 km/h (62.5 mph) was obtained by averaging the output from two independent speed traps located just upstream from the impact point. This speed was confirmed via film analysis. Upon impact the vehicle's right front corner was crushed. The vehicle rode upward on the barrier during impact and stayed in contact for 4.5 m (14 ft). Approximately 0.29 s after impact the right rear tire lost contact with the barrier and the vehicle was in the air. The vehicle rolled to the left and its left front tire landed on the ground 12.9 m (42.3 ft) from the CIP and 0.58 s after the initial impact. The brakes were applied 1.17 s after the initial impact as indicated by video analysis using the brake flash. The vehicle came to rest 61 m (200 ft) from the CIP.

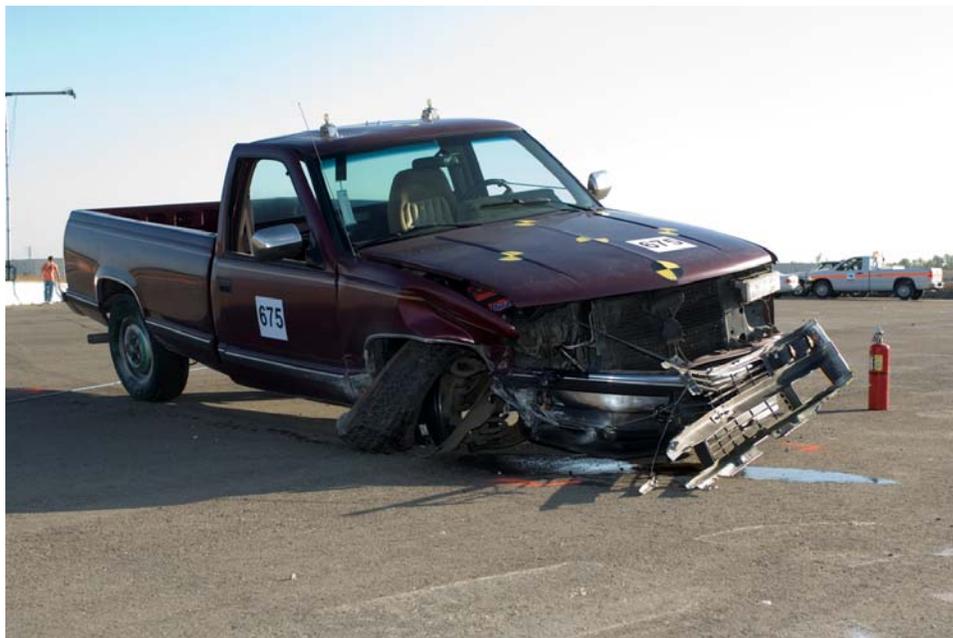
Figure 2-70. Test 675 - Front-right View of Vehicle Post-Impact

The impact damaged the right front corner of the vehicle. The right front quarter panel and bumper were crushed. The tire slipped off the rim. The suspension and steering assemblies were damaged. The tie rod sheered off the spindle. The hub guidance assembly was slightly damaged.

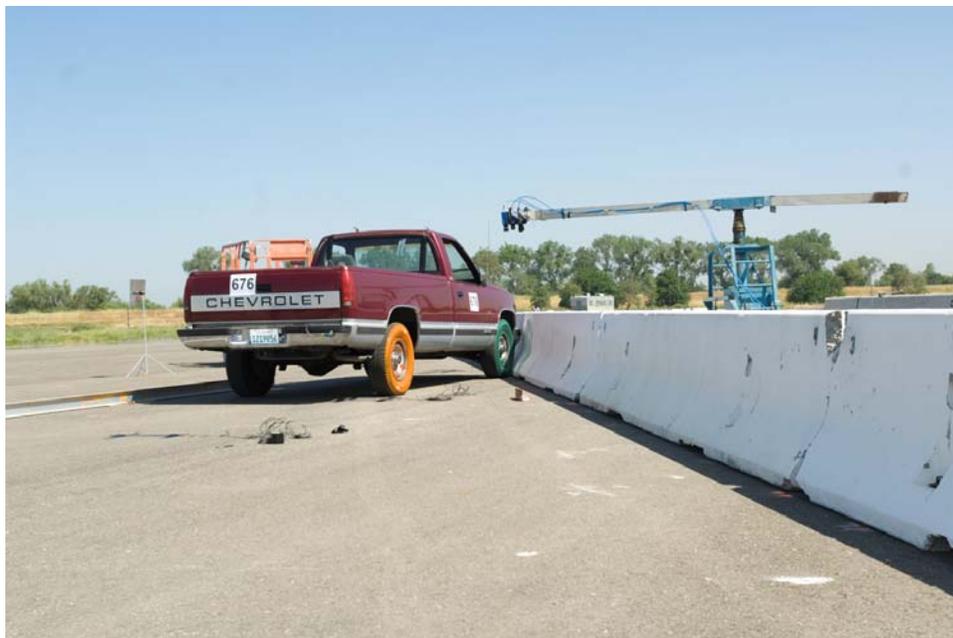
Figure 2-73. Test 676 - Vehicle at Impact Location Pre-Impact

The intended impact angle of 25° and impact location on the vehicle's right-front corner was set by the placement of the guide rail (Figure 2-73). Film analysis indicated that the actual impact angle was 25.1° and the actual impact location was 12 mm (0.5 in) downstream from the intended CIP. The impact speed of 101.8 km/h (63.3 mph) was obtained by averaging the output from two independent speed traps located just upstream from the impact point. This speed was confirmed via film analysis. Upon impact the vehicle's right front corner was crushed. The vehicle rode upwards on the barrier during impact and stayed in contact for 3.4 m (11 ft). Approximately 0.29 s after impact the right rear tire lost contact with the barrier and the vehicle was in the air. The vehicle rolled to its left and its left front tire landed on the ground and barrier simultaneously 13.7 m (44.9 ft) from the CIP and 0.63 s after the initial impact. The rear of the vehicle's undercarriage landed on top of the barrier 48.7 m (160 ft) from the CIP. The vehicle remained in contact with the top of the barrier almost to the end. Approximately 1 m (3 ft) before the barrier's end, the vehicle separated from the barrier and proceeded to rollover. Since the event channel was damaged and the vehicle rolled out of the camera's view, the brake application time is not available. The vehicle came to rest 64 m (210 ft) from the CIP.

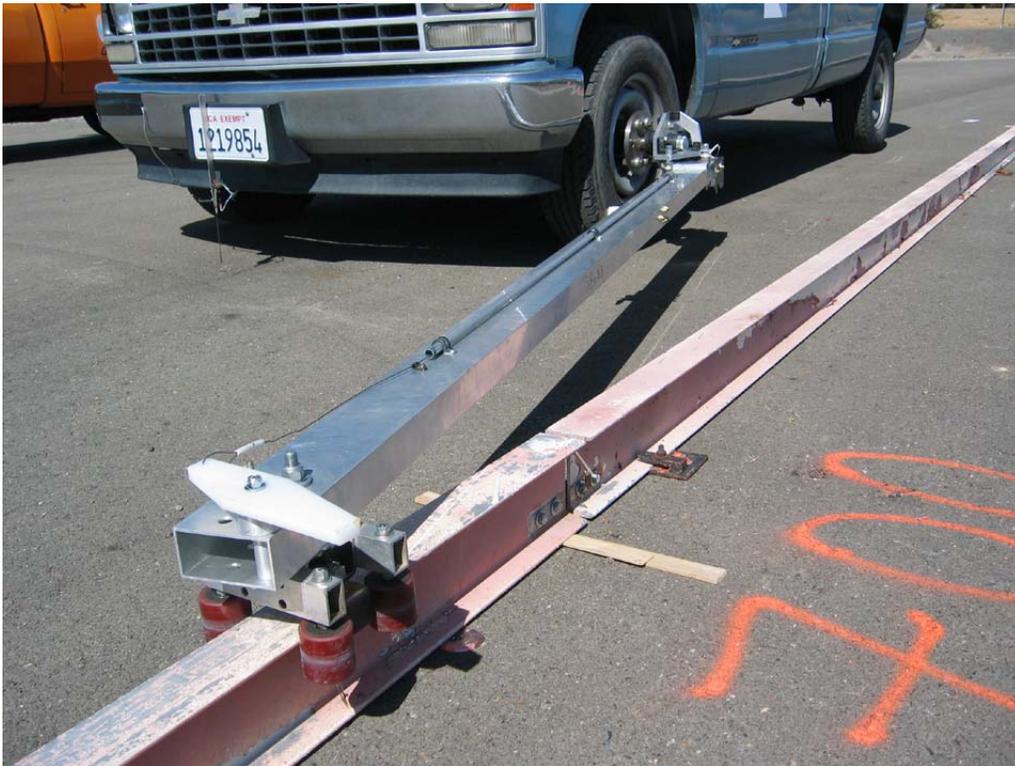
Figure 7-1. Guidance System

A rail guidance system directed all vehicles into the test articles. The guidance rail, anchored at 3.8-m (12-ft) intervals along its length, was used to guide a mechanical arm that was attached to the vehicle's front wheel (Figure 7-1). A 10-mm (0.4-in) nylon rope was used to trigger the release mechanism on the guidance arm, thereby releasing the vehicle from the guidance system before impact.

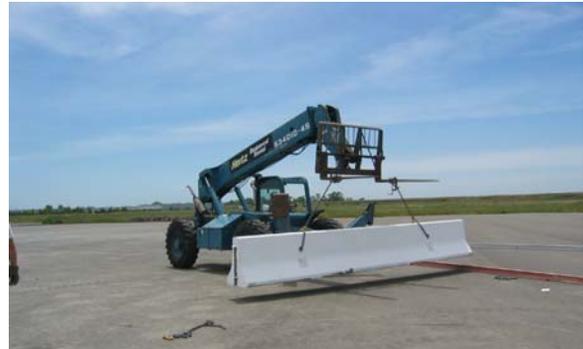
Figure 7-8. Forklift Carrying K-rail

The K-rail barrier was placed on a surveyed line using a forklift with lifting hooks. The pins were placed in the pin-and-loop connection by hand. The barrier was not pull tight to maintain some of the slack in the joints. Holes in the asphalt concrete were drilled by using the K-rail stake holes as guides for a roto-hammer and 7/8-in drill bit. The stakes were installed in the pre-drilled holes using a 60-lb (27-kg) jackhammer with a stake-driving attachment. They were driven in until the head of the stakes cleared the barrier face to prevent wheel snagging (Figure 7-4 and Figure 7-10).

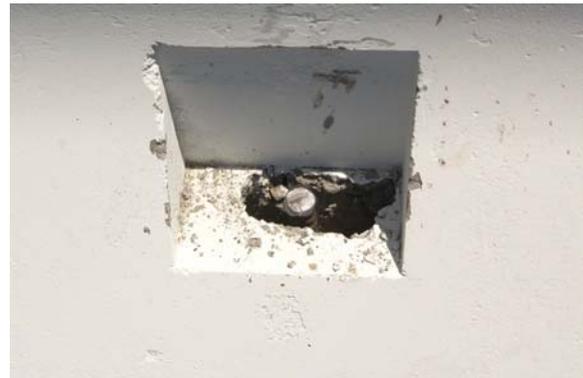
Figure 7-9. Installed Uncapped Stake

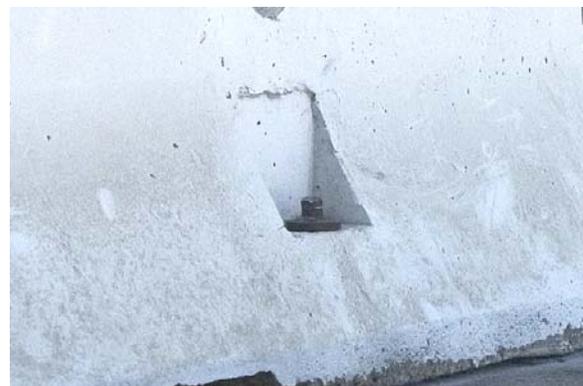
Figure 7-10. Installed Capped Stake
