INFORMATION HANDOUT

LIMITED ASBESTOS AND LEAD-BASED PAINT SURVEY REPORT

ROUTE: 11-SD-5-R59.4/R60.0

CALIFORNIA COASTAL COMMISSION

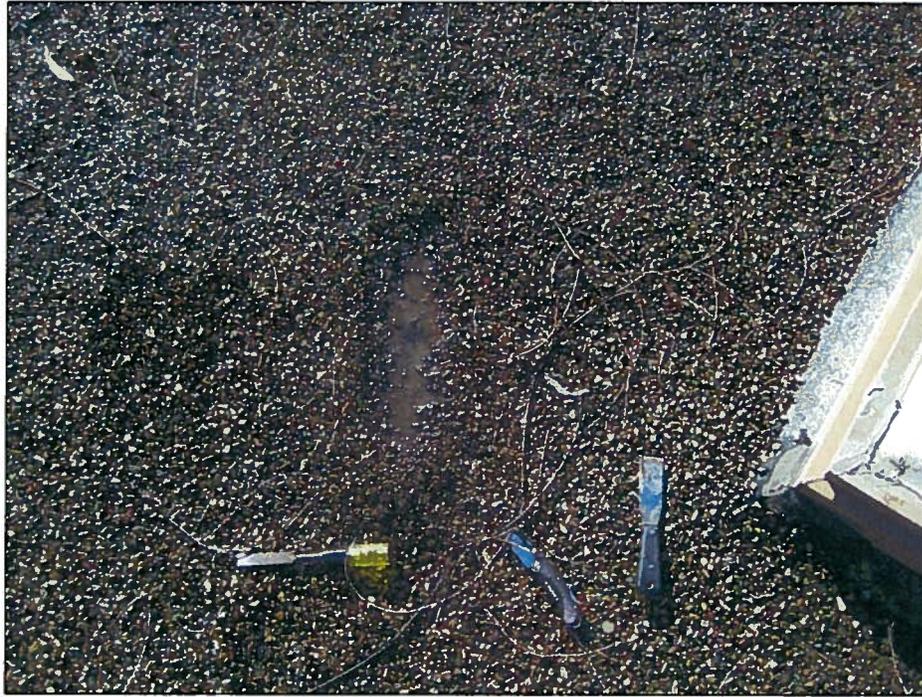
ACS-1A SAMPLE LOCATION-BUILDING 2 ROOF.

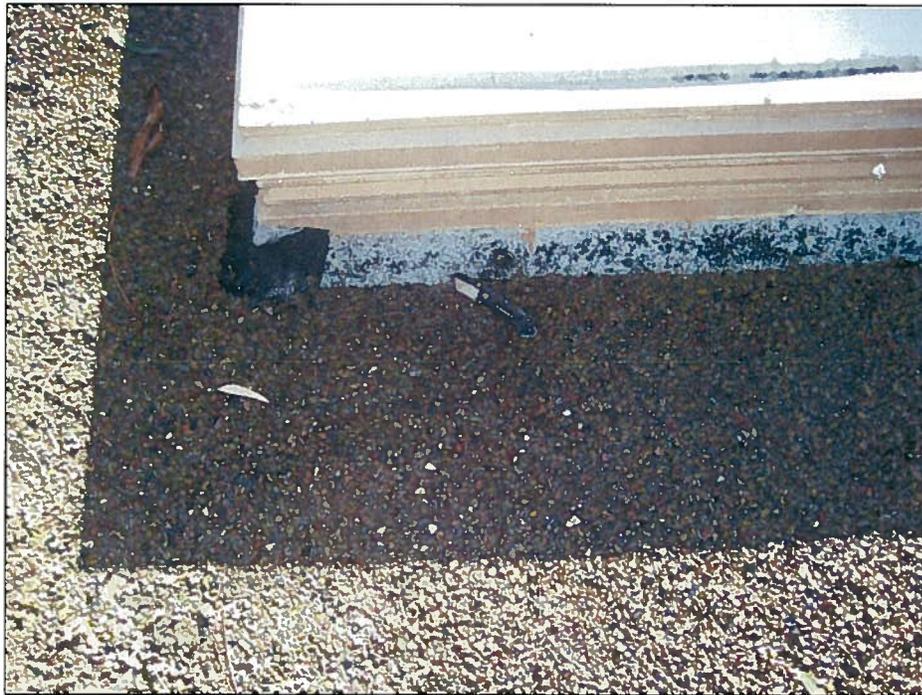
ACS-1B SAMPLE LOCATION- BUILDING 2 ROOF.

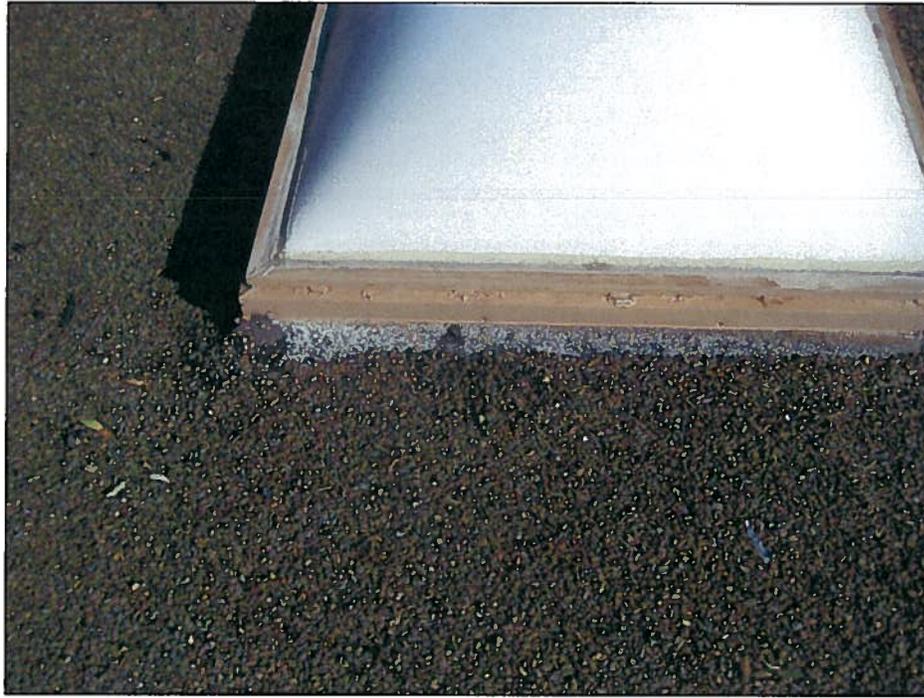
ACS-1C SAMPLE LOCATION-BUILDING 1 ROOF.

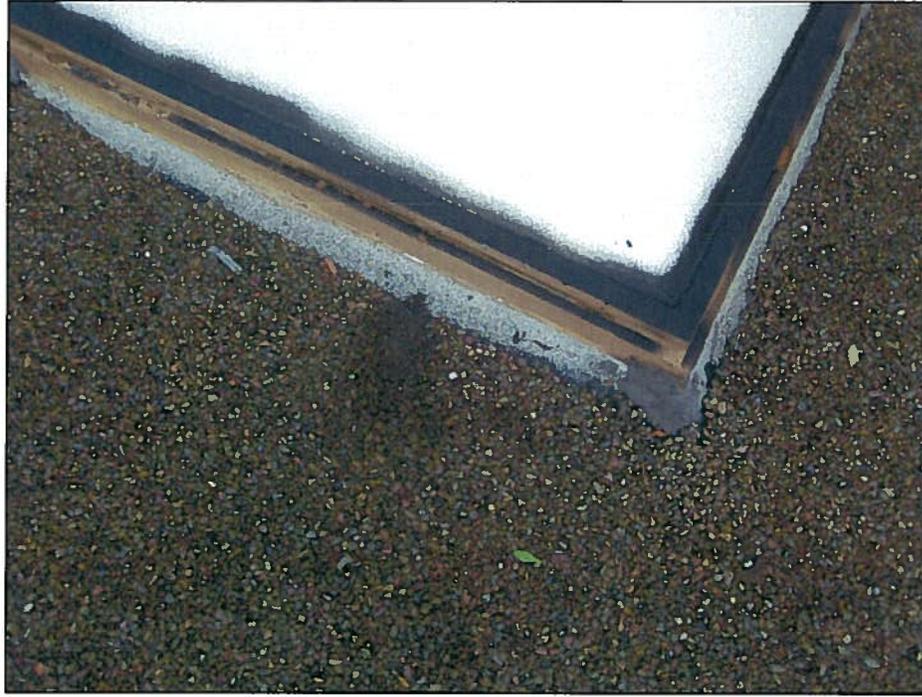
ACN-1A SAMPLE LOCATION-BUILDING 3 ROOF.

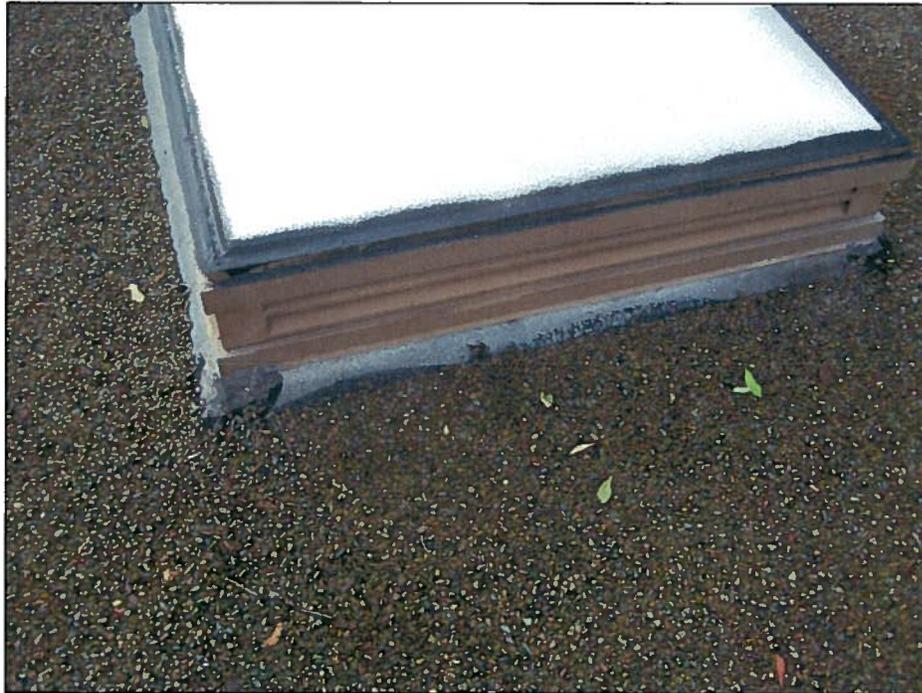
ACN-1B SAMPLE LOCATION-BUILDING 3 ROOF.

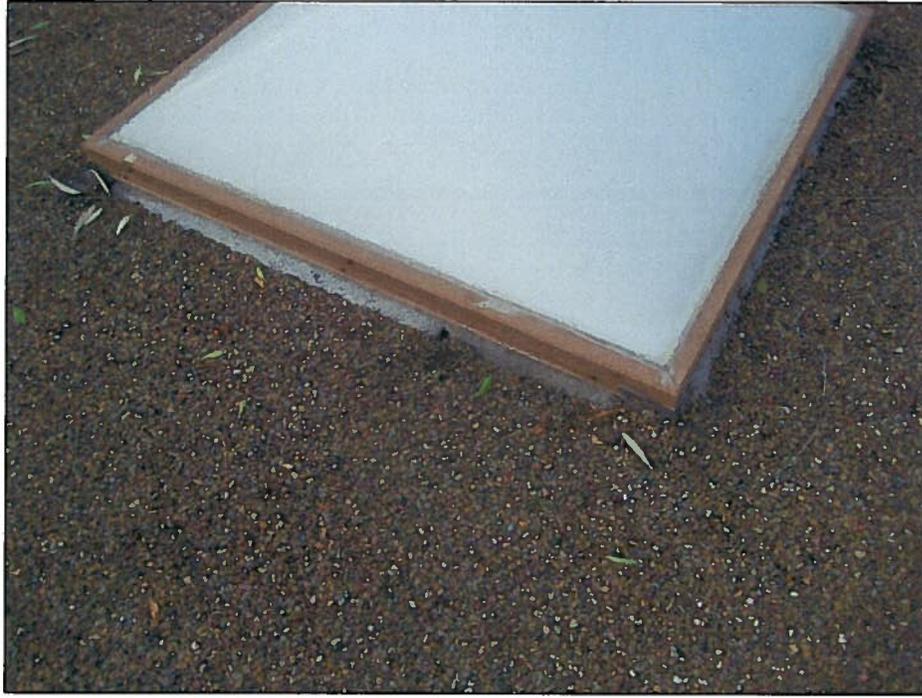
ACN-1C SAMPLE LOCATION-BUILDING 4 ROOF.
